Appendix A
Mine Reclamation Photos

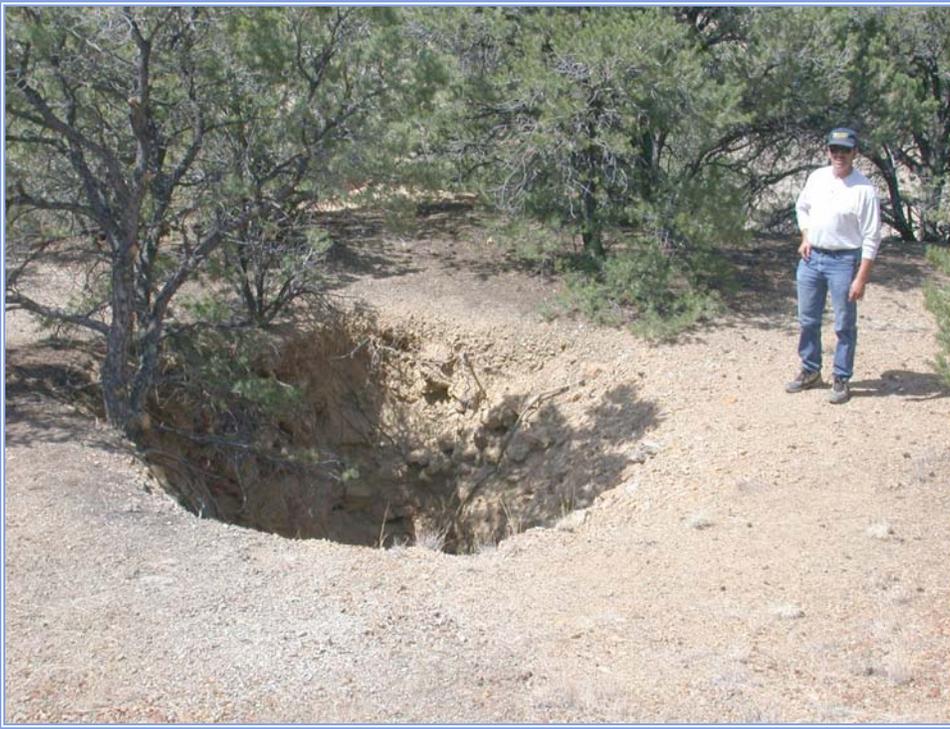
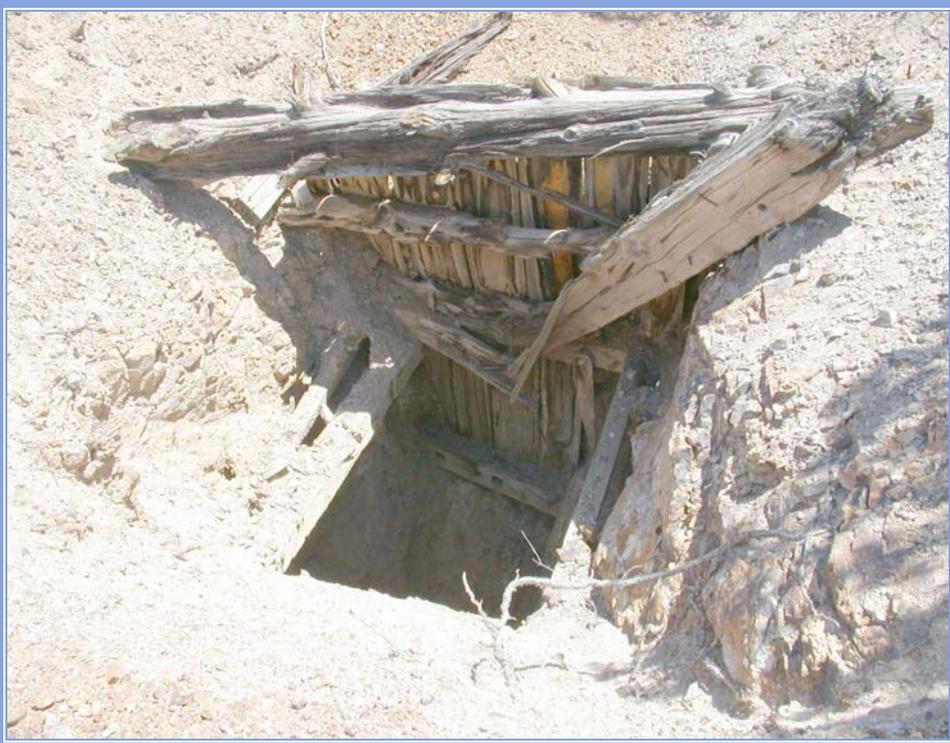
Dangerous Vertical Openings at Cerrillos Mine Safeguard Project.
(Both Opening are High Priority Hazards)

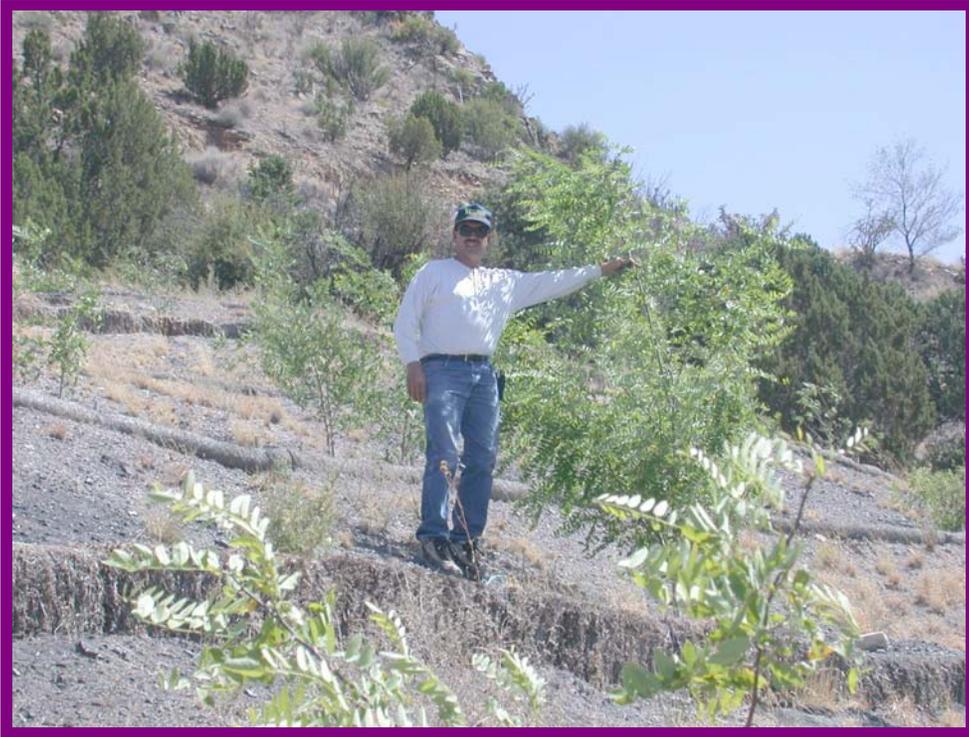
Madrid Reclamation Project – Post-Reclamation Revegetation Success

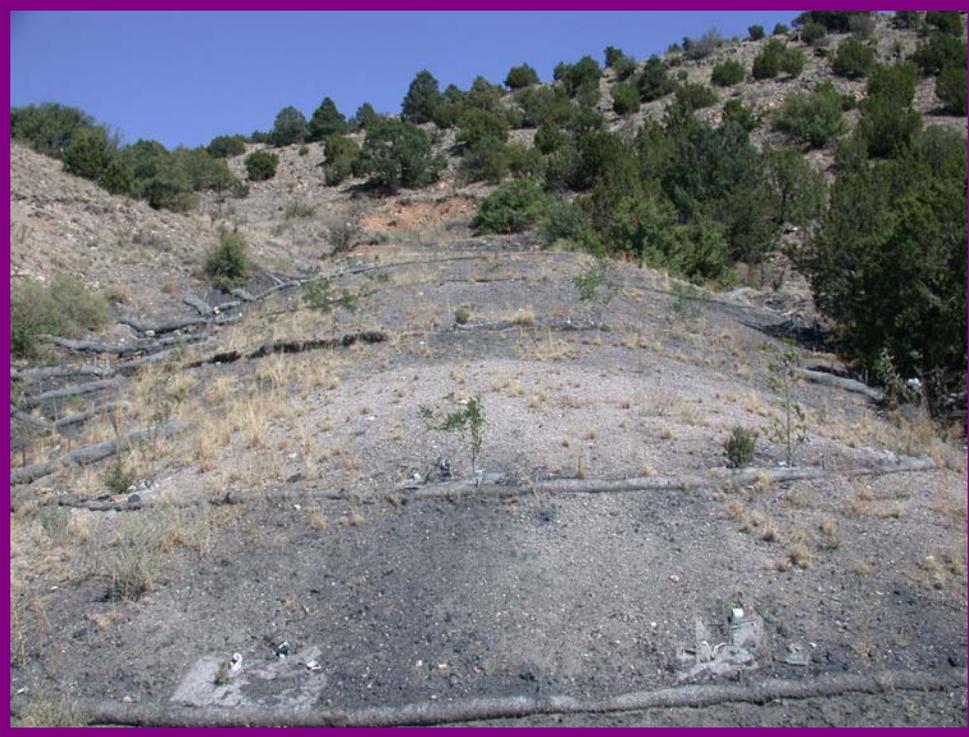
Madrid Reclamation Project – Post-Reclamation Terrace / Stabilization of Coal Waste Pile.

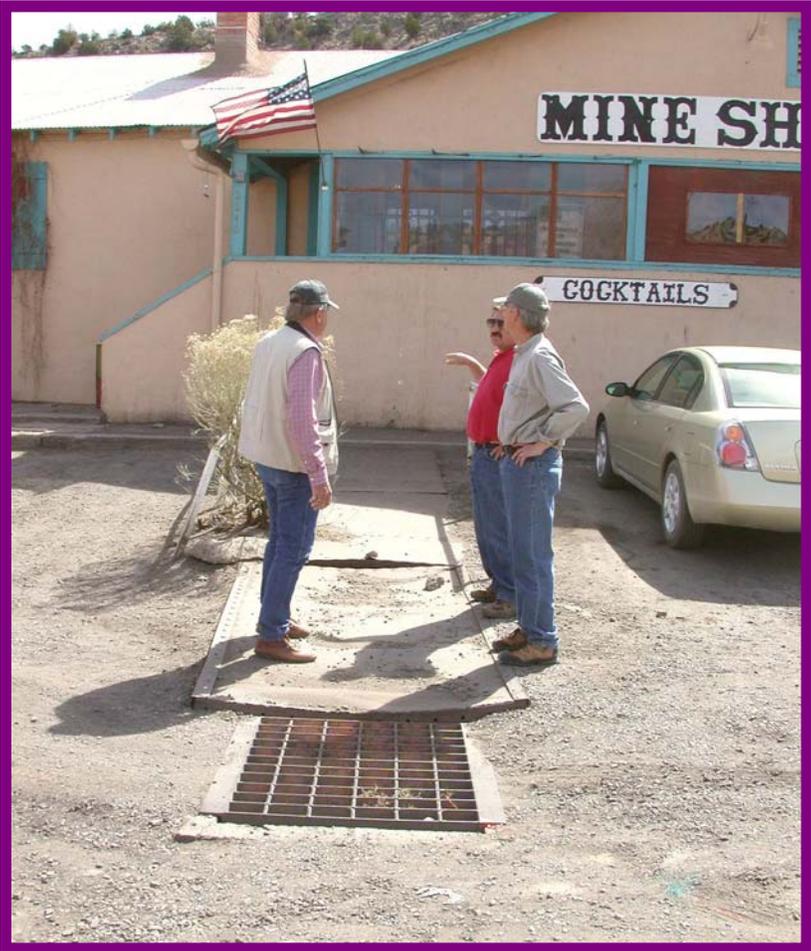
Madrid Drain Project

Top Photograph:
Pre-construction or Existing Drain
Inlet. (On the left is Mr. Bob
Evetts, New Mexico AML
Program Manager)

Bottom Photograph:
Post-construction Drain Inlet.

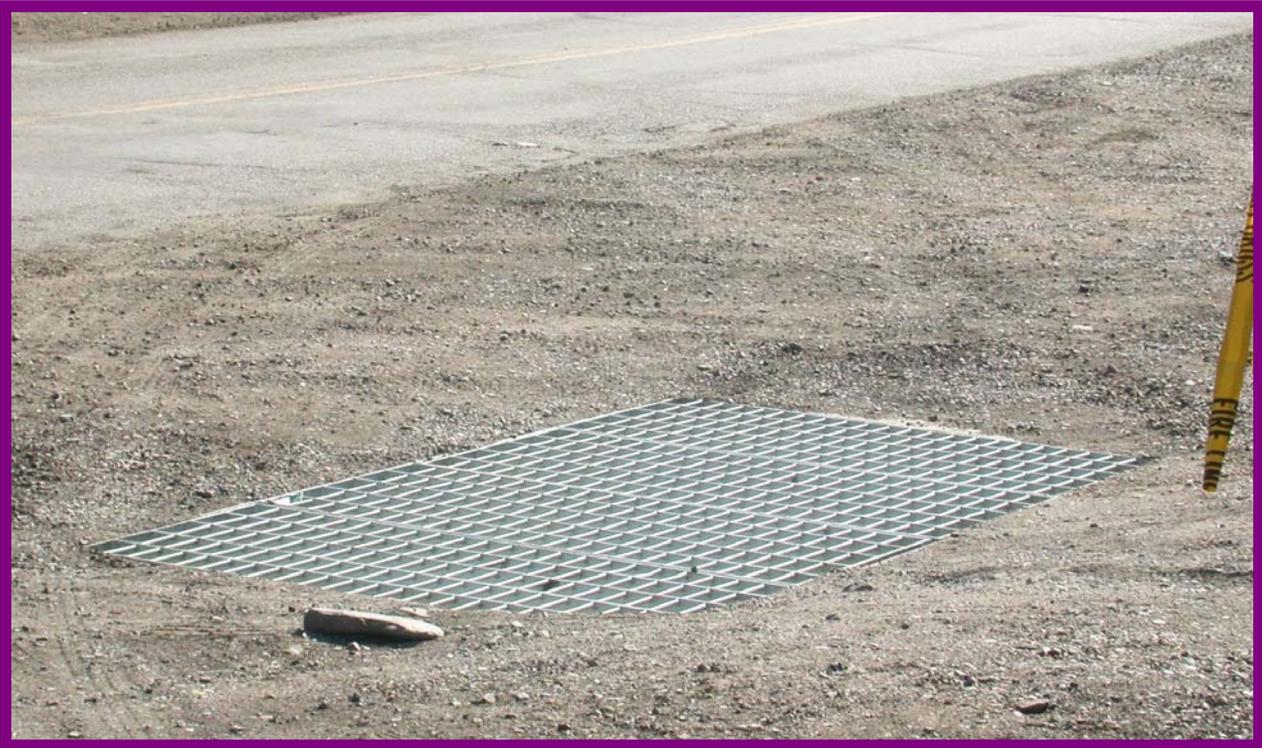
Madrid Road (Highway) Drainage after construction.

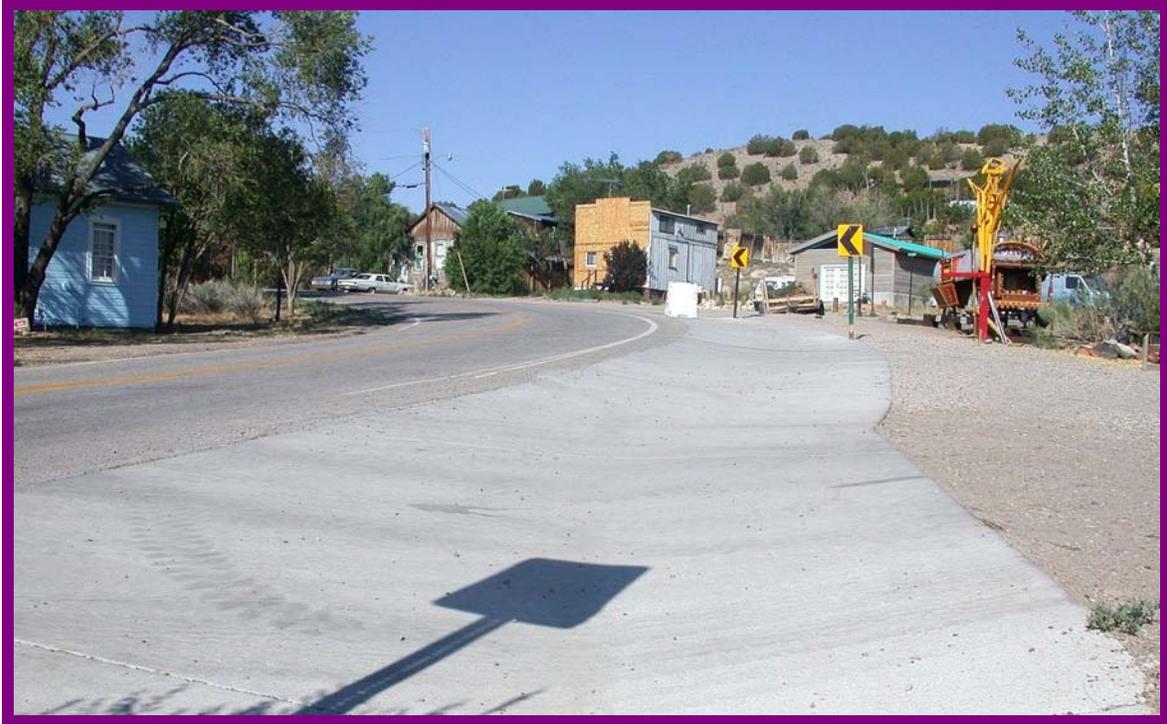
Madrid Drainage near Inlet into Arroyo.
