**Abandoned Mine Reclamation Awards
Indiana 2003**

Victory Mine, Site 82

RACING TO VICTORY

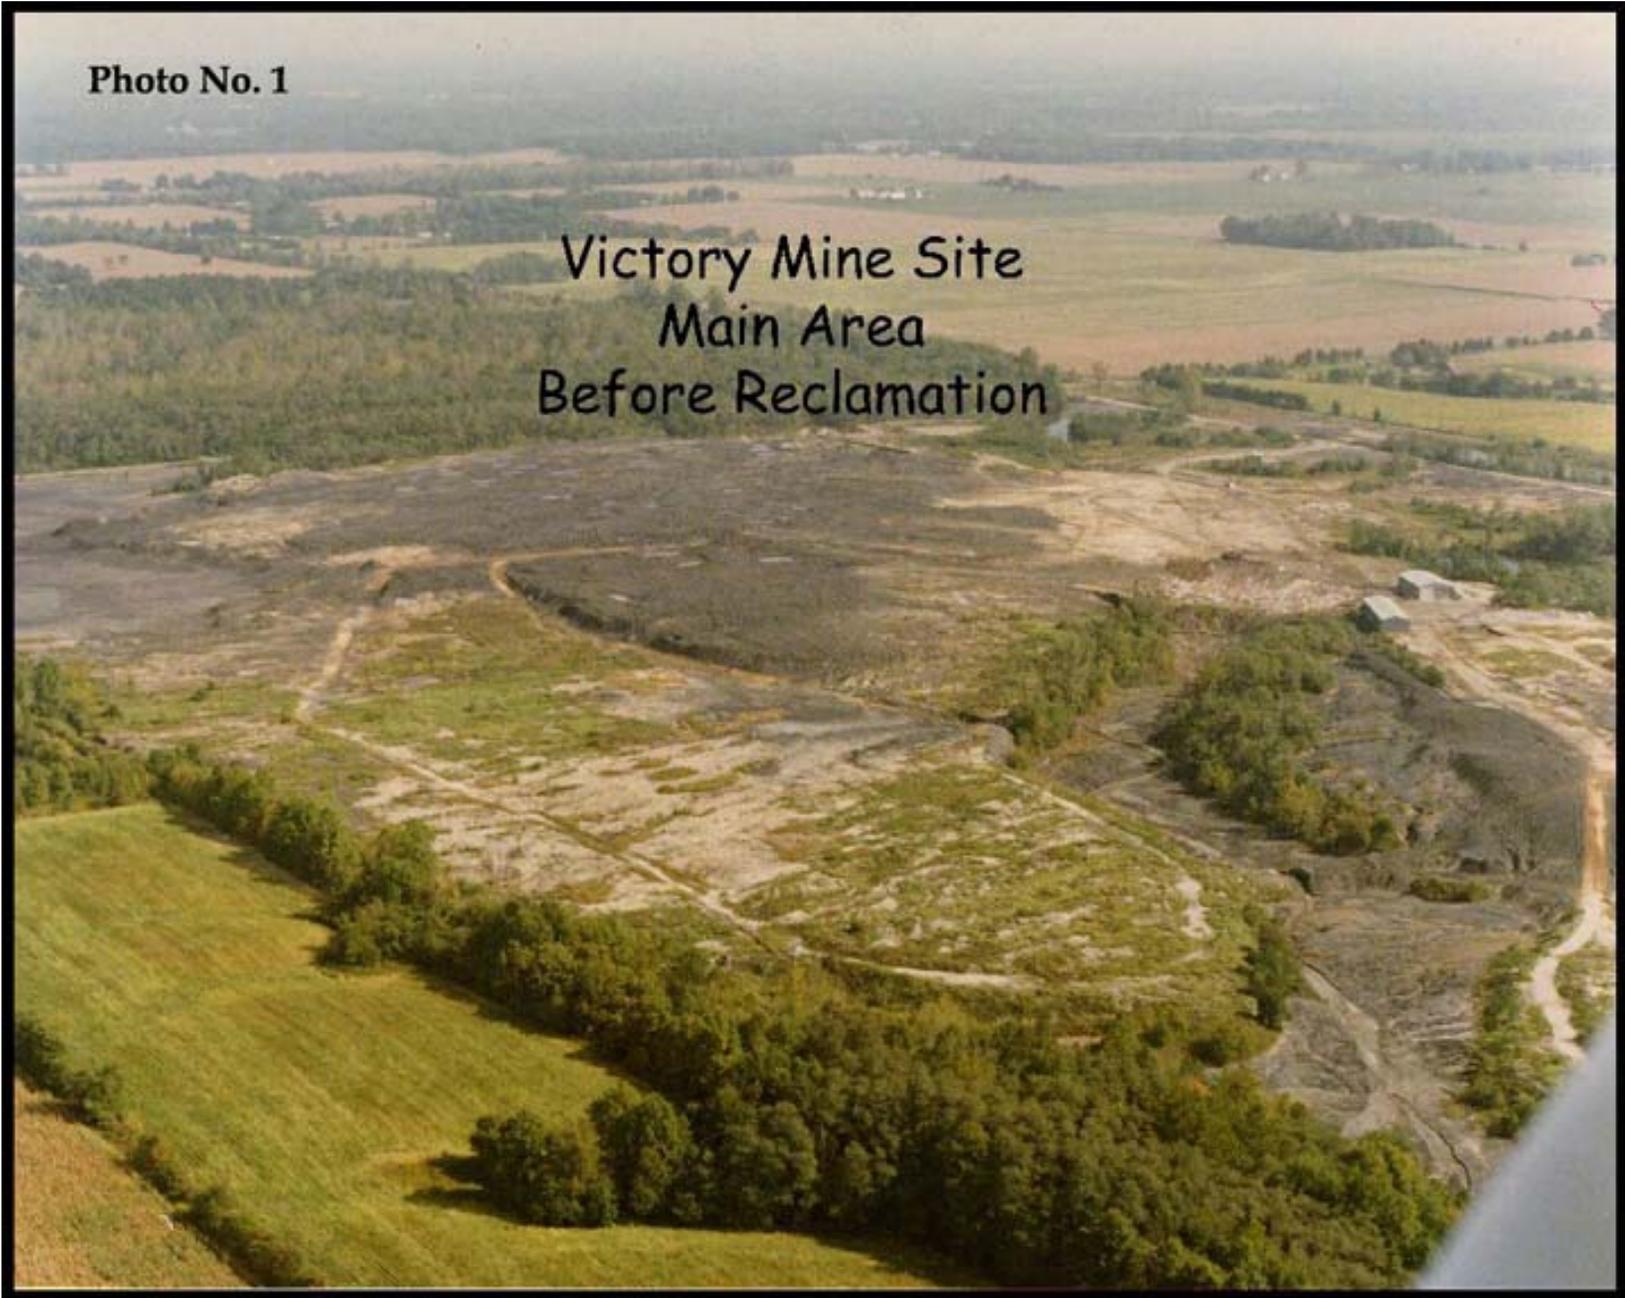
Photo No. 1

The main area consisted of gob and slurry covering 200 acres. The northern 140 acres of the main area was covered with gob up to 40 ft deep (see Photo No. 1). After mine closure in the 1950's, this area became a dumping site and was actually operated as the Vigo County Victory Landfill until the early 1980's. Gob was used as cover material over residential and industrial waste resulting in layers of rubbish intermixed with gob. Concrete foundations from old mine buildings were located on the eastern part of the site along with the open slope entry (see Photo No. 2). The slope entry was open for a distance of 150 ft down to water. Besides the open entrance, a hole existed on top of the entry structure presenting additional hazard to anyone exploring the area. Both the slope entry and the hole on top of the structure were completely unprotected. The east part of the central area was also used by the Vigo County Highway Department to store rock and debris from razed buildings and concrete structures. This material

Victory Mine Site
Main Area
Before Reclamation

Grading of the gob areas presented a particular problem due to buried trash from previous landfill operations being exposed during excavations. Trash resulting from gob grading operations was reburied at a designated area on the site. There were also isolated areas where gob was only one to seven feet deep. This refuse was removed and buried at designated areas on site. Most of the gob and slurry areas were constructed at a 1% to 4% grade with some out-slopes being constructed up to a 25% grade. The grading plan took into consideration the extensive amount of buried trash from landfill operations and the need to establish positive drainage to enhance surface runoff. After sub-grade was established over the gob and the sealed slope entry, the area was then covered with two feet of soil on areas flatter than 6% grade and three feet on slopes greater than 6% grade. Numerous permanent erosion control structures were installed including riprap and erosion control blanket ditches, terraces, concrete and corrugated drop structures, and check dams. The entire site was re-vegetated with grasses and legumes. Strips of trees and shrubs were also planted.

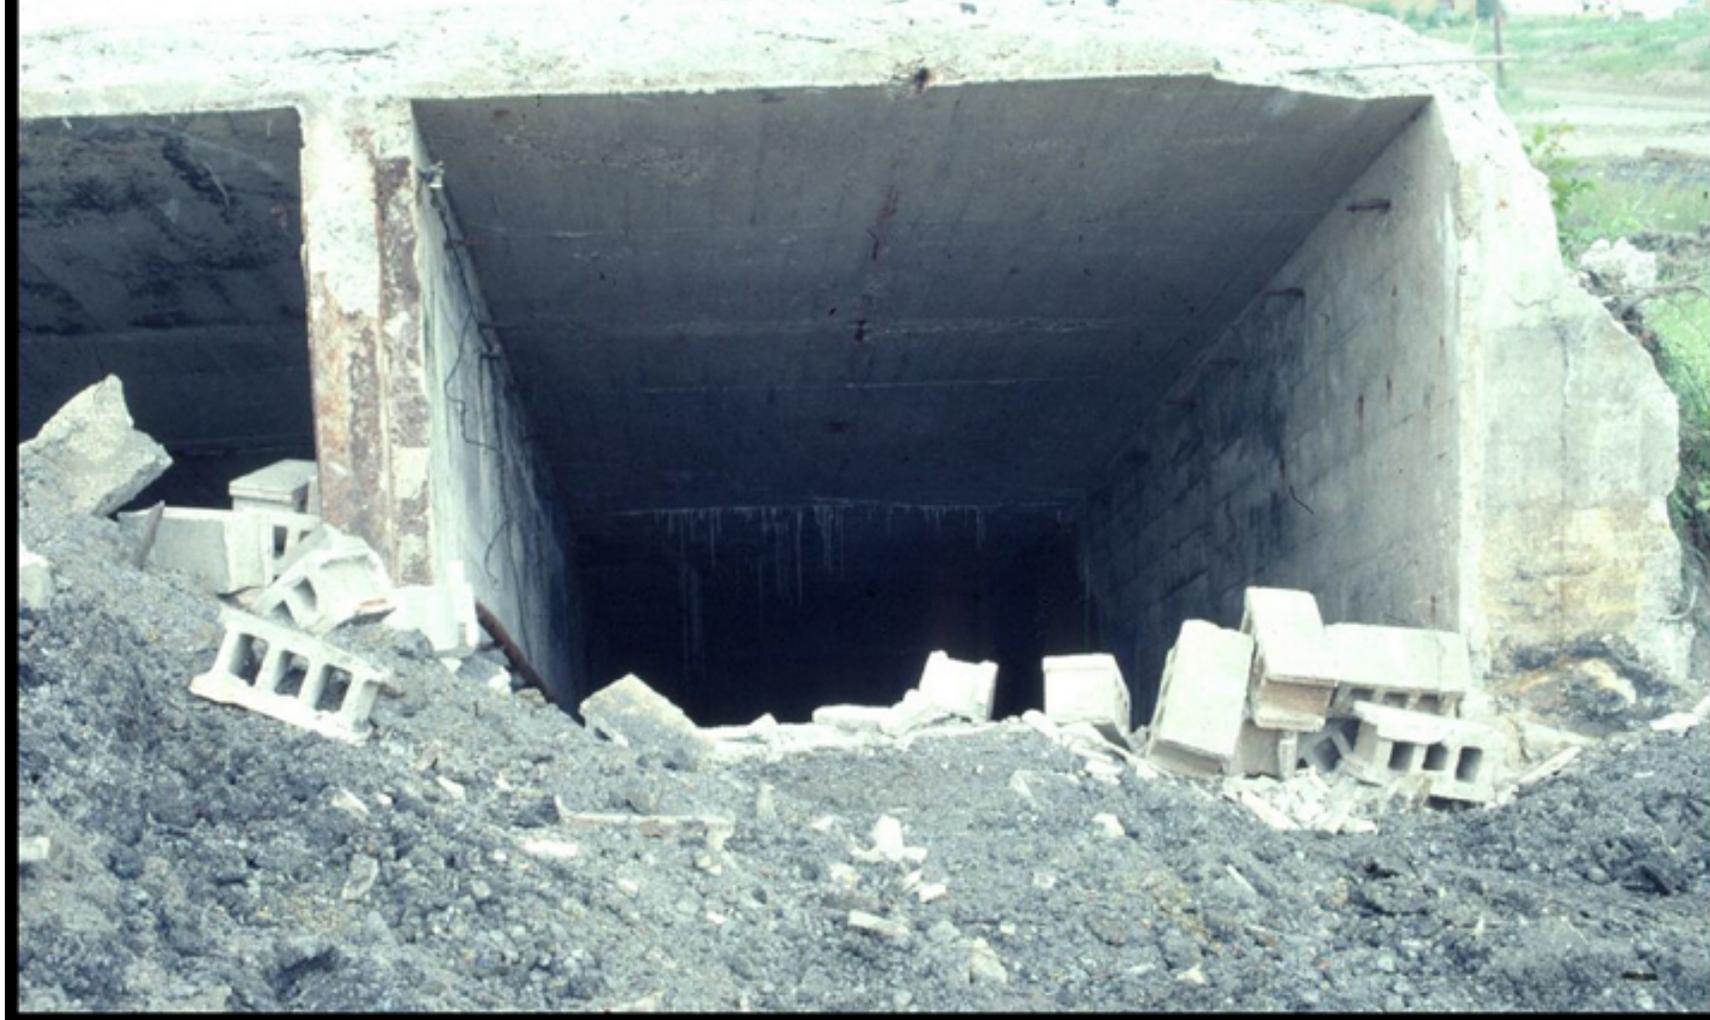
Open hazardous entry to the underground mine works. This was open 150 feet down to water. Located on the east central portion of the site.
Photo No. 2

The concrete slope entry structure descended at a 15-degree angle into the ground. The upper 150 ft section of the structure was demolished and removed to a depth of 25 ft below grade. The resulting rubble was buried at a designated on-site location along with all other razed concrete building foundations that existed around the slope entry. The slope entry was then sealed with a

three-foot thick reinforced concrete bulkhead prior to backfilling and establishing final sub-grades.

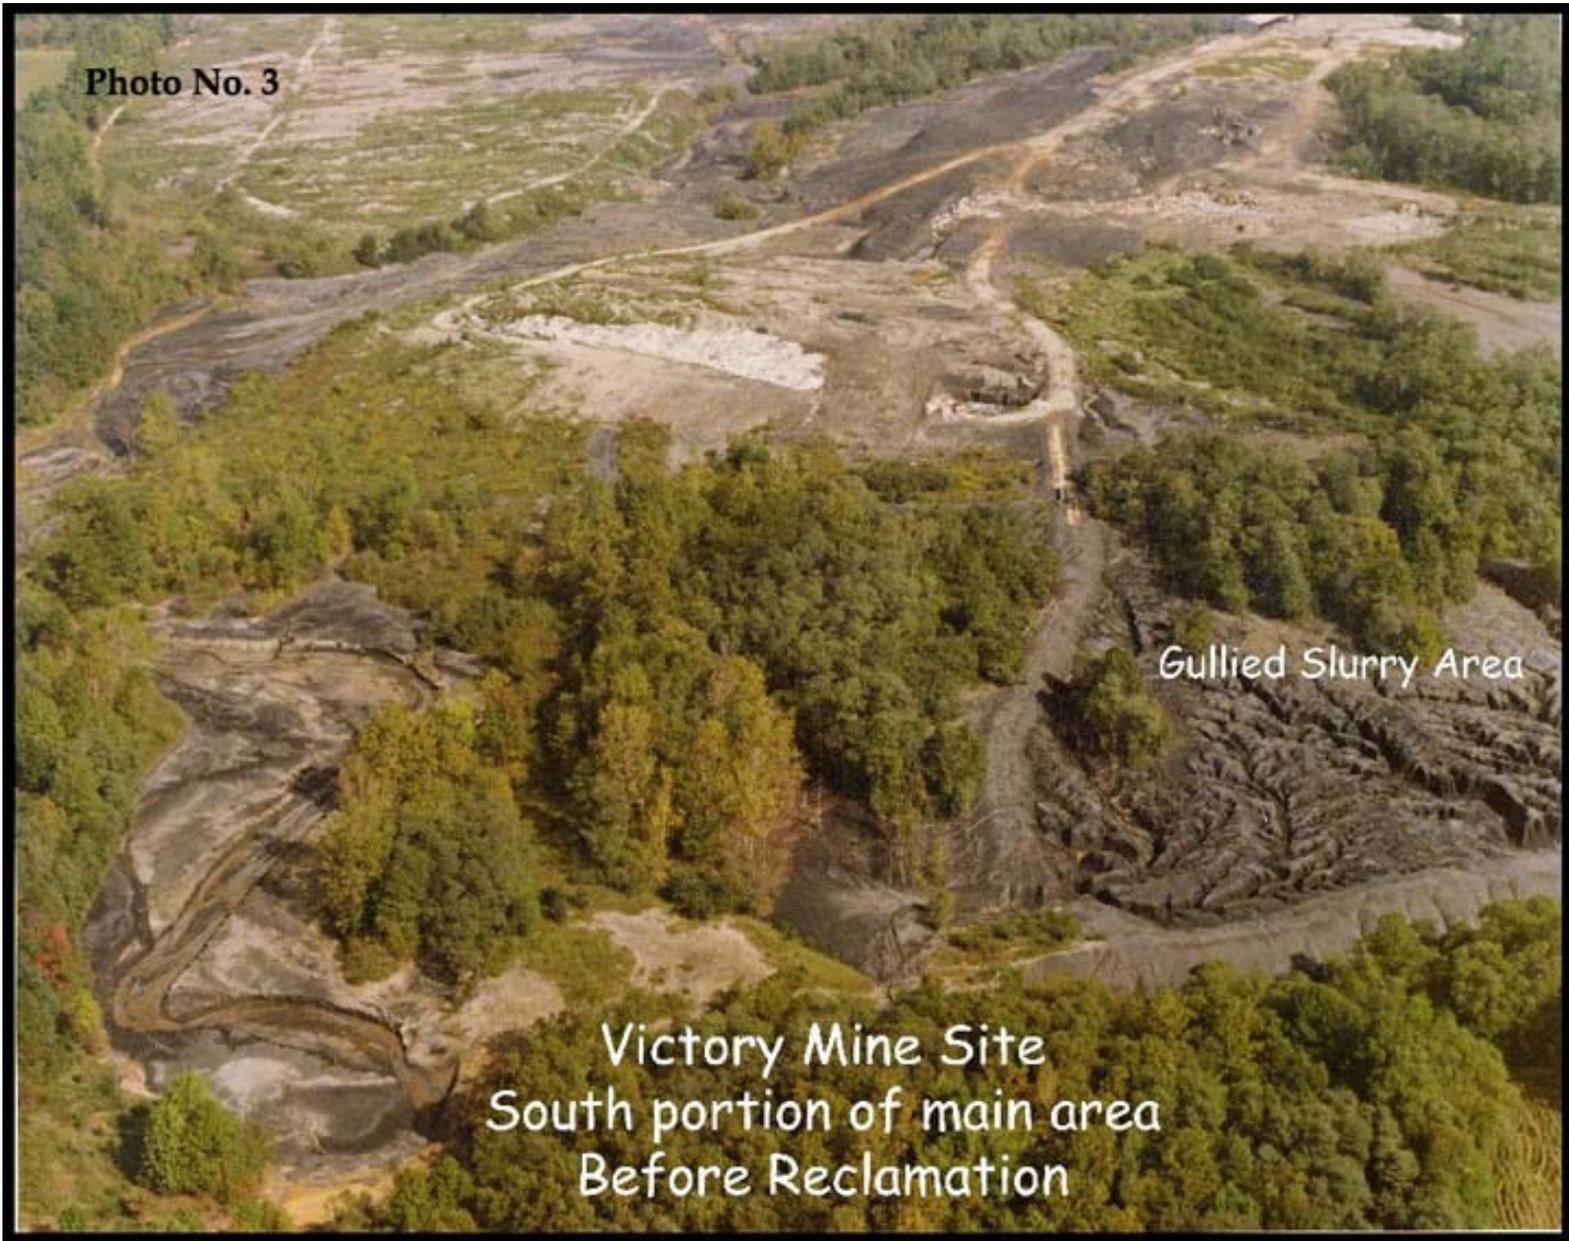
Photo No. 3

The southern 60 acres of the main area consisted of slurry ponds intermixed with areas of gob (see Photo No. 3). Trash was also mixed into the gob areas. The unstable dams retaining the slurry ponds were constructed of gob. Over time the gob dams breached resulting in thousands of cubic yards of slurry and gob being discharged into adjacent Honey Creek. A dendritic erosion pattern developed in the largest of the slurry ponds creating gullies over fifteen feet deep. The stream channel was clogged with coal fines for several miles downstream and the water was adversely affected by acid mine drainage. One sampling point downstream from the site experienced a pH of 3.2.

Gullied Slurry Area

Victory Mine Site
South portion of main area
Before Reclamation

Stabilizing the slurry impoundment dams along the south side of the site was a major concern of the project. There were three breached slurry pond dams constructed out of gob. Two of the dams were only a few feet high and were reclaimed as part of the general grading. The main dam was 1500 ft long, 20 ft high, and was breached in three places. Honey Creek flowed along the toe of the slope for the whole length of the dam. Reclamation of this slurry pond involved filling the gullies to meet planned refuse sub-grade and shaping the face of the dam to a 40% grade. The dam face and slurry was then covered with three feet of borrow material. A keyed-in riprap stream bank protection structure was constructed at the toe of the slope along the entire length of the dam. Sod strips were then placed at the top of the slope and just above the stream bank protection structure. The area was then seeded with grass, legumes and strips of trees and shrubs.

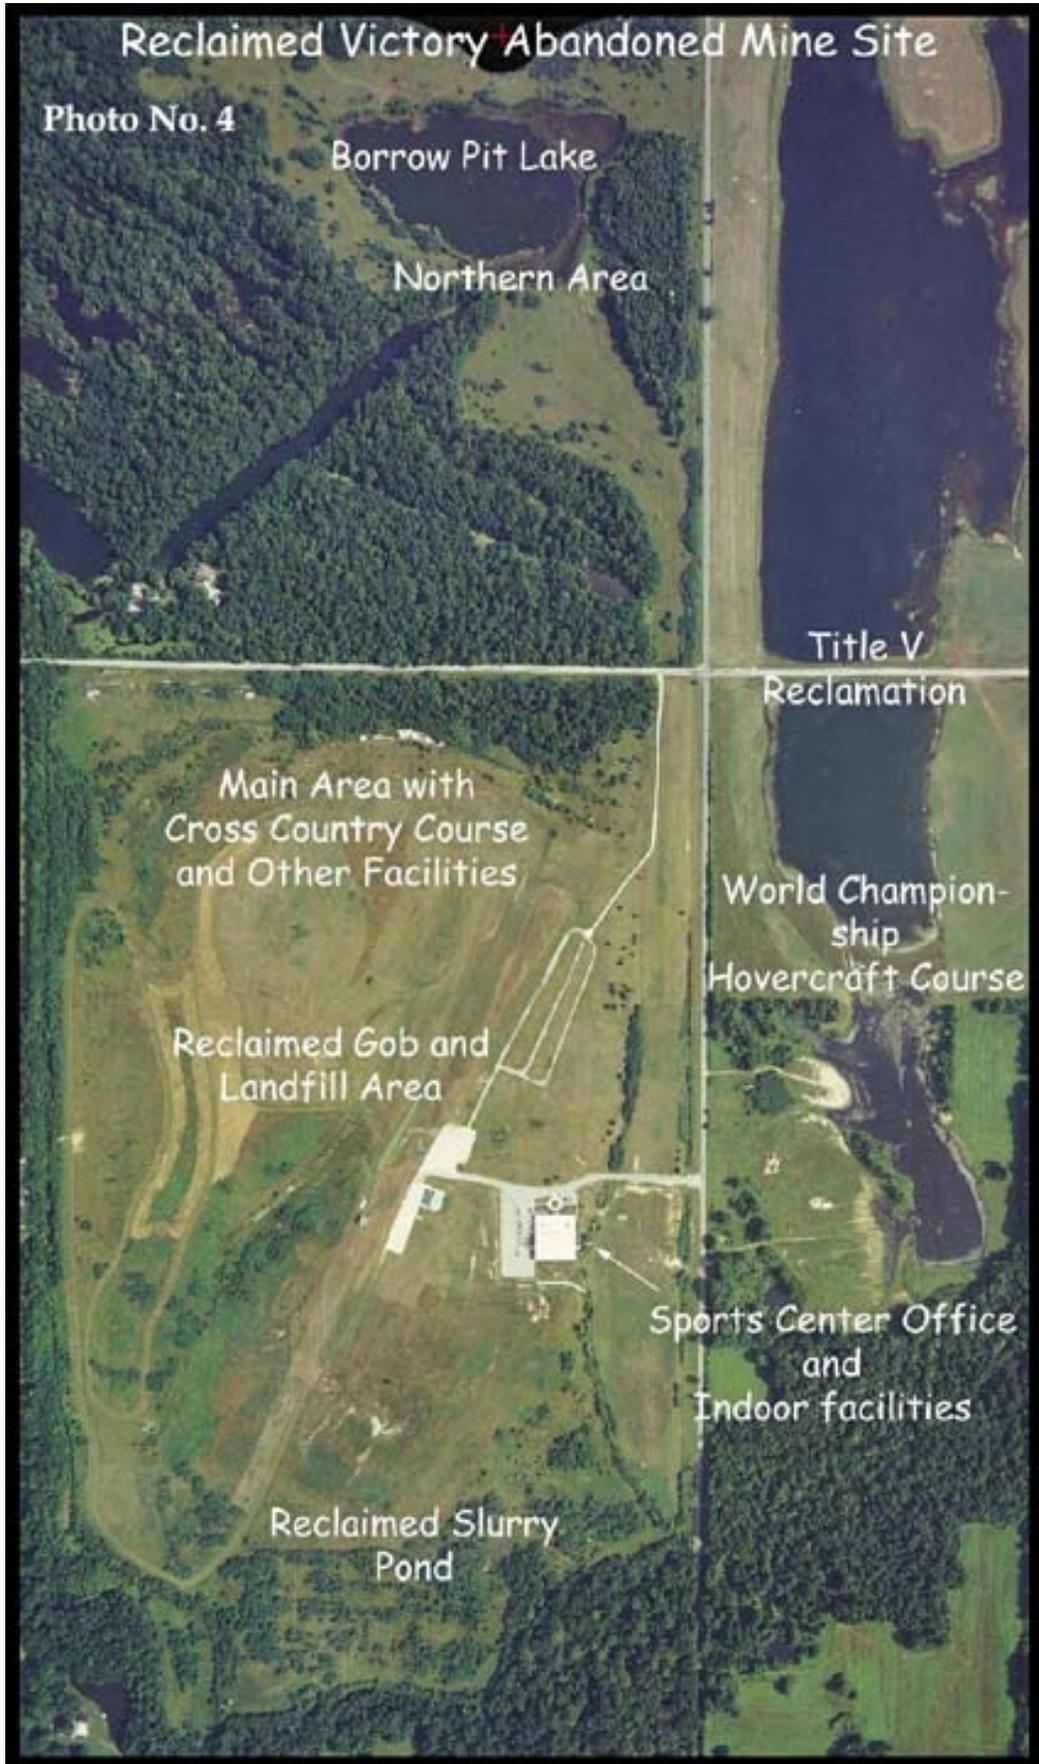
Photo No. 4

Reclaimed Victory Abandoned Mine Site

Reclamation of the northern 45-acre area consisted of removing the veneer of coal and coal refuse and burying it on site in two isolated mine pits created by adjacent surface mining. The concrete scales pit was razed and also buried in the pits along with other debris that was scattered on the area. This northern area was the designated main borrow source to acquire cover material for the rest of the project. A borrow pit in excess of twenty feet deep covering over twelve acres was excavated for borrow material. This pit was then developed into an excellent lake with a pool elevation control structure as part of site reclamation. Following removal of the veneer of coal waste and the concrete rubble, the entire area that was not part of the lake was graded and vegetated with a mixture of grass and legumes. Strips of trees and shrubs were also planted to enhance the habitat diversity for wildlife. This northern area is now an outstanding wildlife habitat and would be an excellent site for residential development (see Photo No. 4).

Reclamation of the remaining 200-acre main portion of the project was much more involved and comprehensive. Work included sealing the slope entry, burying concrete rubble, grading the gob and slurry areas, stabilizing the slurry retaining dams, covering the site with borrow material, establishing erosion control structures, and re-vegetating the site (see Photo No. 4).
