Assessment of Stream Resources at Regulated Coal Mining and Remining Sites in Ohio

Robert Baker¹, Tarunjit Butalia¹, Chin-Min Cheng¹, Cheryl Socotch²

¹The Ohio State University, Department of Civil, Environmental, and Geodetic Engineering, 2070 Neil Ave., Columbus, OH 43210; ²OhioDNR - Division of Mineral Resources Management

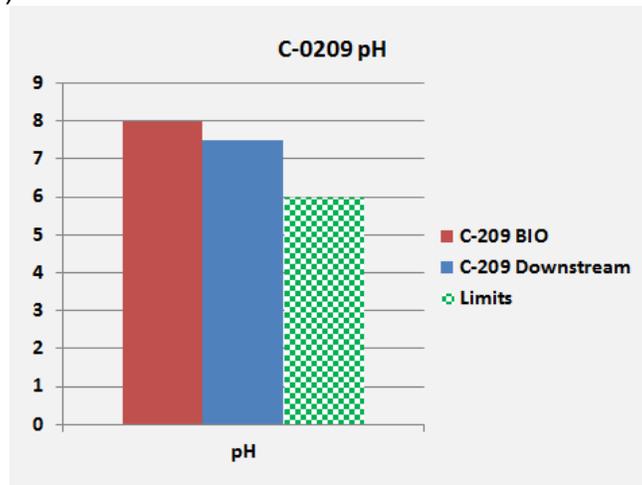
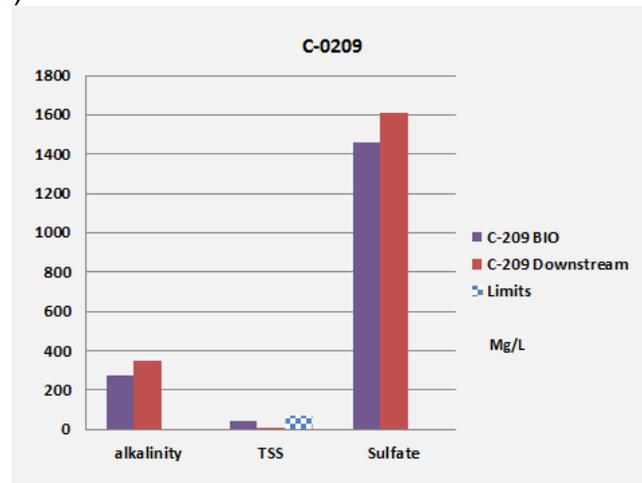
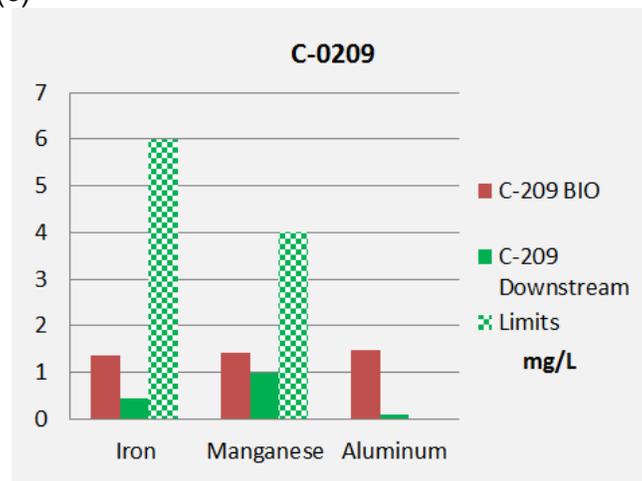
Figure 3. The water quality of the C-0209 Bio and Reconstructed stream reaches stream. (a) pH; (b) concentrations of alkalinity, total suspended solids, and sulfate; (c) Fe, Mn, and Al.

Low flow sampling was conducted on 8/15 2003 and all parameters were found to be within the EPA's Coal Mining Technical Based Limits (Figure 3).

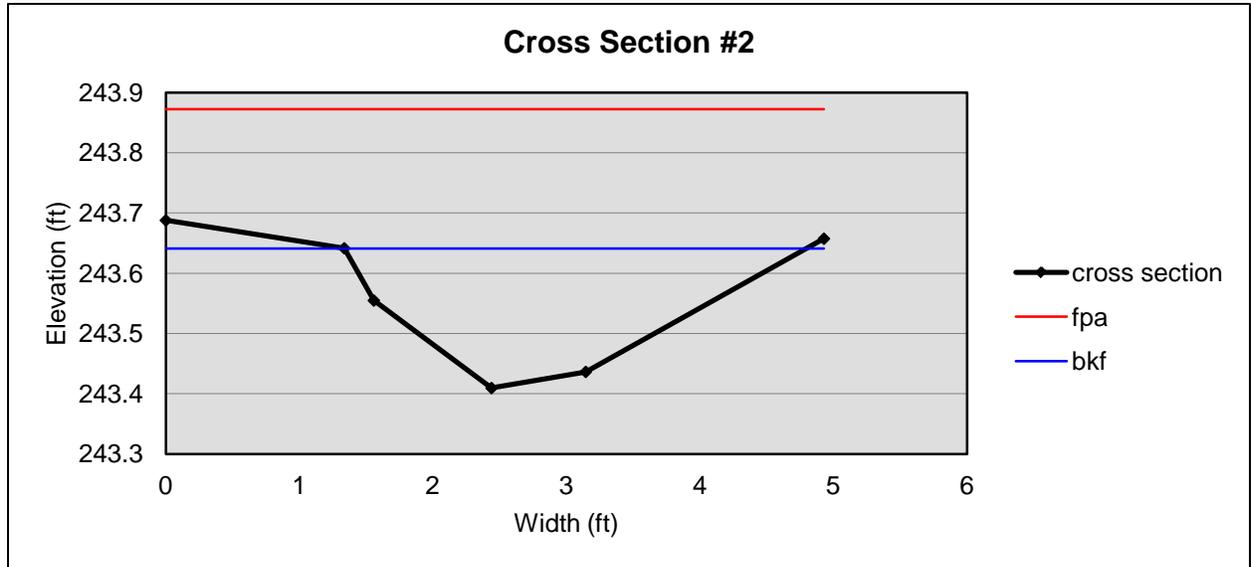
Figure 5. D-0807 Reconstructed Stream Reach

In addition to acquiring field information to complete the reconstructed stream reach HHEI form, the reach's cross section and bankfull width (BFW) at various locations of this stream segment were also measured. Figure 5 depicts the banks of the channel, the bankful (bkf) elevation, the flood plain elevation (fpa) of Cross Section #2.

According to StreamStats Ohio, the 2 year peak flow for this reach was 87.3 cfs, which is very similar to the a peak 1-2 year bankful flow of 82.08 cfs observed in this study. Table 1 contains detailed hydraulic information of Cross Section #2.

Bankfull Dimensions	
0.5	x-section area (ft.sq.)
3.5	width (ft)
0.1	mean depth (ft)
0.2	max depth (ft)
3.5	wetted parimeter (ft)
0.1	hyd radi (ft)
25.3	width-depth ratio

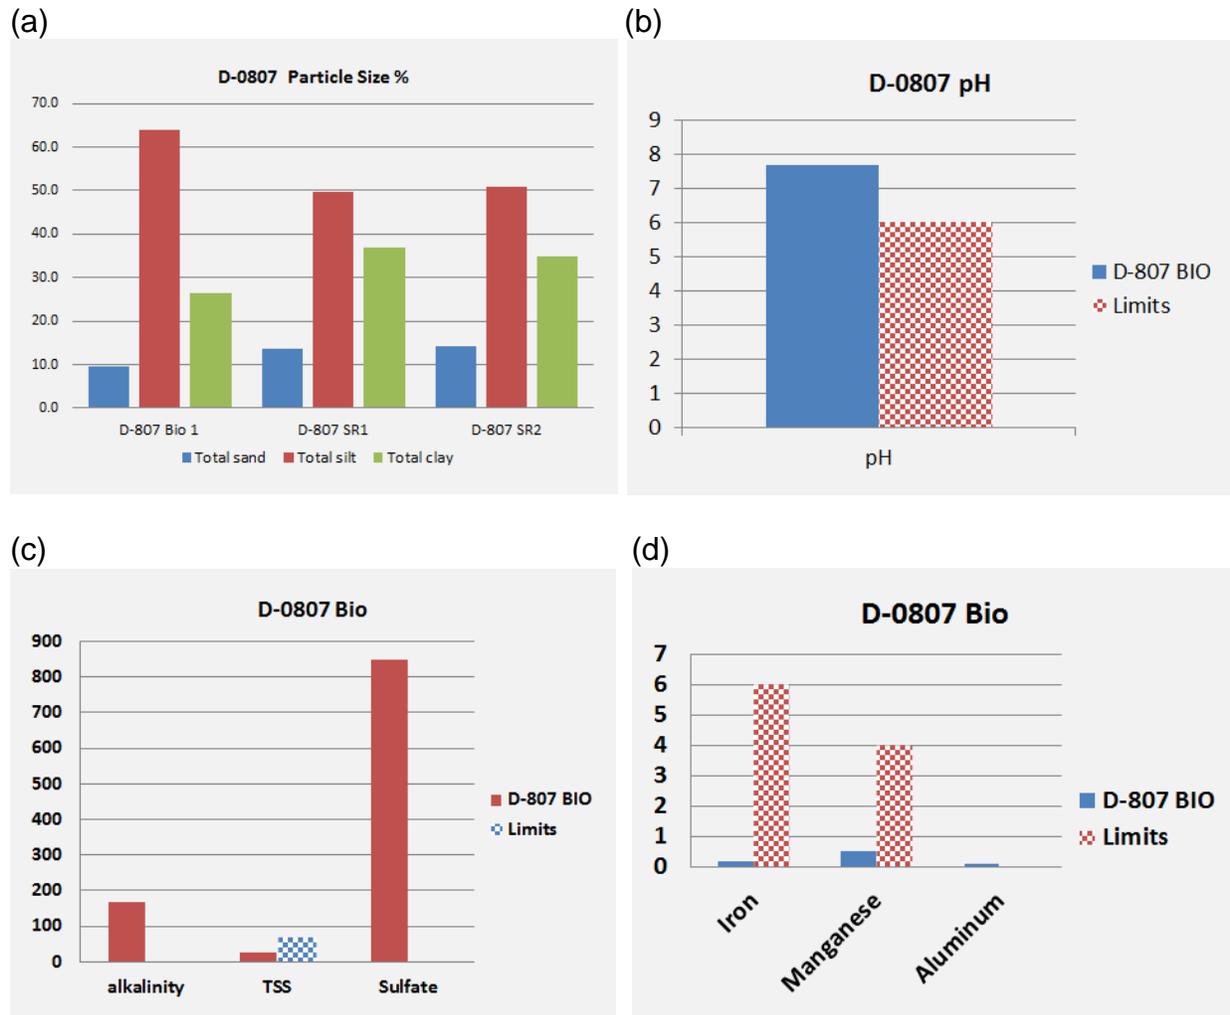
Figure 6. The soil particle size (a) and water quality ((b)-(d)) of the D-0807 Bio and Reconstructed stream reaches stream. (b) pH; (c) concentrations of alkalinity, total suspended solids, and sulfate; (d) Fe, Mn, and Al

When comparing the particle size percent sand, silt and clay there is a consistent correlation between the unmined natural flood plain soils and the soils tested at the reconstructed flood plain. The resoiling materials at the reconstructed site (i.e., D-0807 SR1 and SR2) appear to have excellent properties with respect to particle size (Figure 5 (a)). Low flow sampling was conducted on 6/25, 2013 at the site and all parameters are within EPA's Coal Mining Technical Based Limits Figures 5(b), (c), and (d).

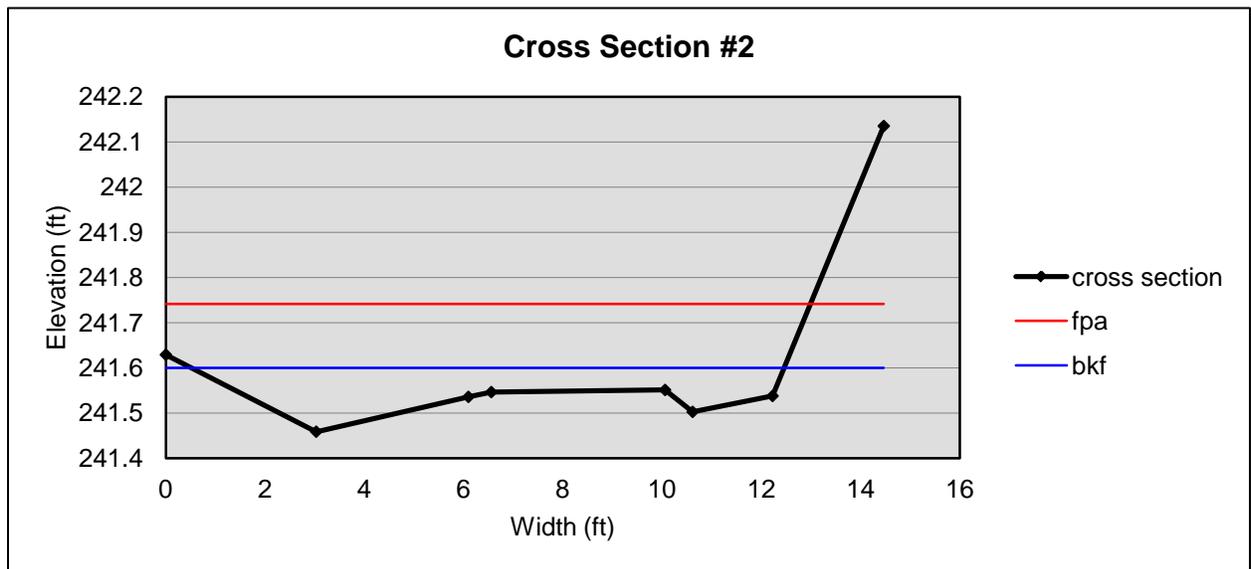
Figure 9. D-0958 Reconstructed Stream Reach Cross Section #2

Similarly to D-0807, a survey was conducted at B&N D-0958 to depict various cross sections along the 200 foot stream reach. Cross Section #2 is depicted below in Figure 9. The channel bank is represented by the black line, the bankful (bkf) elevation blue, and the flood plain (fpa) elevation red. The hydraulic information for this particular cross section in stream reach can be found in Table 2.

The peak 1-2 year bankful flow of this stream segment was calculated to be 77 cfs, which is approximate 22% lower than the 2 year peak flow of 98.1 cfs obtained from StreamStats.

Bankfull Dimensions	
0.9	x-section area (ft.sq.)
11.9	width (ft)
0.1	mean depth (ft)
0.1	max depth (ft)
12.0	wetted parimeter (ft)
0.1	hyd radi (ft)
162.5	width-depth ratio

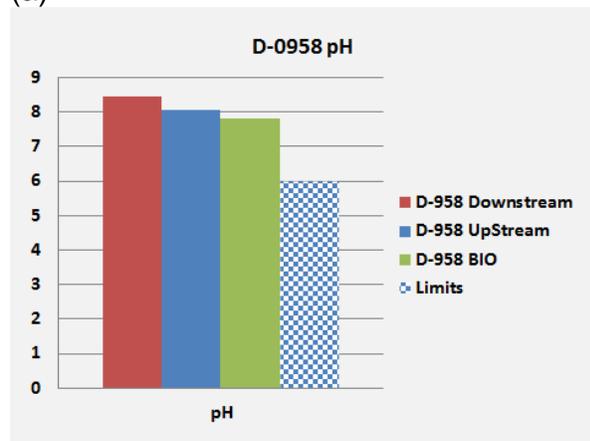
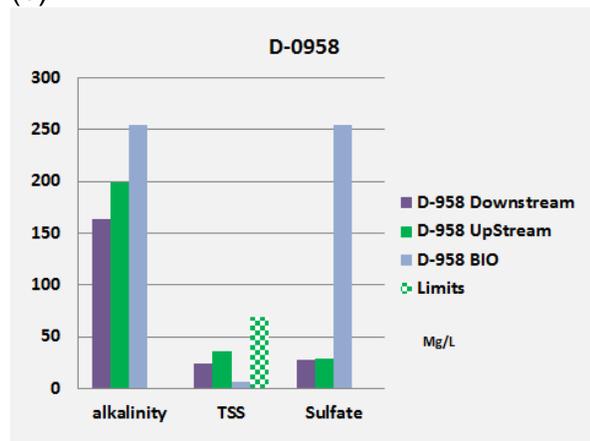
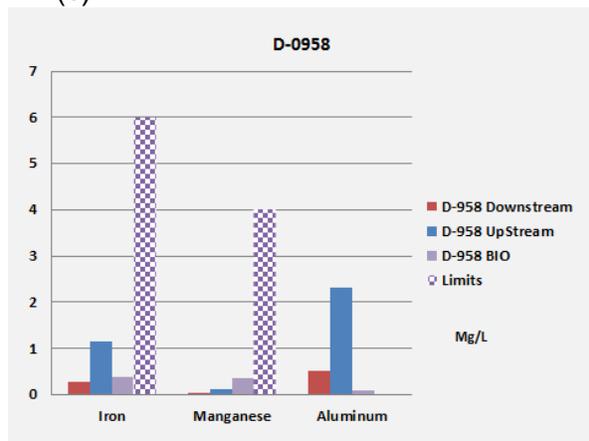
Figure 10. The water quality of the D-0958 Bio and Reconstructed stream reaches stream. (a) pH; (b) concentrations of alkalinity, total suspended solids, and sulfate; and (c) Fe, Mn, and Al

Low flow sampling was conducted on 6/25, 2013. All measured parameters were within USEPA's Coal Mining Technical Based Limits shown in Figure 10.

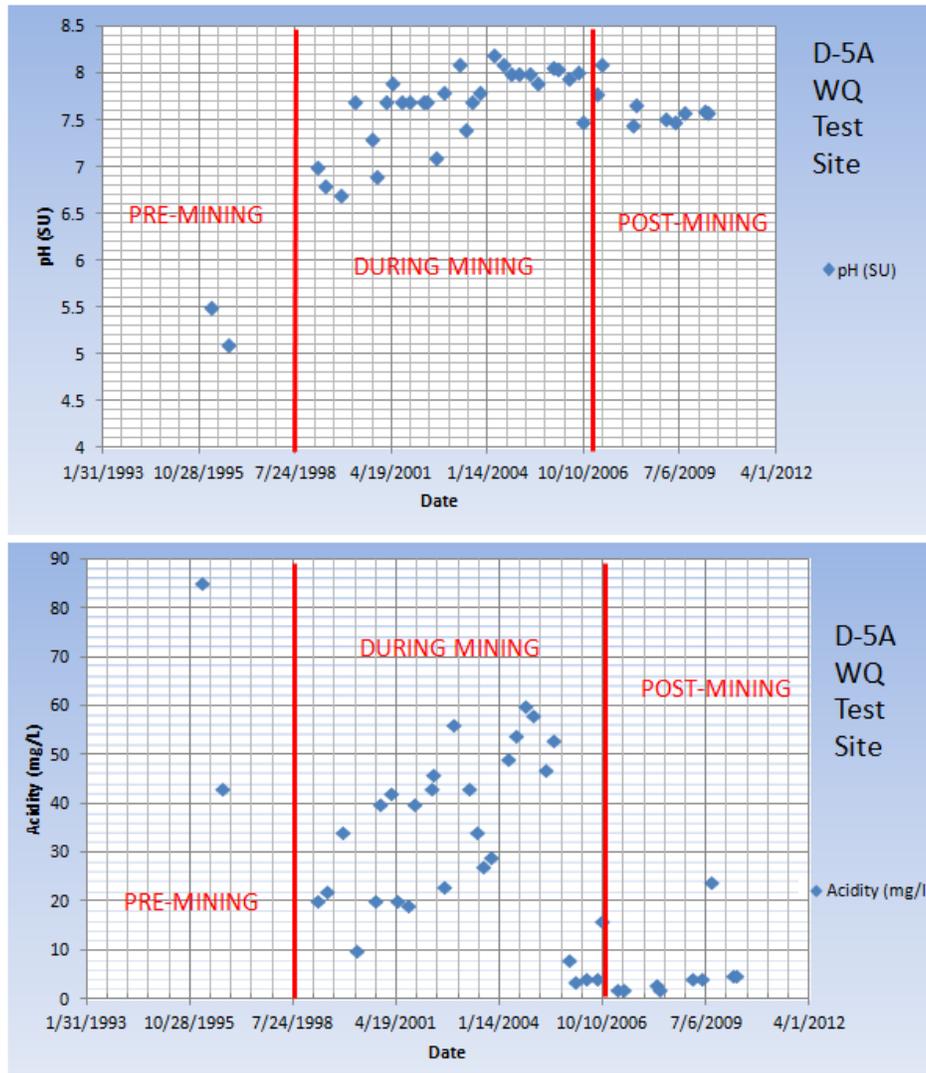
Figure 11. pH and alkalinity of stream water collected from D-5A within the D-0958 remining permit

The D-5A sampling point depicted in Figure 11 captures the water quality in the main stem of Rocky Run, below drainage of remining permit D-0958. The water quality data extracted from DMRM permitting shows broad improvements in pH (S.U) and acidity (mg/L as CaCO₃).

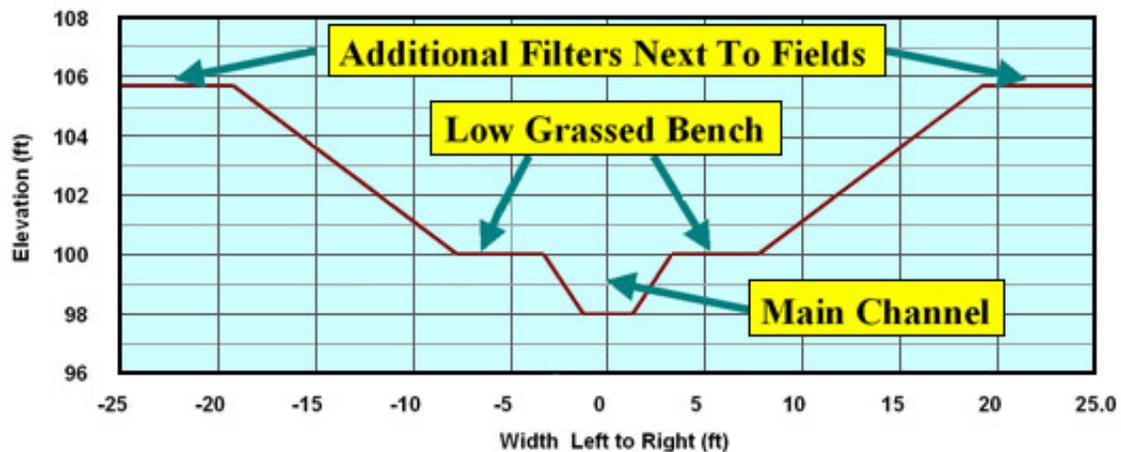
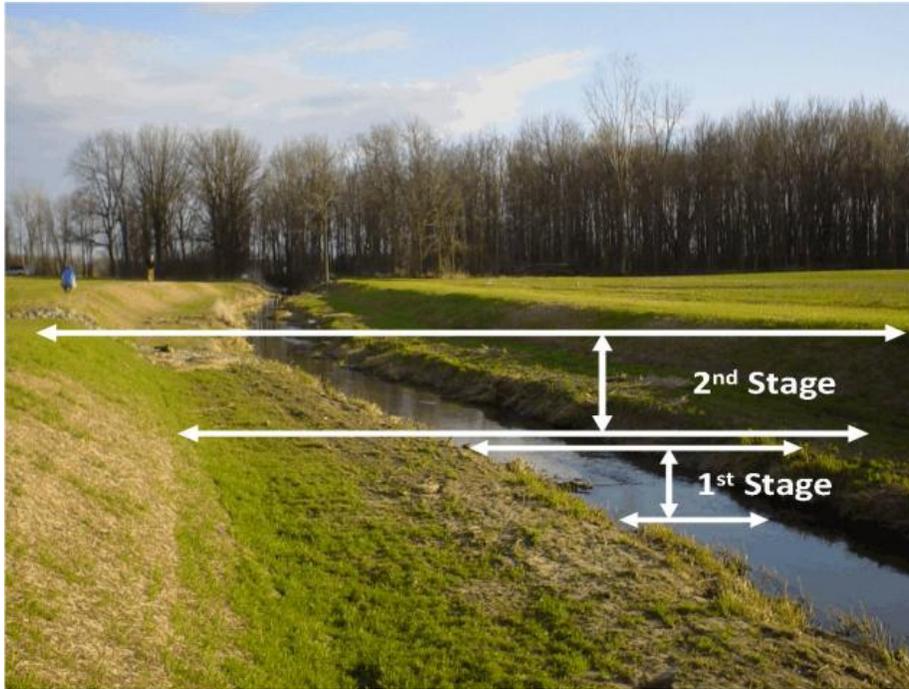
Figure 12. Example Two Stage Channel Cross Section

A typical drainage channel is designed to have a single stage trapezoidal cross section. This channel design is great for efficient downstream water travel; however, with lacking flood plains the channel can experience side bank erosion and sediment buildup. Two Stage channels are designed as such to activate the flood plain and minimize these occurrences. At the first stage, or main channel, a smaller bankful width allows for water velocities high enough to reduce the amount of sediment deposition and promote transport. This sediment transport allows for heterogeneous sedimentation which increases biodiversity. The second stage allows for greater flood control in high storm event flows and an increased stability of the overall channel. For greater stability, the first stage of the channel will be lined with a rock material to counteract bank erosion. Also, two stage channels allow for nutrient removal to occur. With a large channel surface area, denitrification can occur more rapidly. This in turn results in a higher bio-assimilation, or plant growth, allowing for peak flow attenuation. Figure 14 depict a typical two stage channel cross section and an example how a two stage channel would look in the field.

- 1) Consider construction of Two Stage Channels at mine sites. This practice is gaining traction in the agriculture industry, and may have applicability in the mining sector.
- 2) For reconstructed channels increase emphasis and incentives for tree planting in the riparian corridor perhaps in exchange for mitigation credits i.e. per linear foot of stream planted with suitable tree species
- 3) Increase awareness of Ohio coal operators to follow DMRM guidelines for natural channel design and two stage channels where appropriate. Coal Operators and DMRM staff should receive training in this area.
