# Carbon Monoxide Poisoning at a Surface Coal Mine ...

## A Case Study

Kenneth K. Eltschlager, OSM

William Shuss, Pa DEP

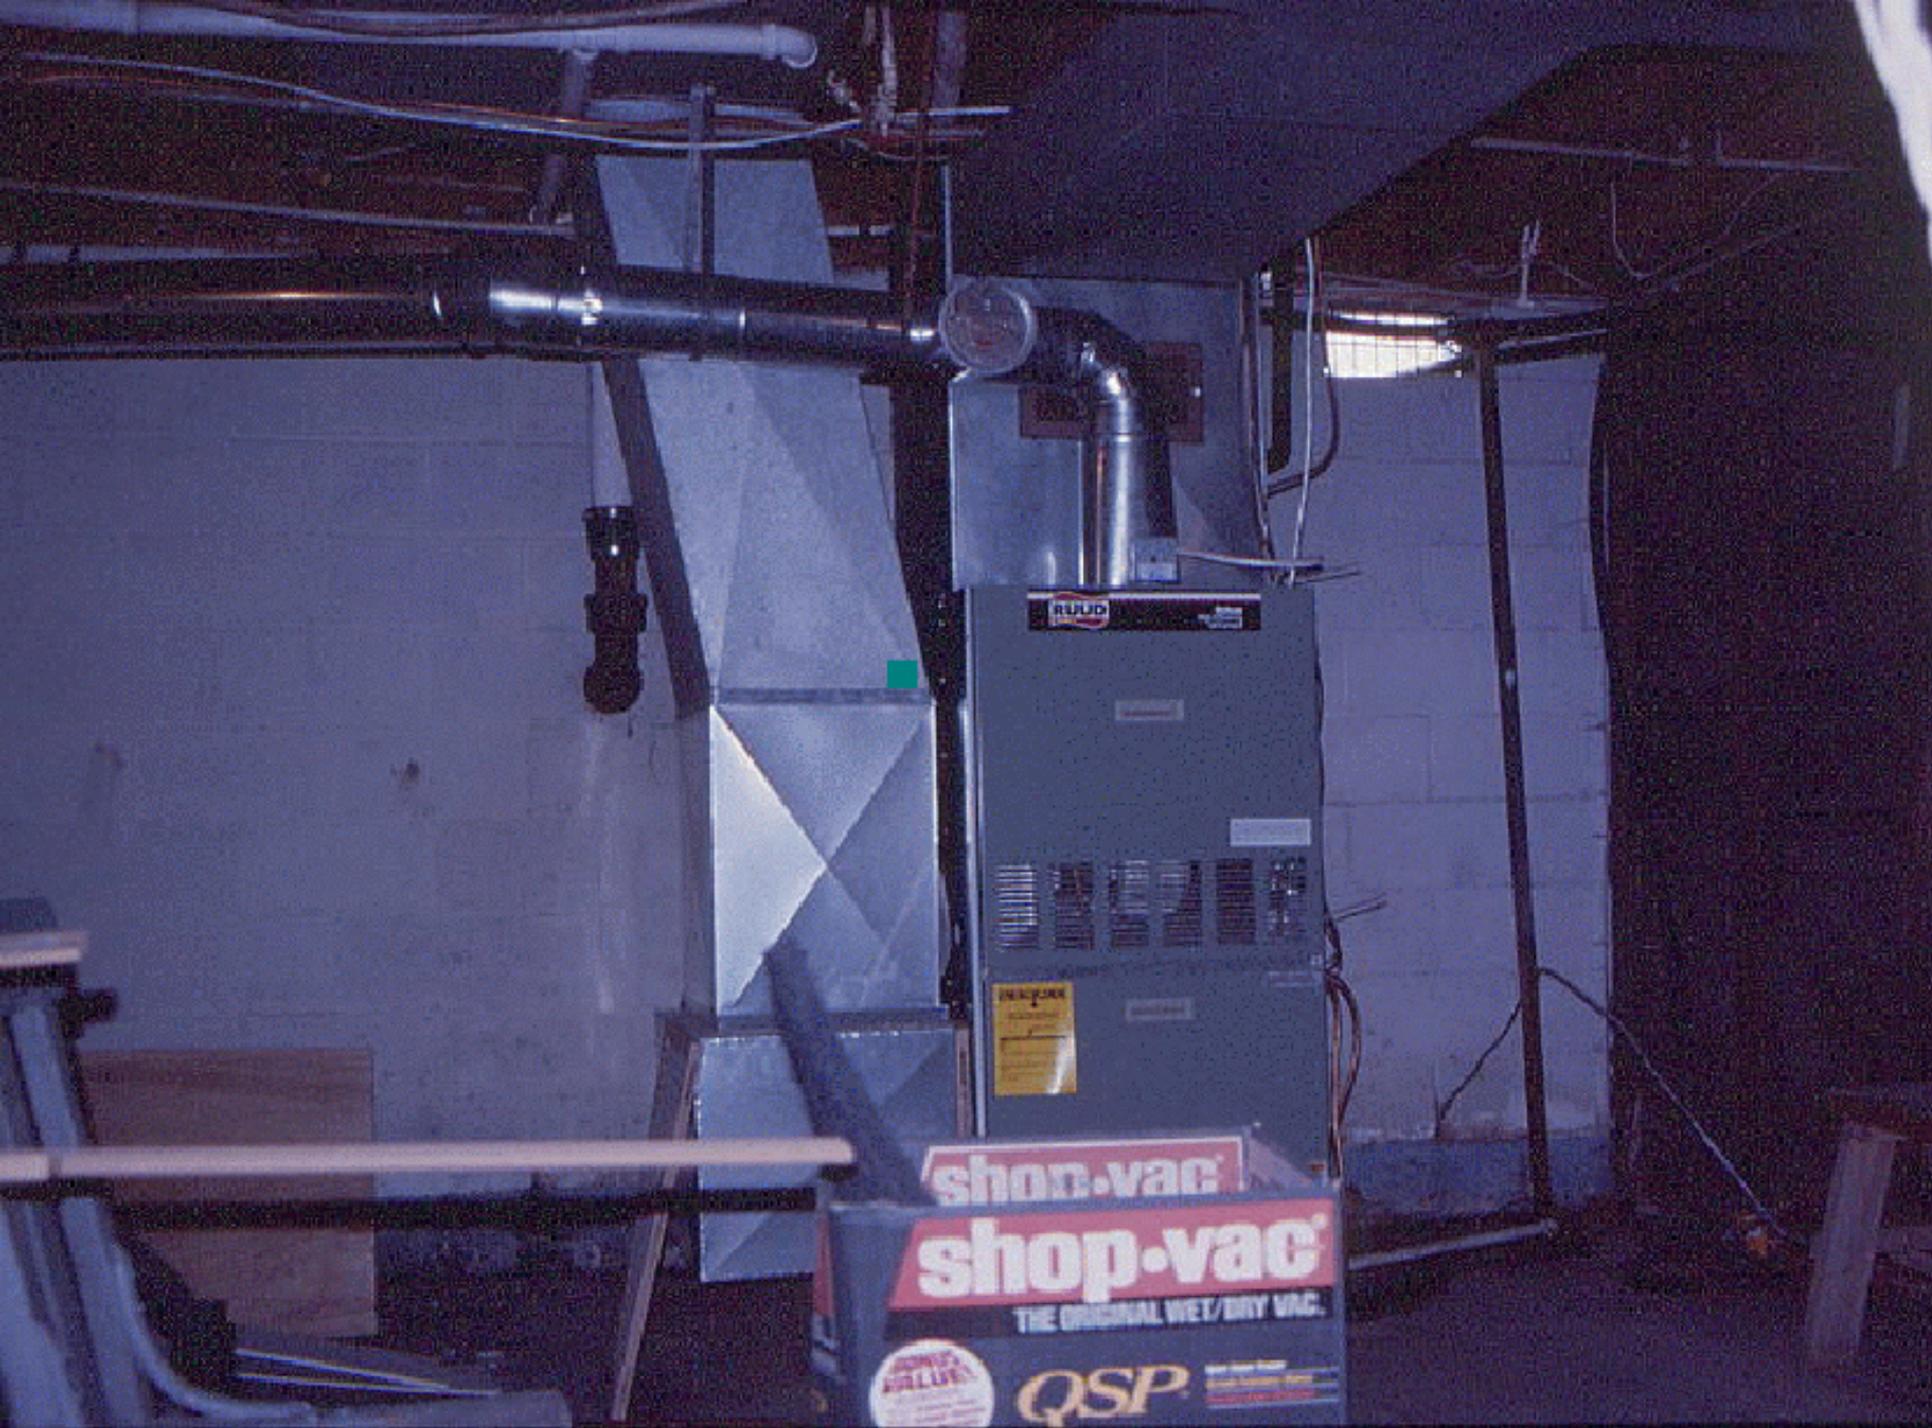
- February 2000 - mining began.
- March 7, 2000 - the first of twenty blasts.
- March 31, 2000 - two blasts are detonated in the afternoon.
- April 1, 2000 - in the early morning, later diagnosed with carbon monoxide poisoning.
- April 2, 2000 - the furnace contractor finds 650 ppm in a floor drain , 450 ppm on the first floor, and 400 ppm on the second floor.

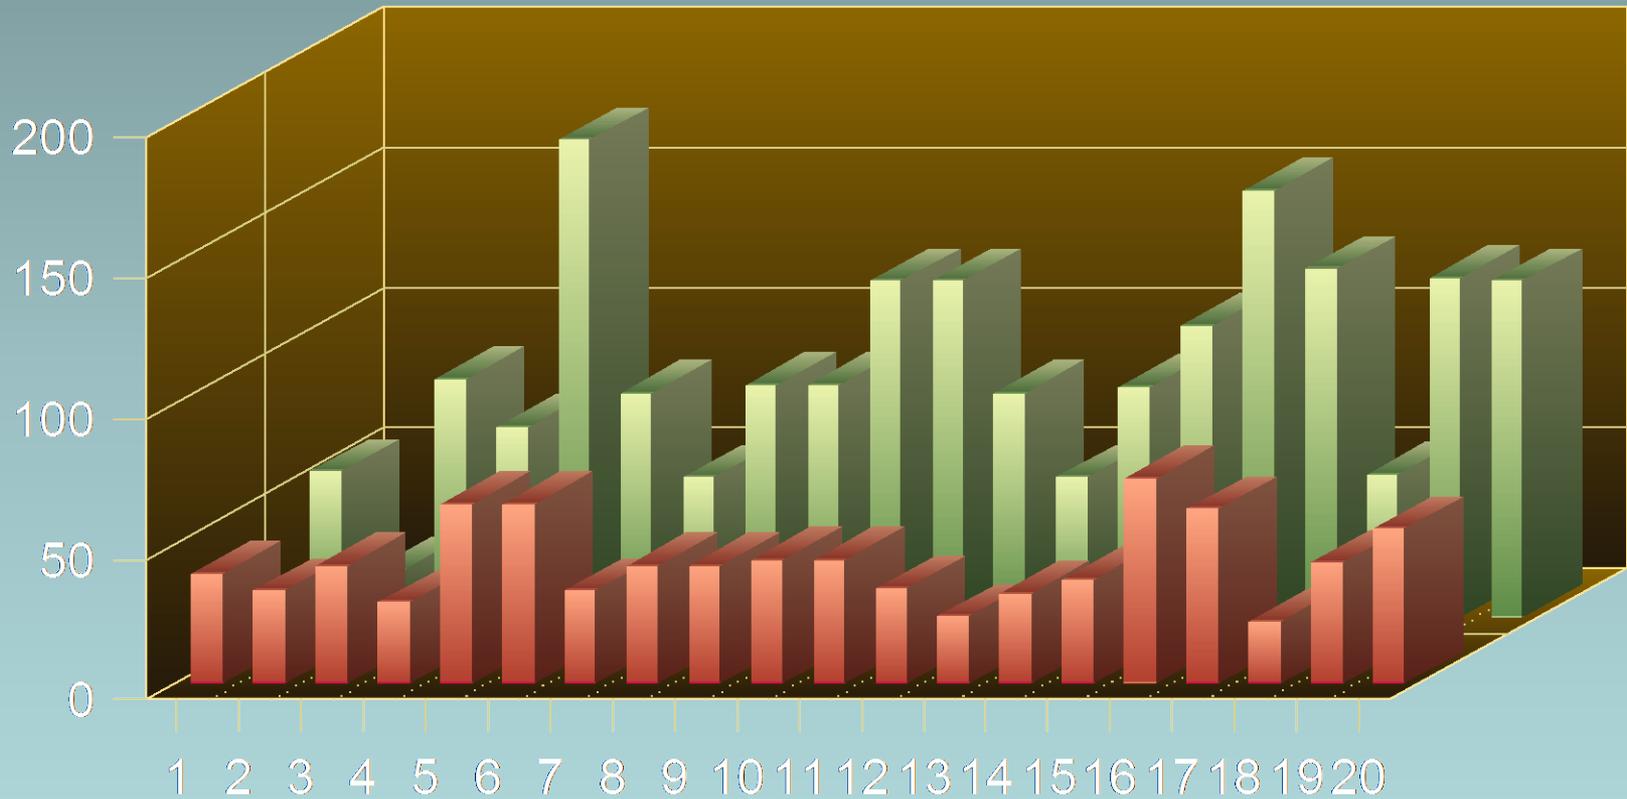
# Blasting Data

Charge per Hole (lbs)

Powder Factor (lb/yd3 x 100)

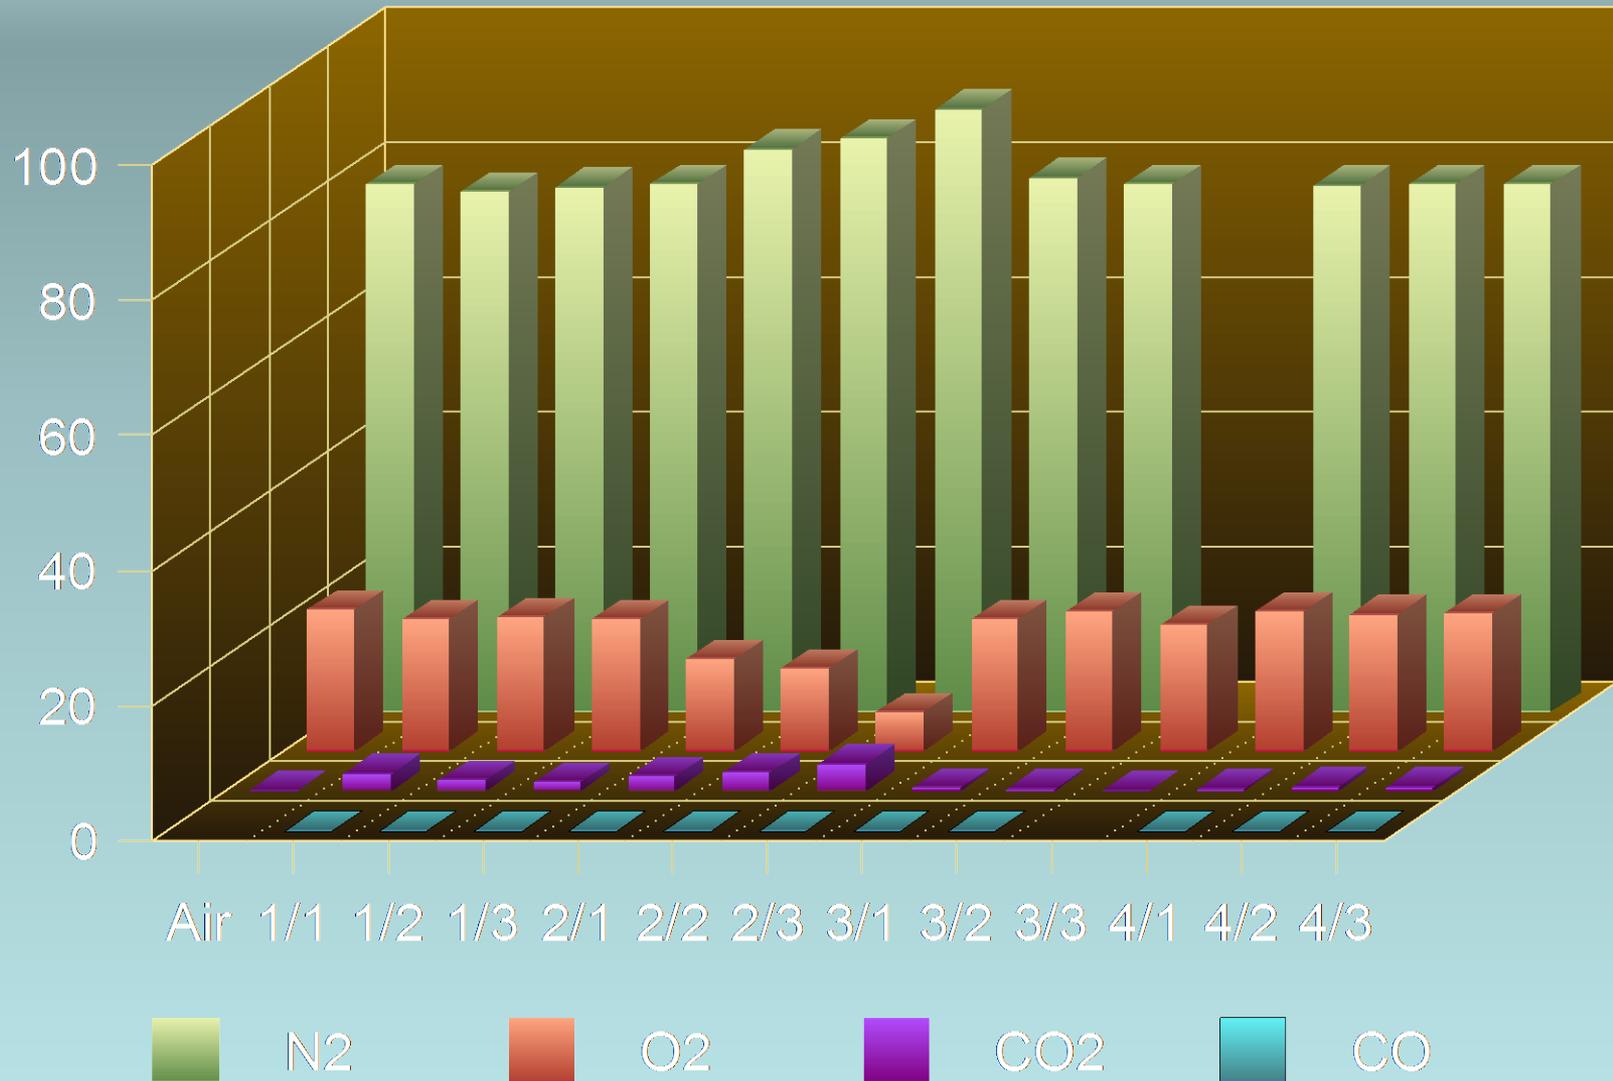
# Borehole Gas Data

- May 31, 2000
- Four holes
- Hole number 2 - 28 - 33 feet sandstone w/ 1' crevice

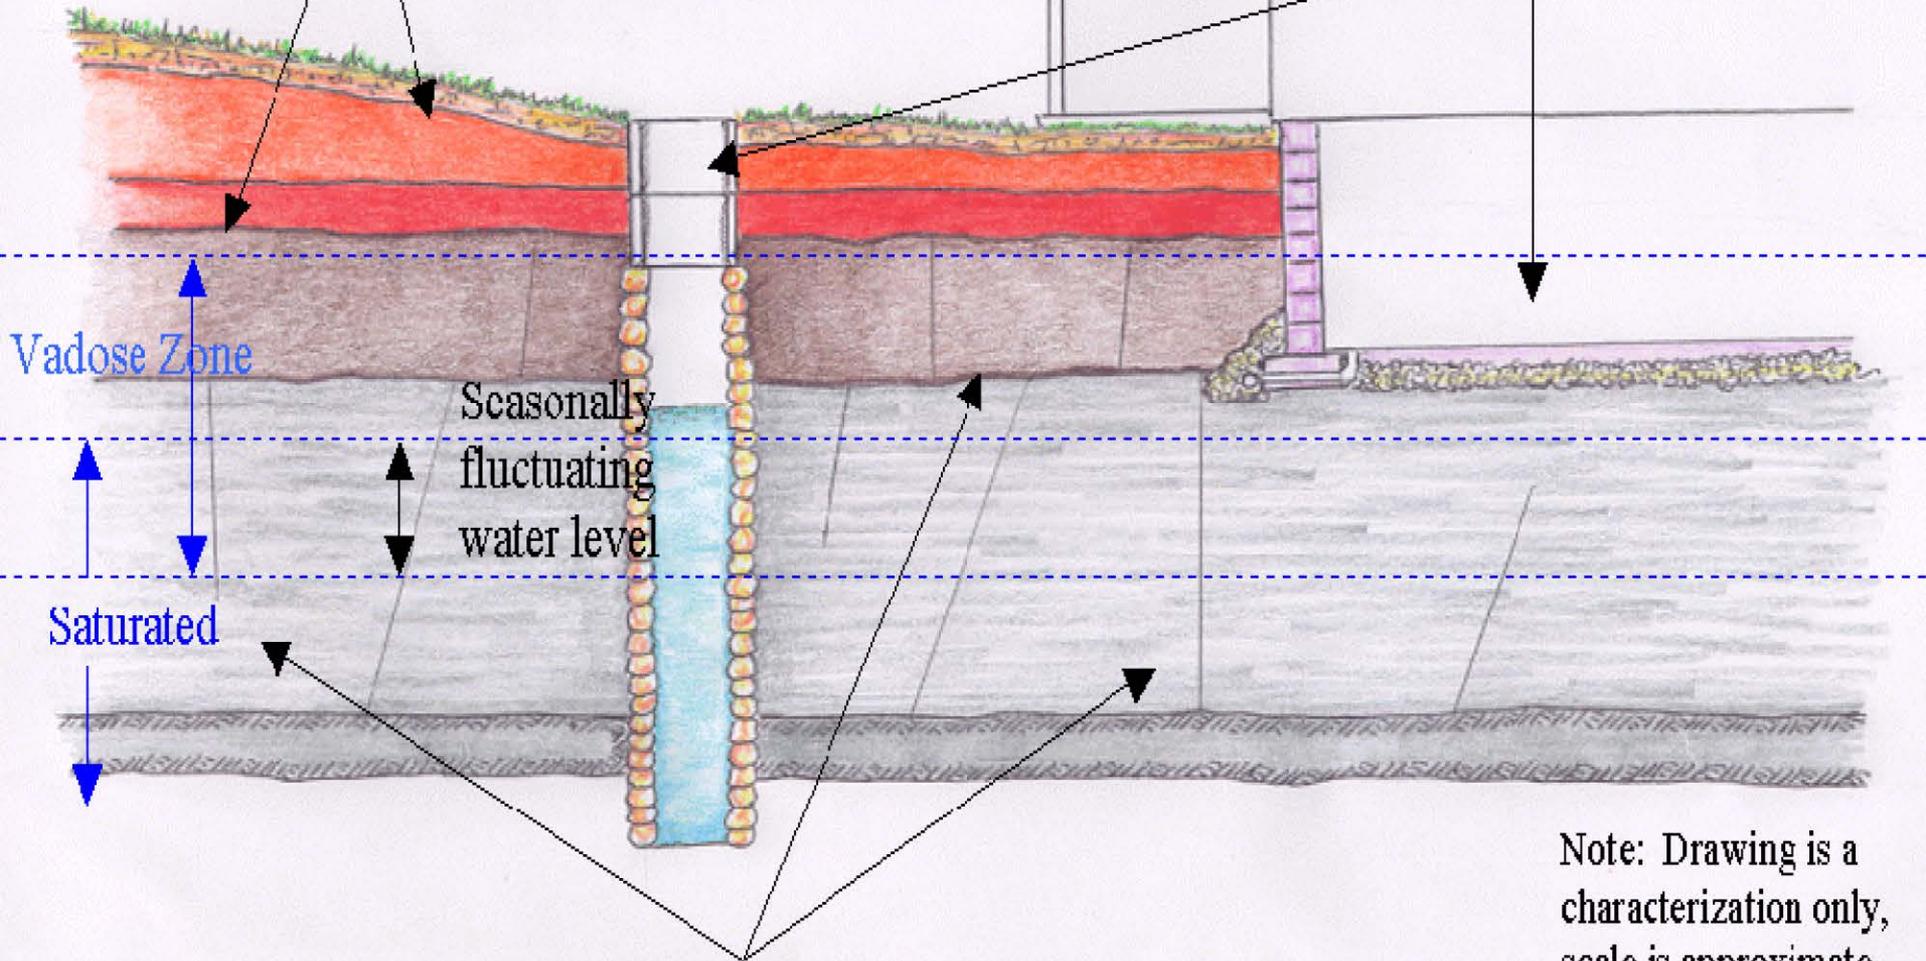
Affected House and Well

Cap rock and soil semi confining aquifer below

Note: Drawing is a characterization only, scale is approximate

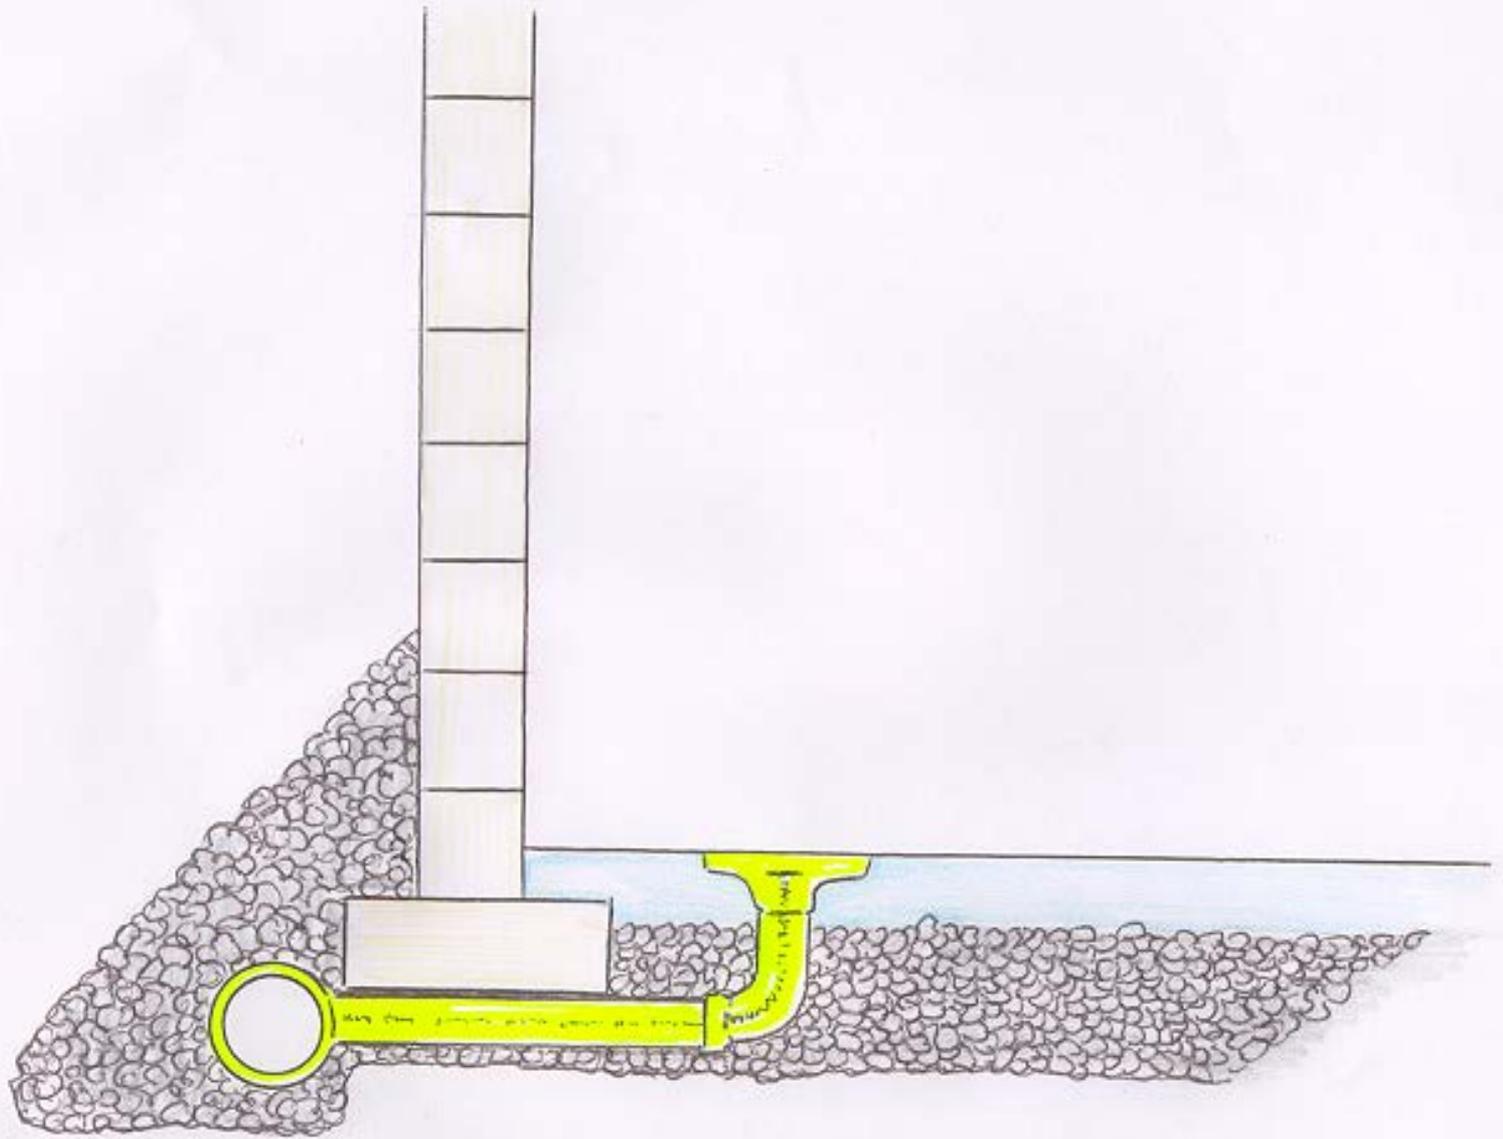
Jointing in the gray shale and brown sandstone carrying water and fumes

- Flyrock control - Primary focus of the blaster
- Inadvertently contained gases in the ground
- Blast holes were aligned with the fracture system
- Site geology provided a “pipeline and reservoir”
- A large diameter well collected the gases
- The french drain was openly connected to the floor drains
- ALL of these combined to cause the poisoning
