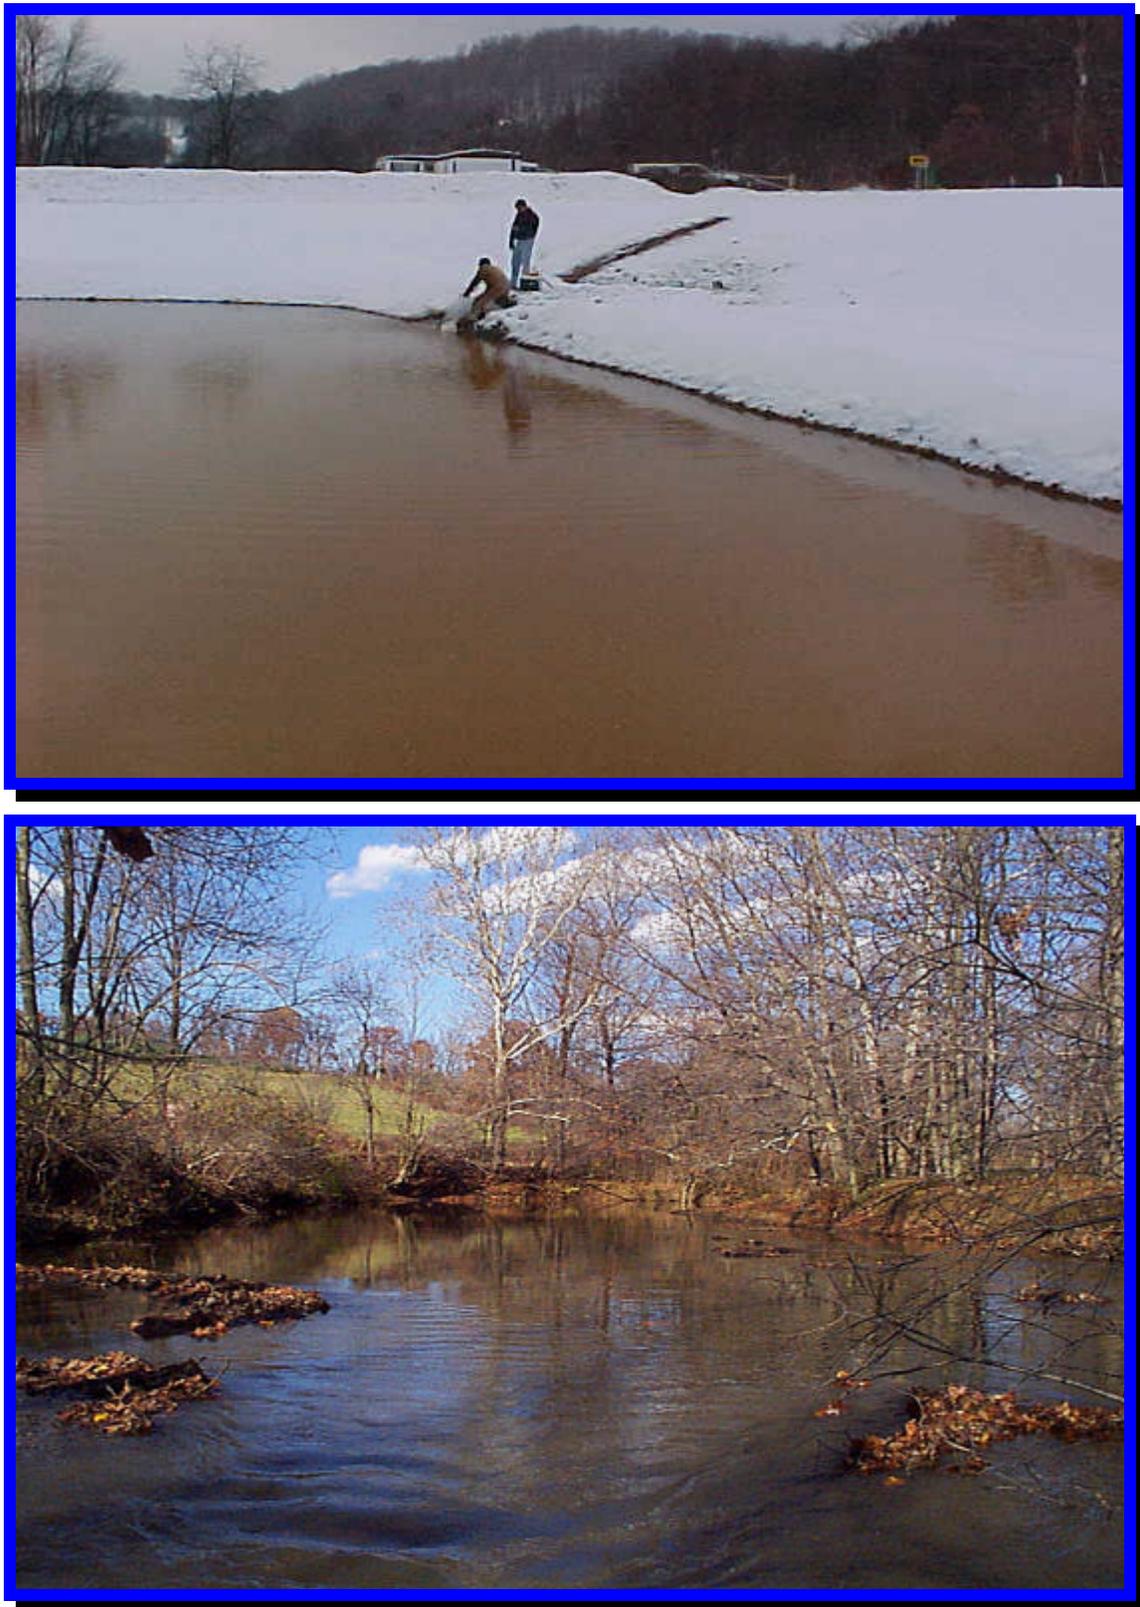
FIGURE 5 – Split photograph showing inlet to passive treatment system (top frame) and a view of Crooked Creek (lower frame) downstream of the treatment system taken in October 2001. Note the typical orange appearance of the pond due to the iron in the discharge being oxidized.
