**2005 ABANDONED MINE LAND  
RECLAMATION AWARDS**

**MIDDLE CREEK SOUTH  
REESTABLISHING STREAM CHANNEL  
AMD 54 (4214) 201.1  
Frailey Twp.  
Schuylkill County, Pennsylvania**

**Commonwealth of Pennsylvania  
Department of Environmental Protection  
Bureau of Abandoned Mine Reclamation  
Wilkes-Barre District Office  
Two Public Square, 5th Floor  
Wilkes-Barre, PA 18711-0790  
Phone: (570)-826-2371  
Fax: (570)-826-2441  
Email: [mferko@state.pa.us](mailto:mferko@state.pa.us)**

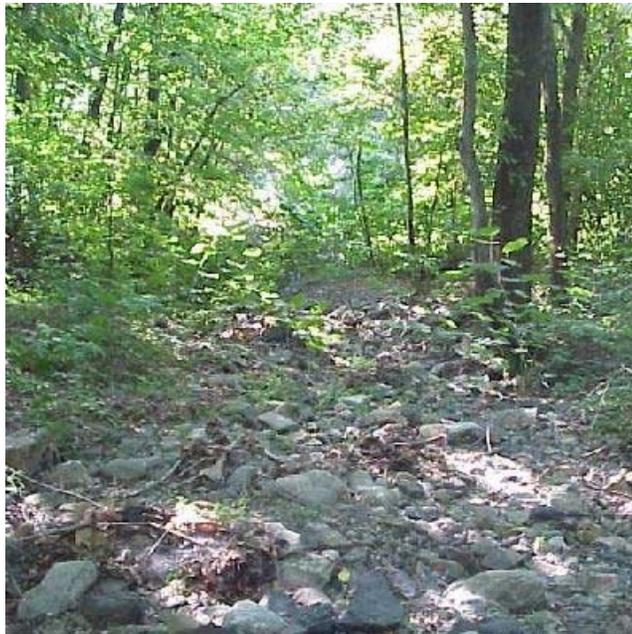
**Picture #1**

This picture illustrates the location of the truncated section of Middle Creek below the stripping pit. This area was all grown in and hiding the fact that a vibrant creek once flowed there.

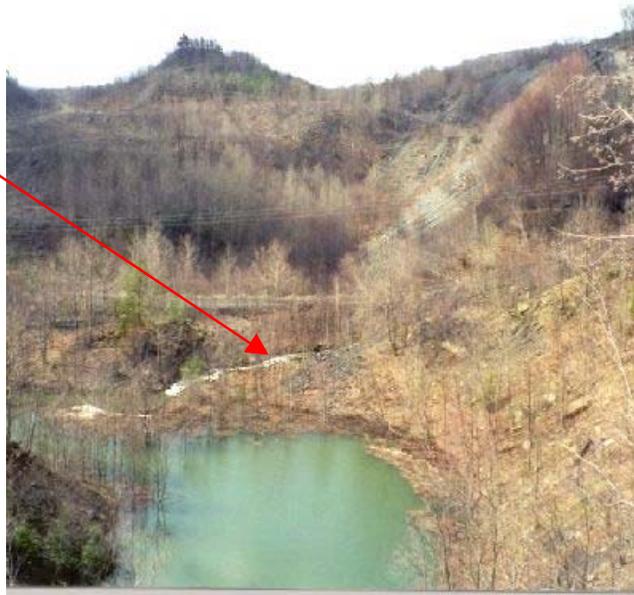
Picture #2

This picture shows the dangerous highwalls, refuse piles, unstable slopes, and ponding water left by years of scarring from mining. The pond at the bottom of this stripping pit is a vivid blue from high concentrations of metals. Also seen at the top part of the pond is Middle Creek emptying into this pit.

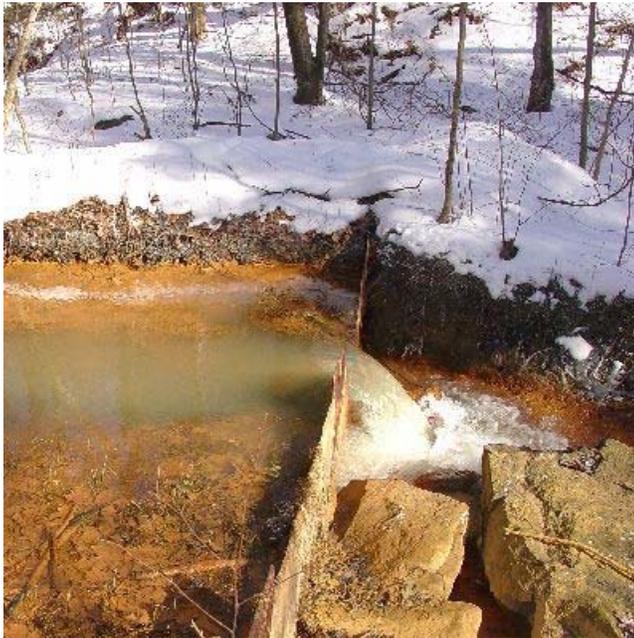
Picture #3

This picture displays the mine pool discharge that flows into Middle Creek. This discharge first started to flow when Middle Creek breached its channel and began emptying into the mine pool in 1972. The discolored water and mud demonstrates the unhealthy amounts of metals that this discharge is carrying. At this location, the discharge is flowing through a V-shaped weir so that water levels can be monitored. Because of this project, it is anticipated that this and one of the two mine pool discharges into Coal Run will be eliminated.

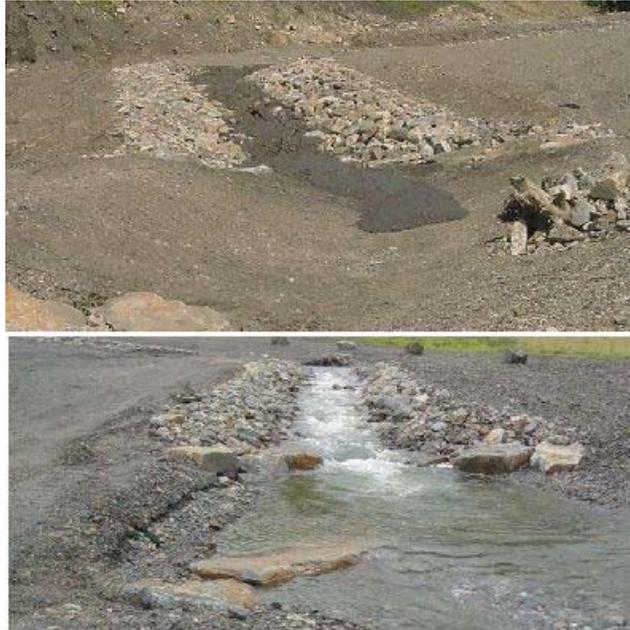
#### Cover Photo

The picture shown on the cover depicts the rebirth of Middle Creek and its condition with a normal flow. At the top, the creek is in the process of filling the channel that it will call home from now on. Also seen are the features in the fluvial geomorphic design. There is a steeper section lined with rock to provide turbulence to the creek that flows to a large rock structure that will form a pool to slow the creeks velocity and erosion power. The bottom picture shows the turbulence in the steeper area and how the energy slows in the pool below it.

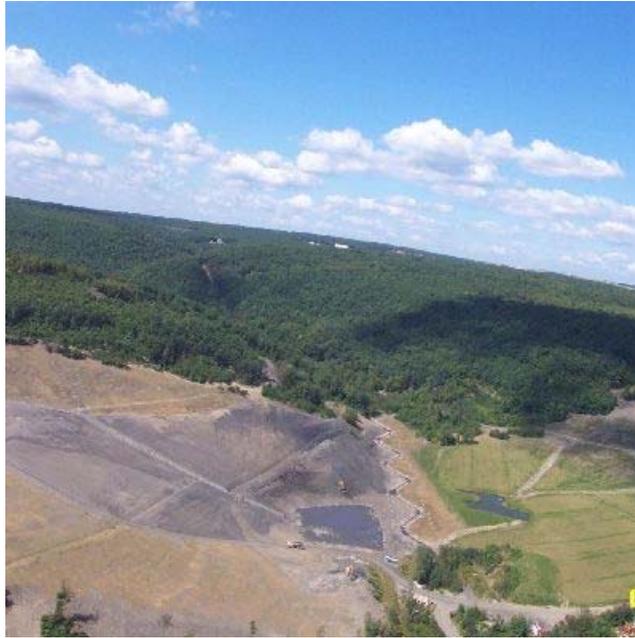
Picture #4

This picture displays an aerial view of the project during construction. The right side is completed and the left side is nearing completion. The highwalls and refuse pile shown in the above Picture #2 have been removed resulting in an area that is much safer. At this point Middle Creek has been reestablished, one wetland constructed, and about half the project seeded with considerable vegetative growth.

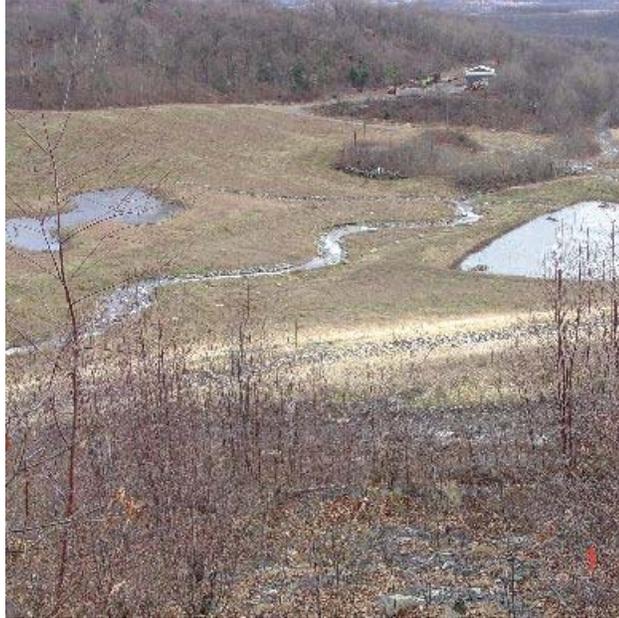
Picture #5

This picture shows the completed project looking down onto the two wetlands and the reestablished Middle Creek. The natural appearing meandering course of the creek is evident with the wetlands on either side. In addition, this picture illustrates that an individual would be able to journey down these slopes without any danger.
