## U.S. DEPT. OF THE INTERIOR OFFICE OF SURFACE MINING Mine Site Inspection Federal Program

Permittee:	Crimson Oak Grove Resources, LLC	
Permit Number:	Alabama P-3232	
Mine Name:	Oak Grove Mine	
Date of Inspection:	November 6, 2024	
Type of Inspection:	Federal Inspection - Partial	
Inspector:	Jeff Hosselton (#115)

## **Inspection Narrative:**

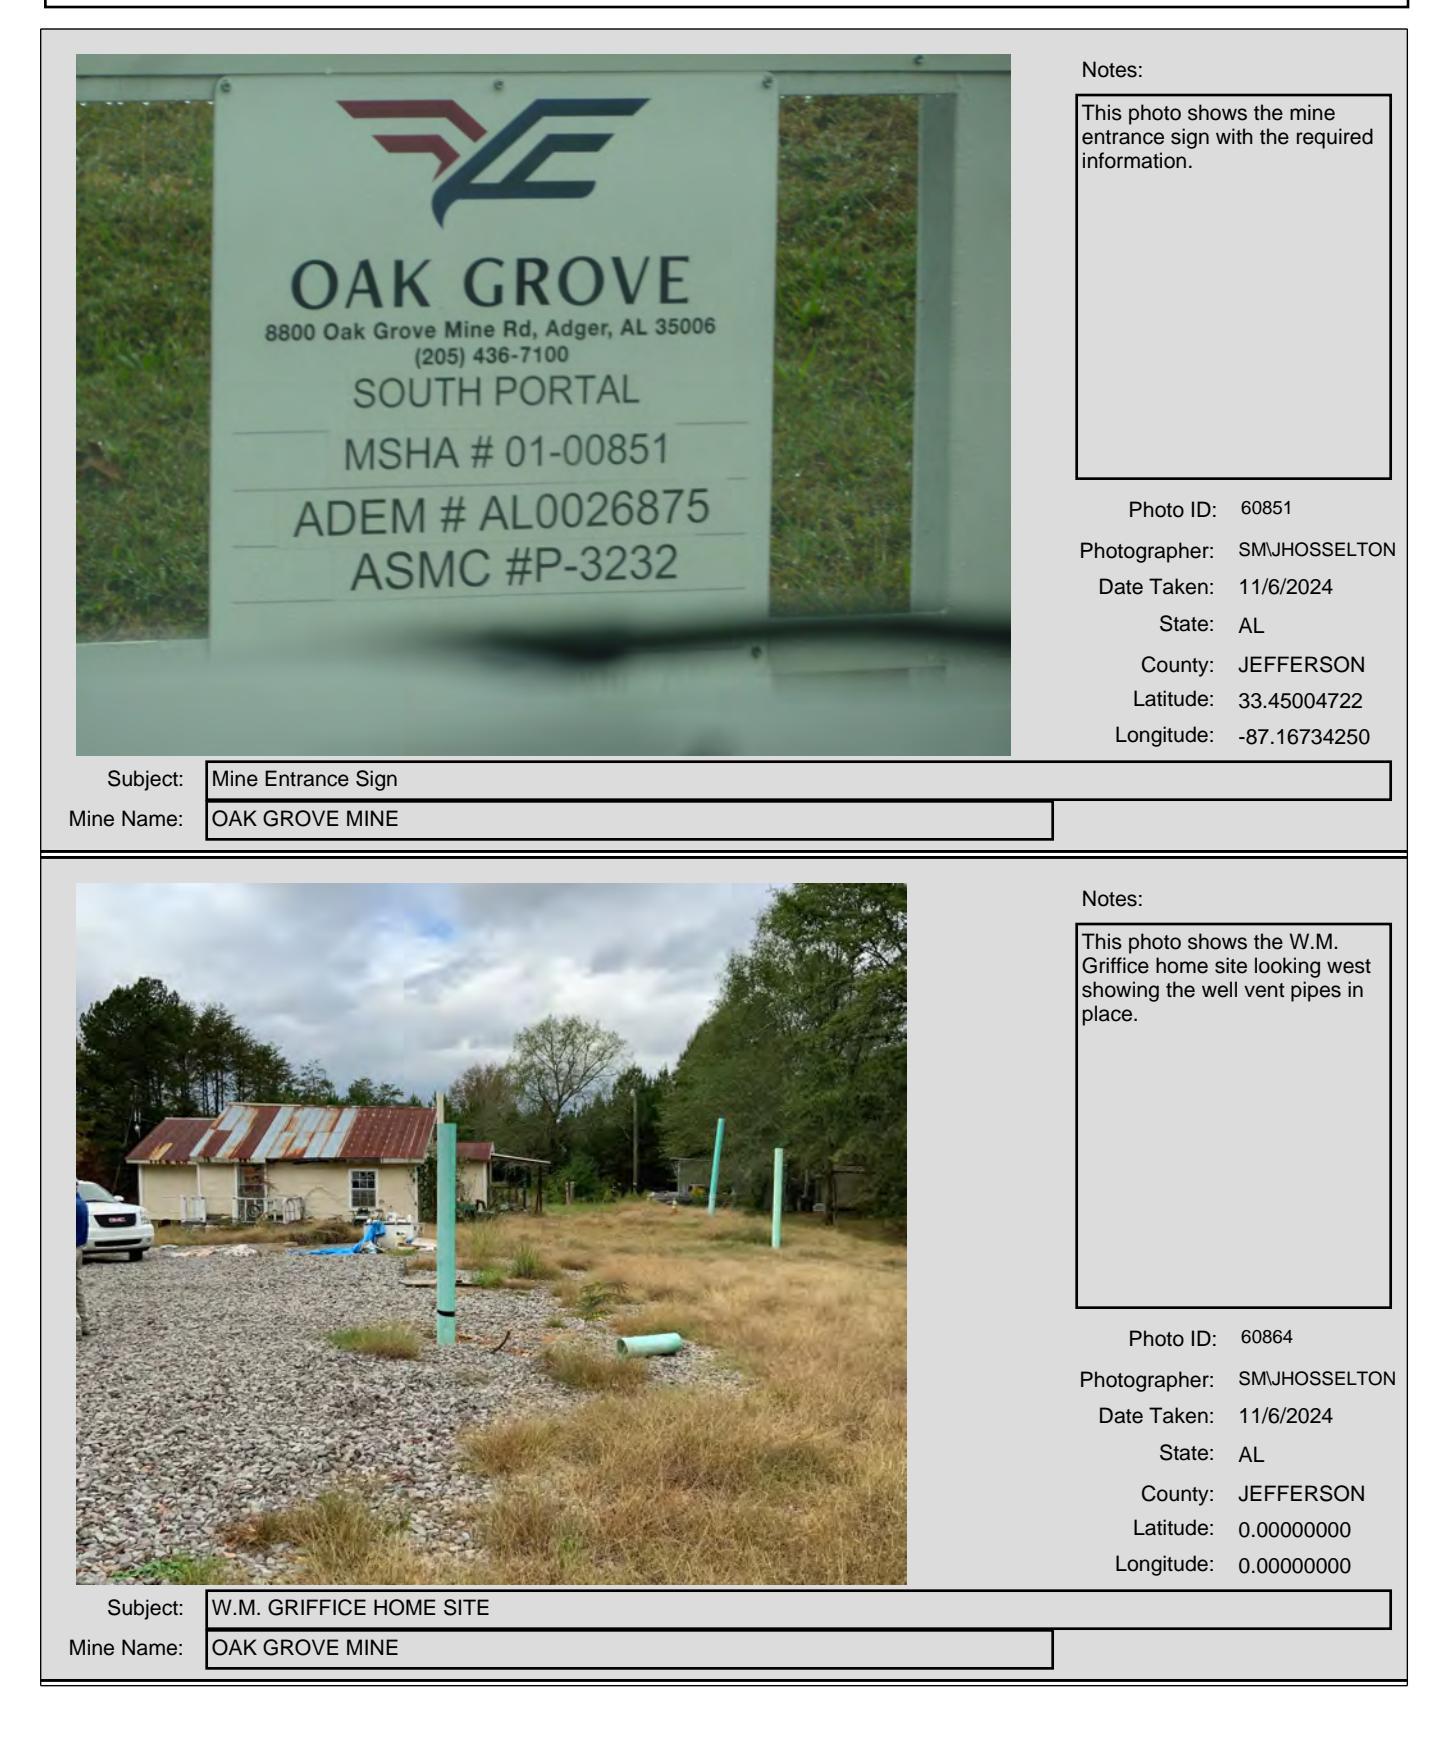
landowner during the pre-subsidence survey and well information request. It is possible that Mr. Griffice was not aware of their existence. See the attached Photo ID #60864 that shows the current well vent pipes. According to OGM personnel, one of the wells was buried under the crawlspace of the home under about 6 inches of dirt, not properly capped, and only discovered during a post fire investigation by ground penetrating radar (GPR). It was also mentioned by the OGM staff that forensic analysis was conducted on the gas coming from this well and it was determined that the gas was coming from the upper coal seam(s), possibly the Mary Lee seam and not the underlying Blue Creek seam being mined by OGM. During our visit to this site, Mr. Hicks of the OSMRE, TSB that accompanied me on this inspection, took a reading from the top of the vent pipe at this location with a portable GX-2012 multi-gas monitor that went into a warning mode and gave a reading of 32 percent of the lower explosive limit of methane according to Mr. Hicks. See Photo ID #60865. The vent pipe was venting into the air as designed, functioning like a normal degasification well would, and did not constitute an immediate hazard to the health and safety of the public. There are no structures near this subject vent pipe. The other vent pipes on site were too tall to get a gas reading from the multi-gas monitor. I looked at the water well that was capped at the request of Mr. Griffice when his home was connected to public water supply prior to mining. The attached Photo ID #s 60866 and 60867 show the water well pump house and the capped well inside the pump house, located approximately 80 feet north, and downhill of where the Griffice home was located. Mr. Griffice's brother's house is still standing next door to the fire location, but it was not occupied. This inspection narrative is reporting only what was observed or discussed during this inspection and in no way is attempting to determine the exact cause of the events that occurred at Mr. Griffice's home on 3/8/2024. There are many factors at this site, such as the unknown well location under the Griffice home; other wells on the property discovered later by GPR; the fact this area has an active coal bed methane operation with low-pressure and high-pressure lines transversing through the immediate area with several collection wells and one such well located just southwest of Mr. Griffice's home; and the home had a secondary heat source of a wall gas heater and two one-hundred-pound propane tanks standing beside the location of the home. The Alabama State Fire Marshal's Office report concerning this event, dated 3/9/2024, concluded the cause of the fire to be undetermined. The site will continue to be guarded and monitored daily.

# **I&E Inspection Photos** Permit: P-3232 Inspection Date: 11/6/2024 Permittee: CRIMSON OAK GROVE RESOURCES, LLC Notes: This photo shows Mr. Brian Hicks testing the well gas with the portable GX-2012 multi-gas monitor. 60865 Photo ID: SM\JHOSSELTON Photographer: Date Taken: 11/6/2024 State: AL County: JEFFERSON Latitude: 0.00000000 Longitude: 0.00000000 W.M. GRIFFICE HOME SITE Subject: OAK GROVE MINE Mine Name: Notes: This photo shows the water well pump house that previously housed Mr. Griffice's water well prior to the well being plugged. Photo ID: 60866 **SM\JHOSSELTON** Photographer: Date Taken: 11/6/2024 State: AL **JEFFERSON** County: Latitude: 33.43441778 Longitude: -87.16679778 W.M. GRIFFICE WATER WELL PUMP HOUSE Subject: Mine Name: OAK GROVE MINE

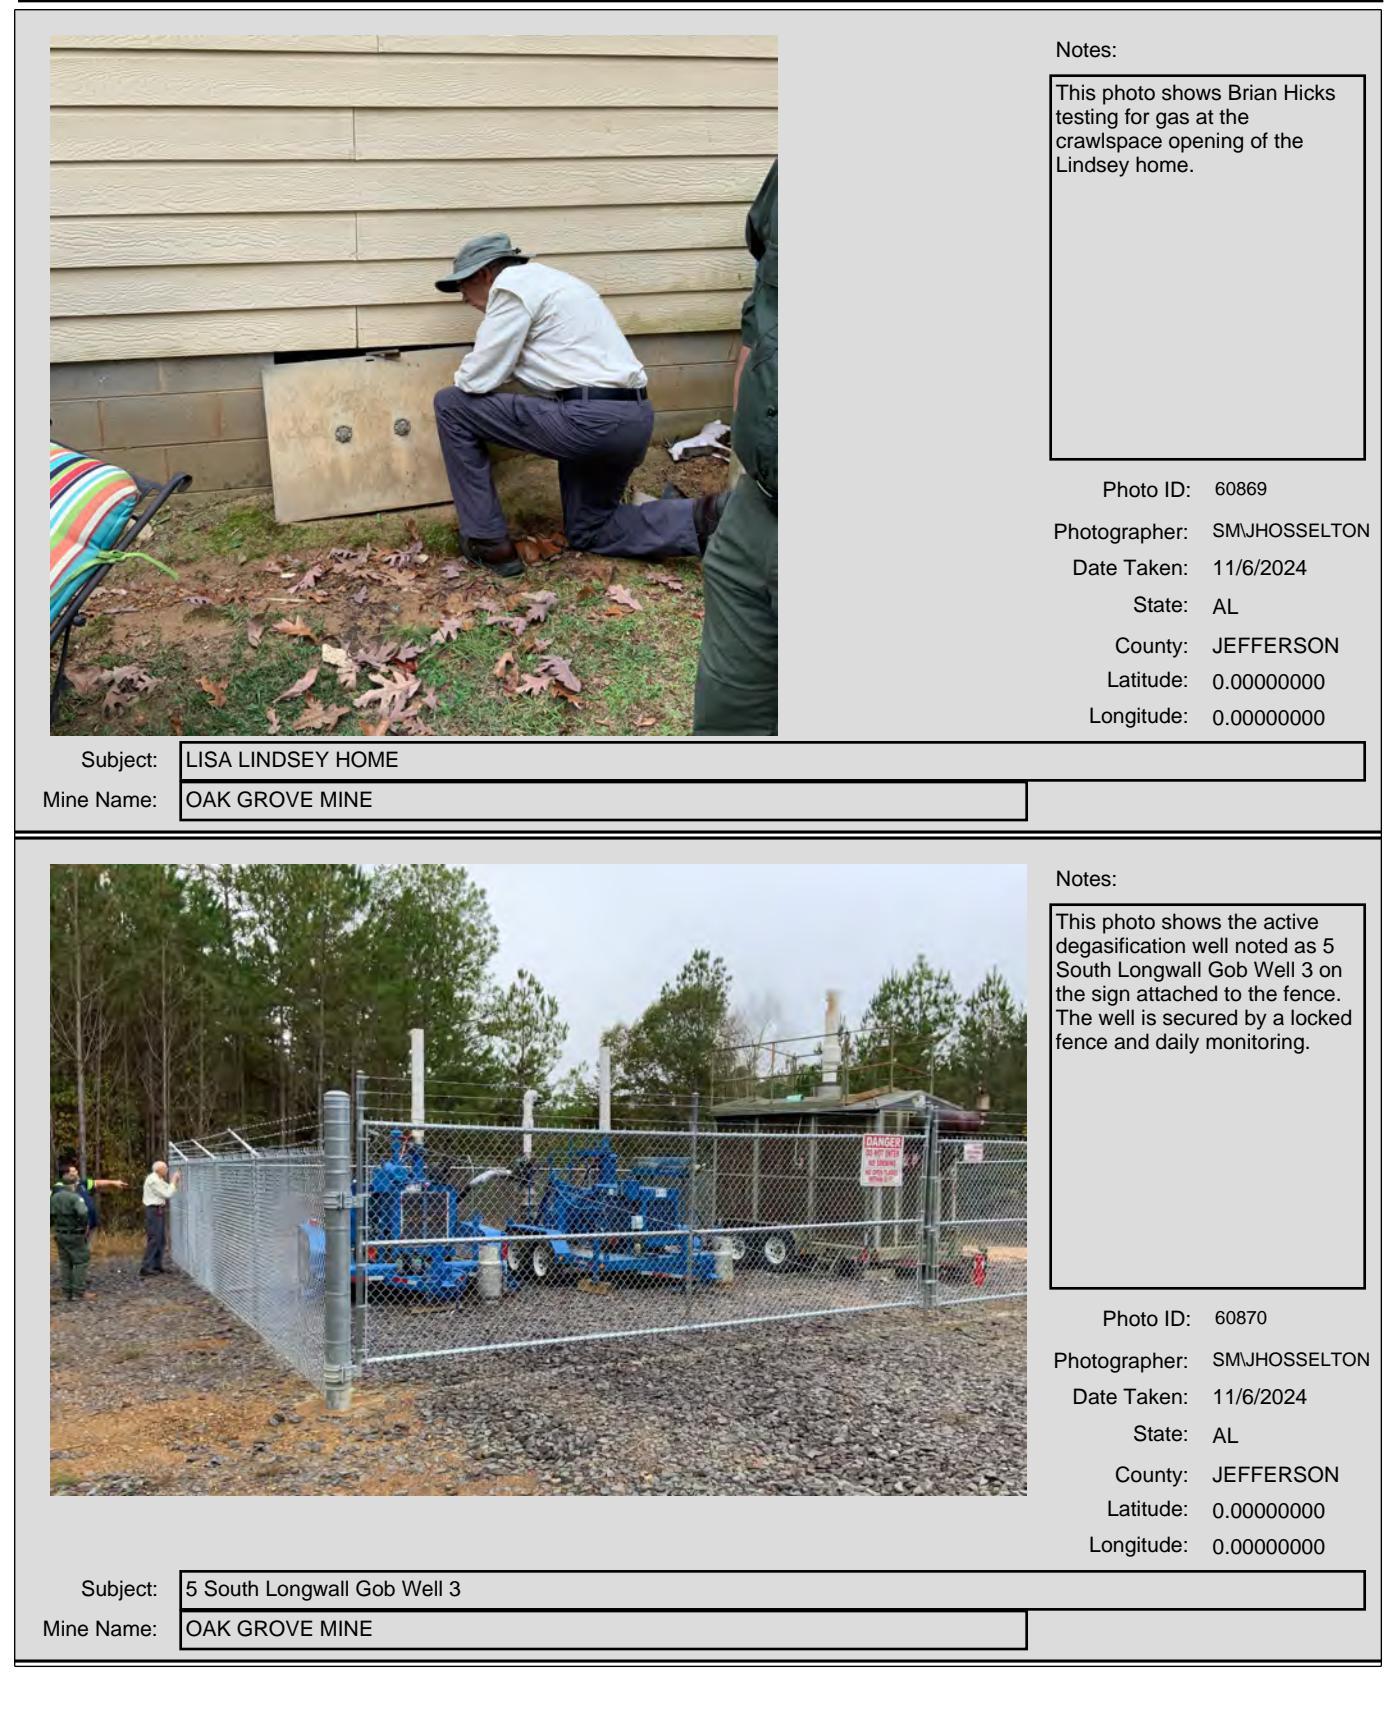
The second site visited was the home of Mrs. Lisa Lindsay at 2290 Griffis Road, Adger, Alabama. This home was just around the corner from Mr. Griffice's home. Mrs. Lindsay has a current subsidence complaint pending with the Oak Grove Mine. Typically, the coal company waits four to six months after mining to initiate repairs to the home. Mrs. Lindsay showed Mr. Hicks, Mr. Kiser, and me around the foundation of the home where most of the subsidence damage is located. See Photo ID #60868. Mr. Hicks took a reading with the multi-gas monitor under the crawl space the Lindsay home. The meter did not detect any gas under the home. See Photo ID #60869. The attached photos show the foundation cracks that concern Mrs. Lindsay and Brian Hicks testing for gas.

<image/>	Notes: This photo shows Brian Hicks testing for gas at the Lindsey home. The photo also shows the suspected subsidence cracks in the foundation. Photo ID: 60868 Photographer: SMJHOSSELTON Date Taken: 11/6/2024 State: AL
<image/>	Notes: This photo shows Brian Hicks testing for gas at the Lindsey home. The photo also shows the suspected subsidence cracks in the foundation. Photo ID: 60868 Photographer: SMJHOSSELTON Date Taken: 11/6/2024 State: AL County: JEFFERSON Latitude: 0.0000000
<image/>	Notes: This photo shows Brian Hicks testing for gas at the Lindsey home. The photo also shows the suspected subsidence cracks in the foundation. Photo ID: 60868 Photographer: SMJHOSSELTON Date Taken: 11/6/2024 State: AL County: JEFFERSON Latitude: 0.0000000 Longitude: 0.0000000
With the second seco	Notes: This photo shows Brian Hicks testing for gas at the Lindsey home. The photo also shows the suspected subsidence cracks in the foundation. Photo ID: 60868 Photographer: SMJHOSSELTON Date Taken: 11/6/2024 State: AL County: JEFFERSON Latitude: 0.0000000 Longitude: 0.0000000
