Emergency!

Congress established Section 410, the "Emergency Powers" part of the Surface Mining Act to address the potential for any type of crisis resulting from past mining practices. Section 410 provides for immediate response to emergency situations related to mine hazards that may adversely affect life, safety and health when no other agency has the authority to act.

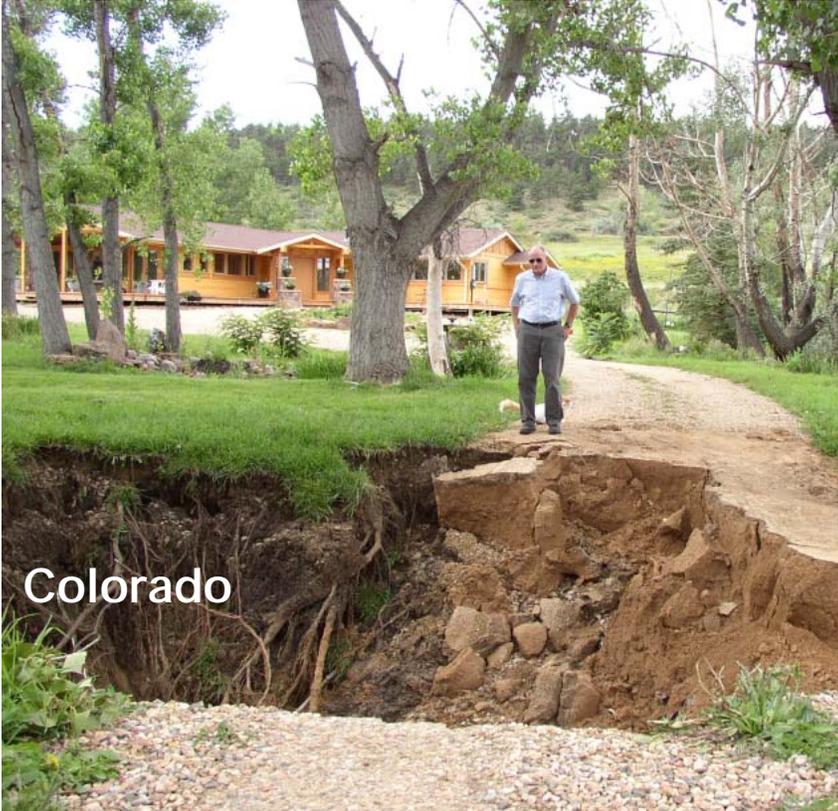
Jim Fulton, chief of OSM's Denver Field Division, surveys the damage caused by mine subsidence to the driveway of a Marshall, Colorado, residence. OSM's Denver Field Division reclaimed the pit quickly. Hazards like this can happen anywhere underground mining has occurred.

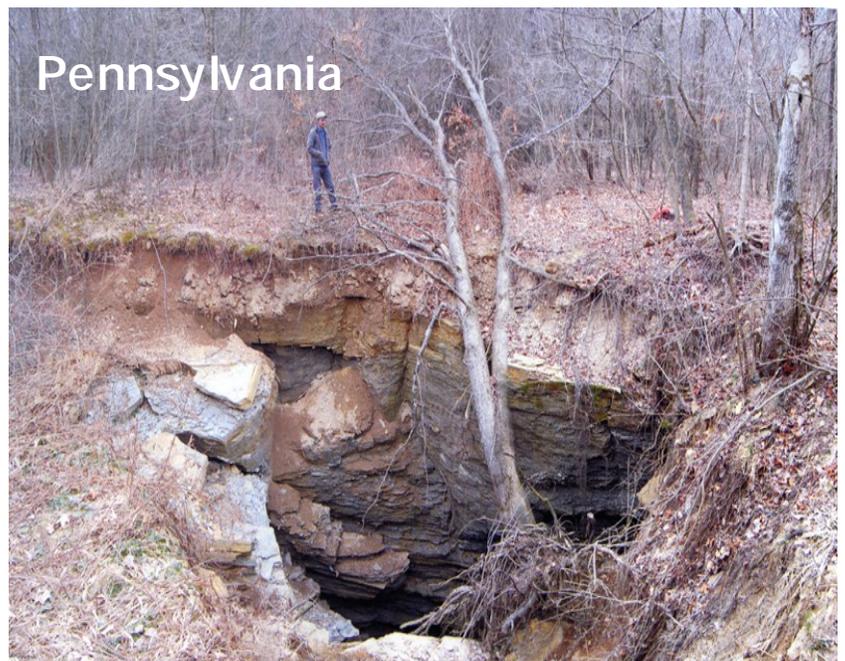
Not Much Fun Here
A huge subsidence void appeared in a high-density recreation area when the roof collapsed in an abandoned mine near Indiana Township in Allegheny County, PA. The resulting pit covered an area of approximately 2,400 sq. ft. with a depth of 60 feet. OSM's Federal Emergency Redamation Program Division responded by backfilling the void with durable rock followed by site restoration.

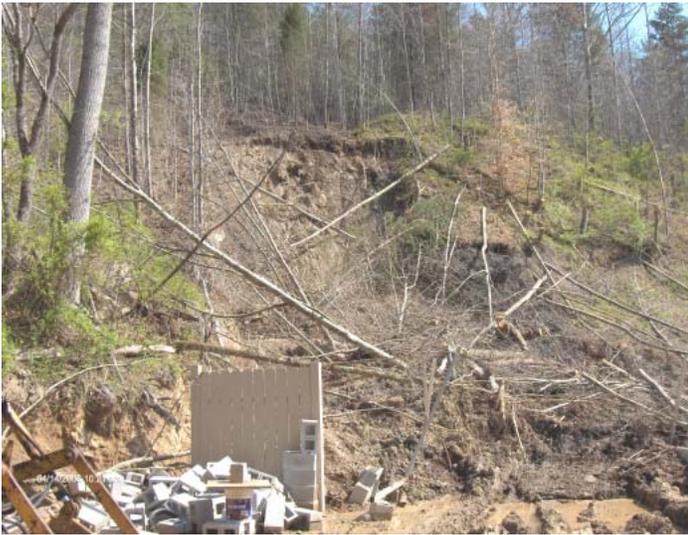
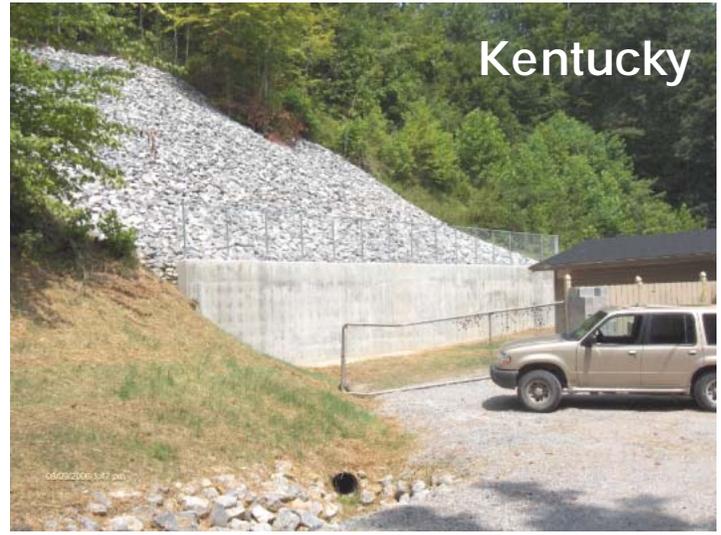
Kentucky

The "KY-06-025" landslide in Cranks, Harlan County, KY, before (left) and after (right) restoration.

In April 2006 a sudden landslide occurred behind a home in Cranks, KY. The landslide damaged a carport and a utility building adjacent to the home. Large deposits of soil, rock, trees and mud were in the backyard and driveway of the home.

The landslide impacted an area of approximately 5,000 square feet. The cause was attributed to water from an abandoned coal mine saturating surface mine spoil on the hillside above the residence.

Investigation confirmed that the sudden event was the result of pre-SMCRA coal mining activities and that the landslide posed a significant threat to life, safety and health.

The unstable material was excavated and hauled to an approved fill location. An 80 ft. long, 10 ft. high reinforced concrete retaining wall was constructed at the base of the slope behind the residence. A number of surface and subsurface drainage control structures were installed behind the wall and on the hillside above the home.

The disturbed areas around the home were revegetated. The forest areas that had been impacted were replanted with a mixture of hardwoods, pines and ornamentals. All work was completed by July and cost approximately \$151,000.

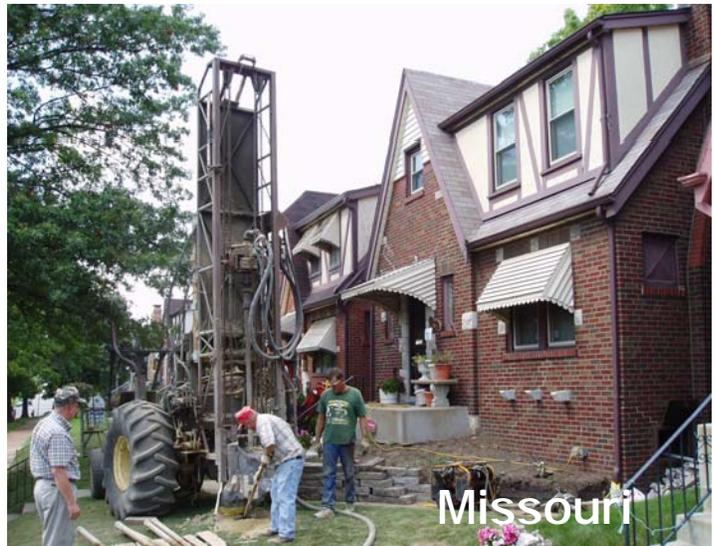
The Missouri Land Reclamation Program received a complaint about a home's foundation shifting causing cracks in the outer shell. An investigation was initiated to confirm if the cracks were caused by mine subsidence or another mechanism. The area has a history of underground clay mining. However, exploratory drilling revealed neither coal nor voids. This information was useful to the homeowner for planning his own foundation stabilization measures.

Clint Bishop of the Missouri Land Reclamation Program (lower left) with crew drilling to look for mine voids.

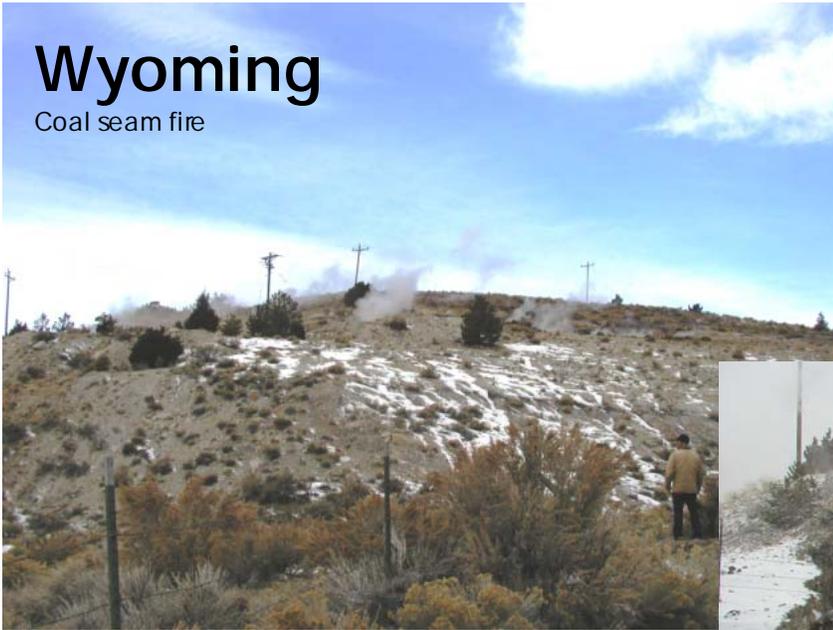
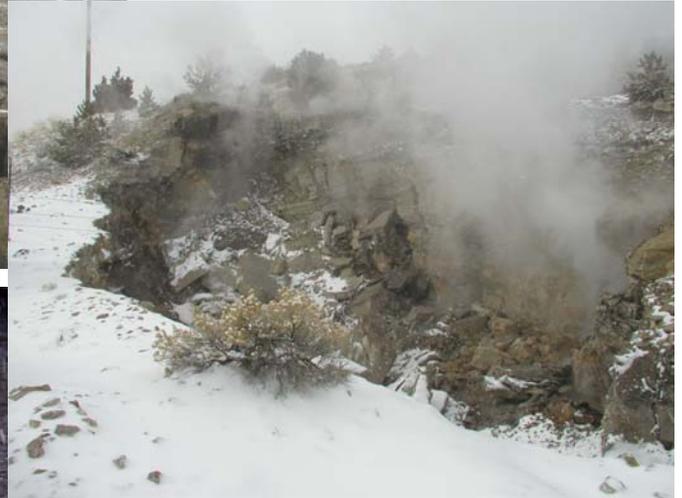
Coal seam fire

In late December 2005 the Wyoming AML Program investigated a newly-discovered fire in an abandoned coal mine. It had already been burning for quite a long time, (left), but had not manifested itself to the surface. When it came through to the surface, it did so with a flourish (below).

The Wyoming AML Program took quick action to control the fire, and within a few weeks had the fire under control. More work will be needed before the project is complete, but the threat from the fire is now greatly reduced.

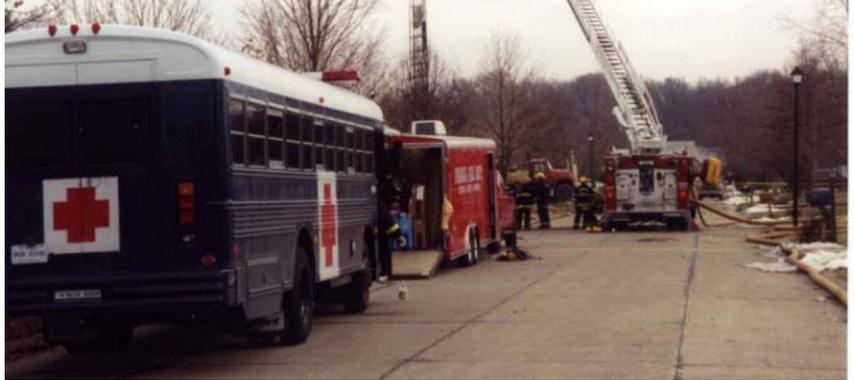
Illinois Adam Drive Gas Leak Emergency Belleville, Illinois

The Illinois AML Emergency Program leapt into action when dangerous concentrations of methane gas were reported seeping into homes and sewer lines in the Illinois community of Belleville.

The problem occurred when a driller was boring a hole for the installation of a geo-thermal heating system and the boring intersected an abandoned underground coal mine filled with methane gas. The driller took immediate precautions and plugged the hole, however, the gas began to seep through the utility lines into homes and sewers in the neighborhood.

Cooperative agencies respond to methane gas leak in Belleville, IL.

Emergency agencies responded by evacuating residents, installing a vent pipe, and permanently grouting the hole to ensure that gas could not reach homes or utilities. Fans were used to dilute gas concentrations around workers while a water mist was sprayed to prevent accidental electrostatic discharges.

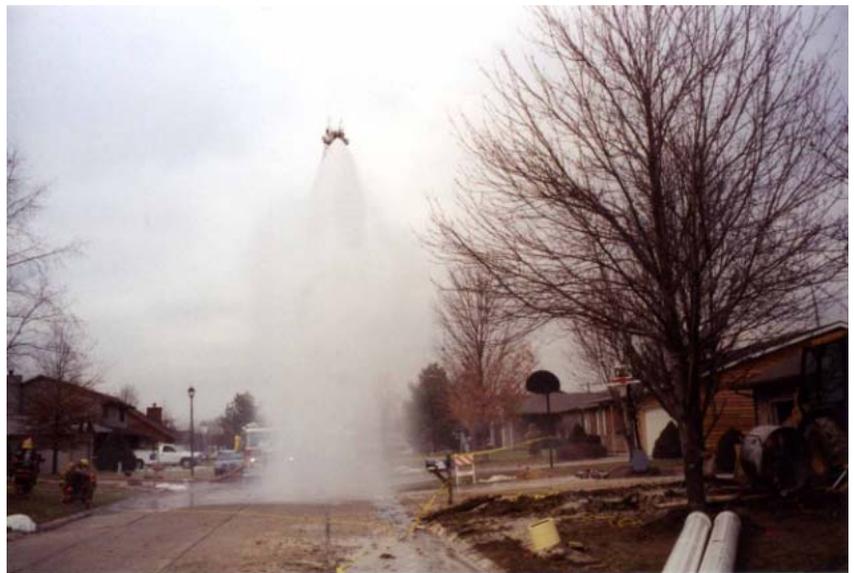
The area is sprayed to prevent accidental electrostatic discharges.

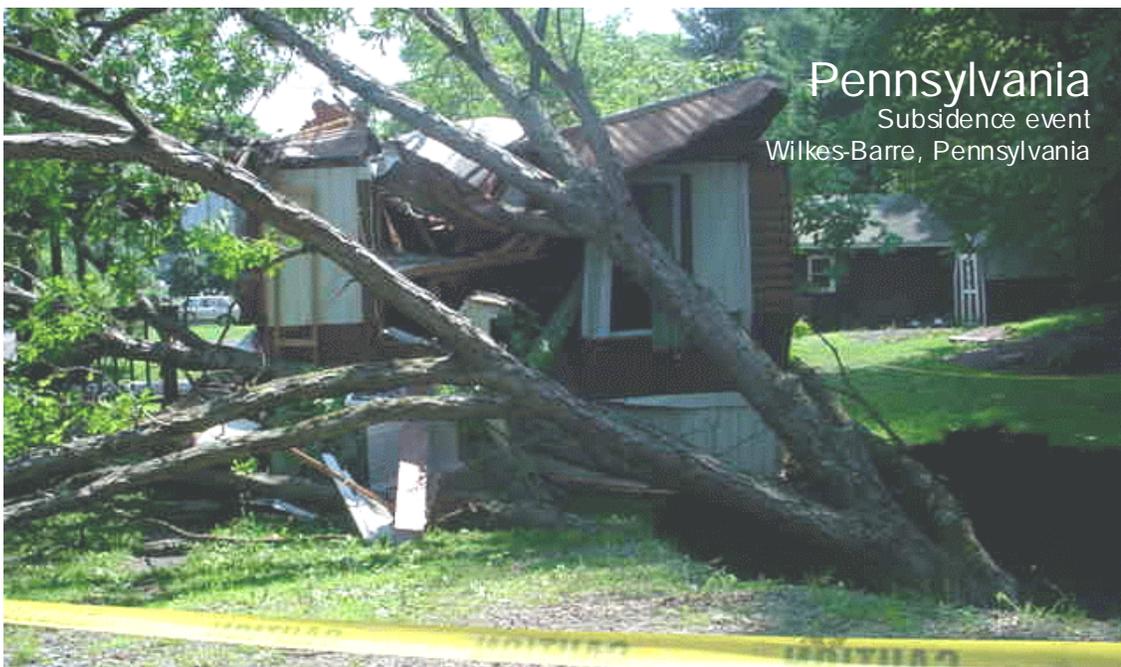
Pennsylvania Subsidence event Wilkes-Barre, Pennsylvania

Subsidence damages a mobile home in Wilkes-Barre, PA.

On June 28, 2006, the residents of a mobile home in Wilkes-Barre, PA, were awakened by the sound of a loud crash. They discovered a large hole adjacent to the mobile home and evacuated the trailer.

OSM personnel reviewed mine maps, determined the subsidence had occurred over an abandoned mine and immediately began emergency procedures.
