**Indiana Midwestern Abandoned Mine Land
Reclamation Project**

MIDWESTERN ABANDONED MINE LAND RECLAMATION PROJECT
Site 1087

MIDWESTERN ABANDONED MINE LAND RECLAMATION PROJECT
PIKE COUNTY, INDIANA

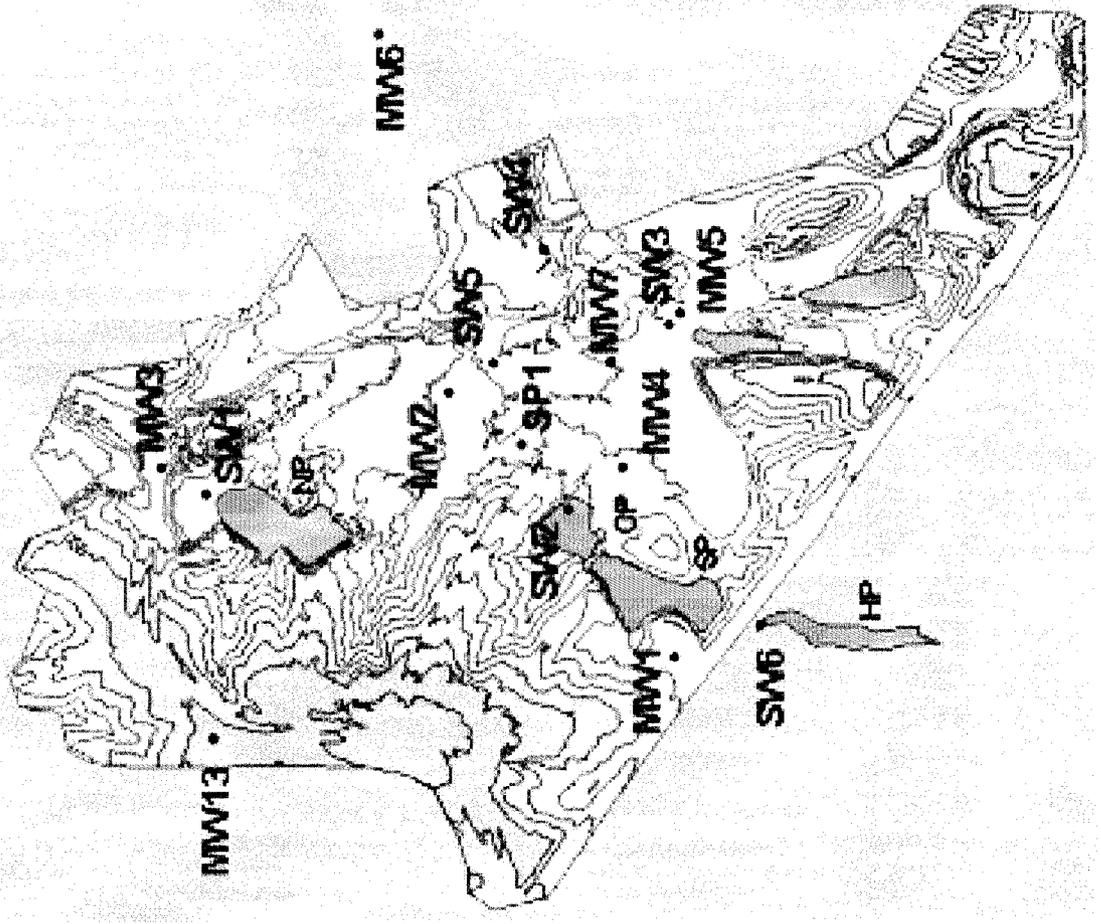
Pre-reclamation
Water monitoring sites
began in April 1995

The relationships of pre- and post-reclamation monitoring sites to topography. Following graphs and tables from IGS Study.

To document the effectiveness of reclamation at this site, the IDNR-DOR retained the Indiana Geological Survey (IGS) to monitor water quality both before and after construction. The purpose of their study was to evaluate the quality of ground and surface water in the vicinity of the site and determine the effectiveness of reclamation at improving the chemistry of water discharging from the site. Photograph 9 provides a view of one of the monitoring stations established by IGS. The following table presents the acid-mine drainage parameters on the Midwestern site and water quality at each monitoring station.
