Award Nomination

2001 National Abandoned Mine Land Reclamation Awards

Sunnyside Project

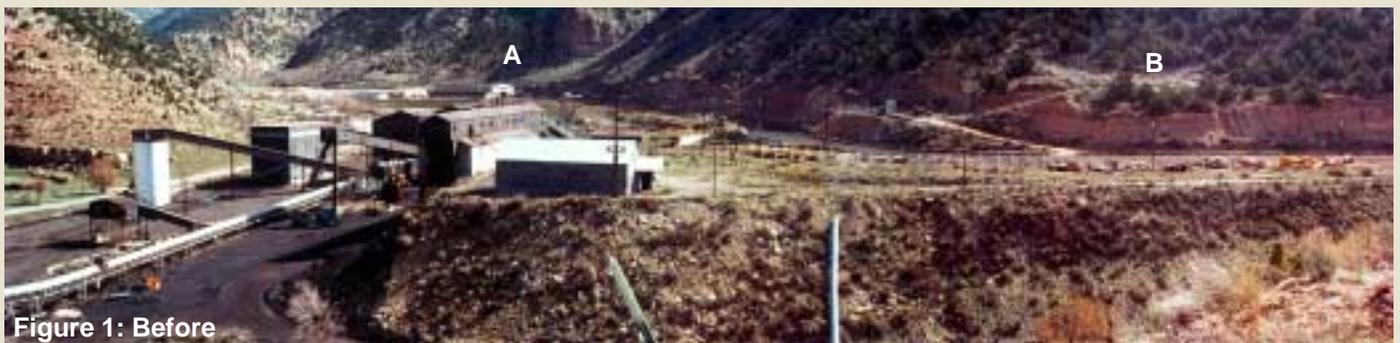
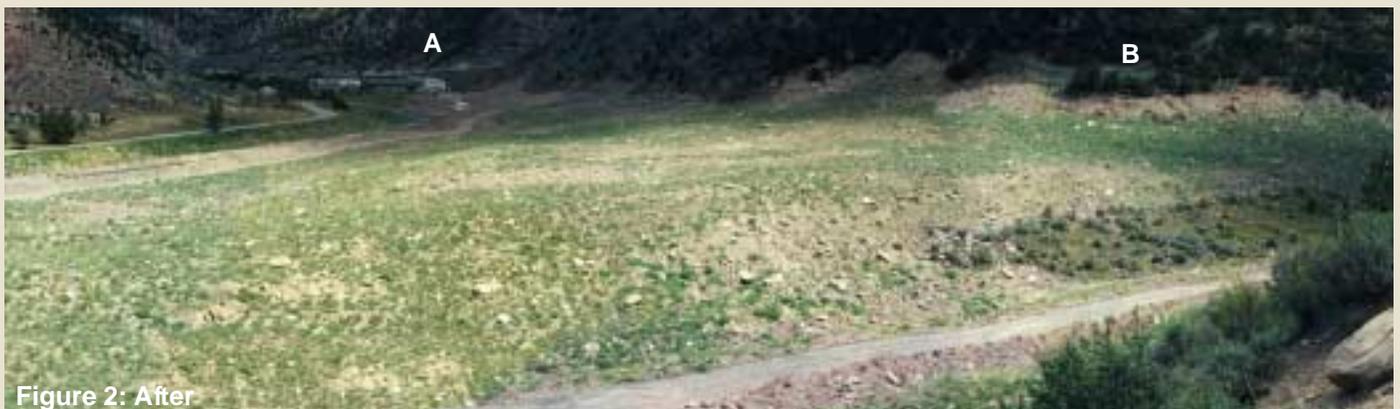
The Main Facilities Area underwent a dramatic transformation through demolition, realignment of Grassy Trail Creek, and 478,800 cyd of earthwork.

Through nearly 100 years of operation, mine workings and associated surface facilities became extensive. Surface facilities were scattered over a six square mile area and included the Main Mine Facility immediately adjacent to the town of Sunnyside (Figure 1), five other major facilities areas and several additional portal areas. Reclamation included nearly 200 acres of surface disturbance and addressed nine hazardous shafts and 48 hazardous portals (Figure 2). Additional work included restoration of a 1/4-mile reach of Grassy Trail Creek and the planting of over 600 potted trees and shrubs. Reclamation was completed using a combination of AML and bond forfeiture funds.

Massive concrete structures left from coal mining, including the coal preparation and wash plant, coal loadout facilities and intra-mine transportation system were demolished or buried depending on their location. Heavy rebar and oversized wall and foundation construction typical of such structures made during World War II and the 1950's made the demolition work difficult. In addition to known structures, several buried concrete foundations were discovered during massive grading operations, increasing demolition cost and time. A total of over 160,000 cubic yards of

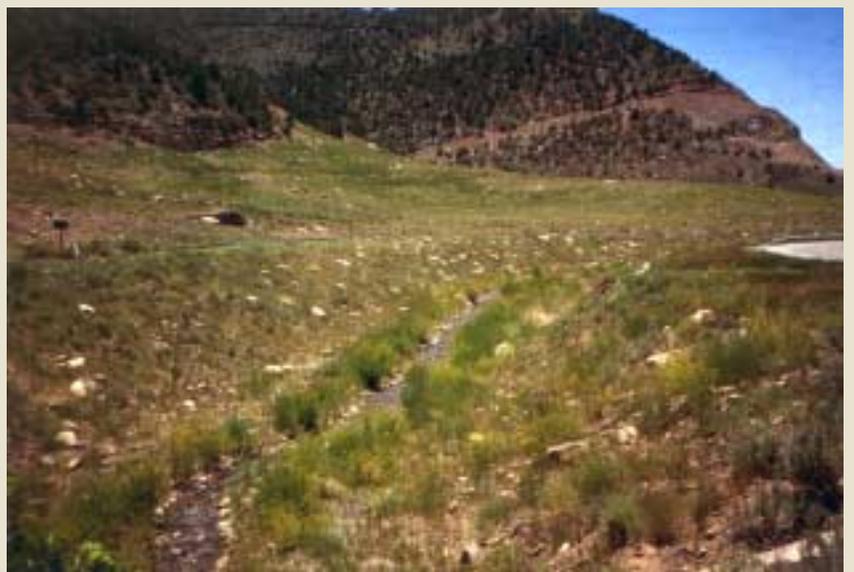
An additional 287,100 cyd of earthwork was made possible by low earthwork costs, allowing for reclaimed landforms that closely match natural contours

With a fixed project budget, the extent of site recontouring was dependent on the successful contractor's bid per cubic yard of material to be moved. Based on initial predictions (using average earthmoving costs), over 200,700 cyd of earthwork was planned. However, because the winning contractor's bid per cubic yard was much lower than average, it was possible to move an additional 287,100 cyd for an ultimate total of 478,800 cyd. The additional yardage provided the opportunity to further reduce highwalls and create final reclaimed landforms that more closely match natural contours and minimize erosion into Grassy Trail Creek and other local drainages (Figure 3). Extreme surface roughening of the final slopes has reduced the potential for generating sediment from over 200 acres of reclaimed disturbance.

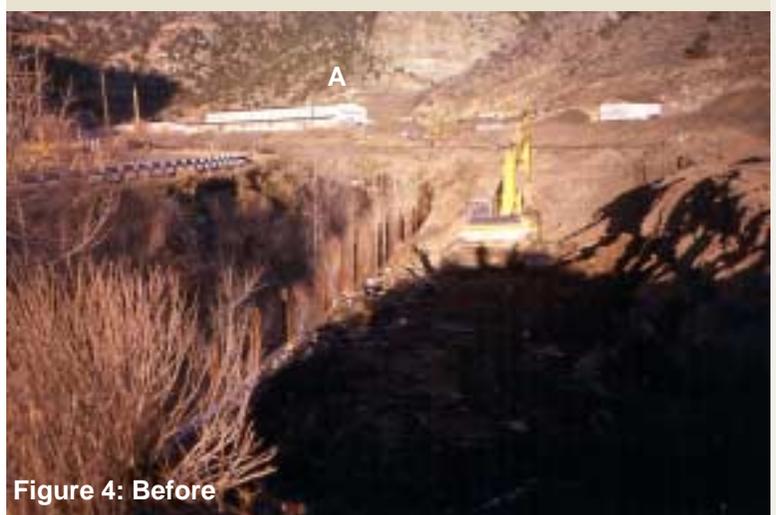
Figure 4: Before

The reach of Grassy Trail Creek flowing through the main facilities area was heavily impacted by mining operations over the course of a century of mining. The stream was gradually channelized and pushed further toward the edge of the canyon. Eventually, the stream was contained within a deep channel and pinched between a county road and the railroad line serving the mine (Figure 4).

Several problems existed within the reach. The position of the stream immediately adjacent to the road caused bank erosion with each high flow event and had begun to impact the stability of the adjacent county road. The opposite bank was retained with timber crib walls ranging from five to ten feet high. Various utility lines spanned the channel and mine buildings were built only a few feet behind the crib walls. The natural channel and floodplain configuration had been obliterated, and the stream corridor was of little to no value as a wildlife corridor or as an aesthetic amenity.

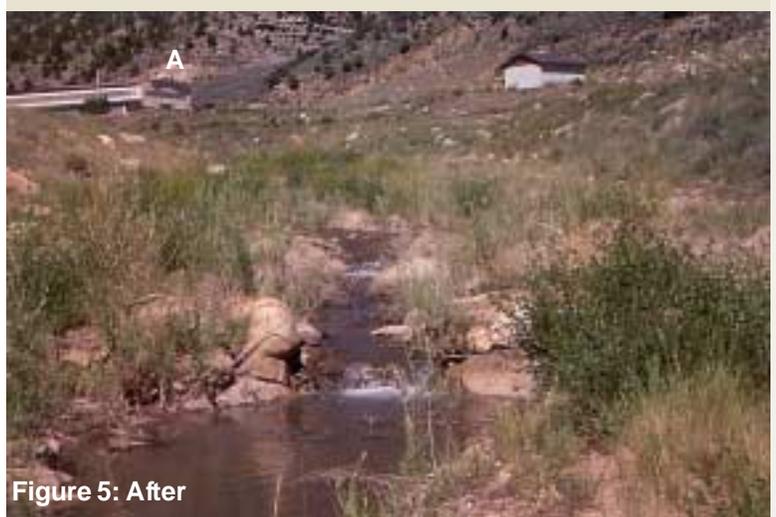
Figure 5: After

Grassy Trail Creek was transformed from an entrenched, eroding ditch to a meandering stream with functional ecological processes and a natural appearance.

The new stream was modeled after relatively natural reaches upstream. A new main channel was constructed with a bed of gravels, cobbles and boulders. Three boulder drop structures were incorporated into the channel. The stream corridor was widened to create a floodplain with off-channel wetland areas. Before construction began, the AMR staff harvested willow cuttings from the existing channel. These cuttings were stored over the winter using two very different methods (shallow burial and bundled in buckets) and were planted in the spring in a variety of bioengineering applications. Willow survival has been very near 100% regardless of storage method or planting technique. Additional revegetation incorporated eight separate seed mixes and 189 potted trees and shrubs.

Grassy Trail Creek now meanders through a restored floodplain and provides attractive habitat for bighorn sheep and other wildlife species in the area. In addition, the road has been stabilized, more natural hydrology and sediment transport has been established, and what was once an unattractive ditch has become a community asset (Figure 5).

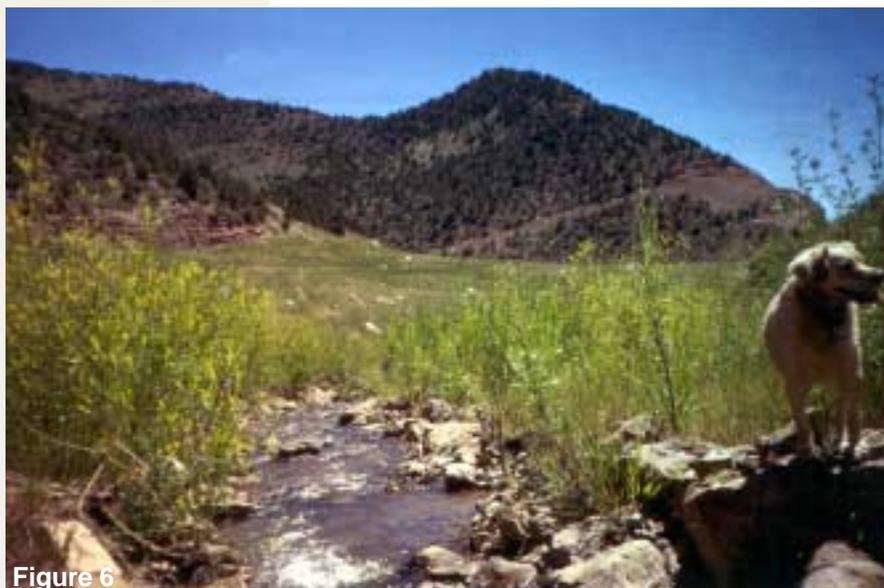
Figure 6

A mining landscape that once provided economic benefits now provides a new set of benefits as a reclaimed landscape.

The land occupied by the Sunnyside Coal Mine has evolved through two major phases of existence. The first phase provided employment and economic benefits that created and sustained the town of Sunnyside over nearly 100 years of mining. The area is now entering its second phase as a reclaimed landscape and continues to provide positive benefits to the community. The natural attributes of the reclaimed landscape, including the opportunity to view wildlife, have quickly become a valued component of the local landscape for area residents (Figure 6).
