Award Nomination

Cottonwood Wash Reclamation Partnership Project

2005 National Abandoned Mine Land Reclamation Awards

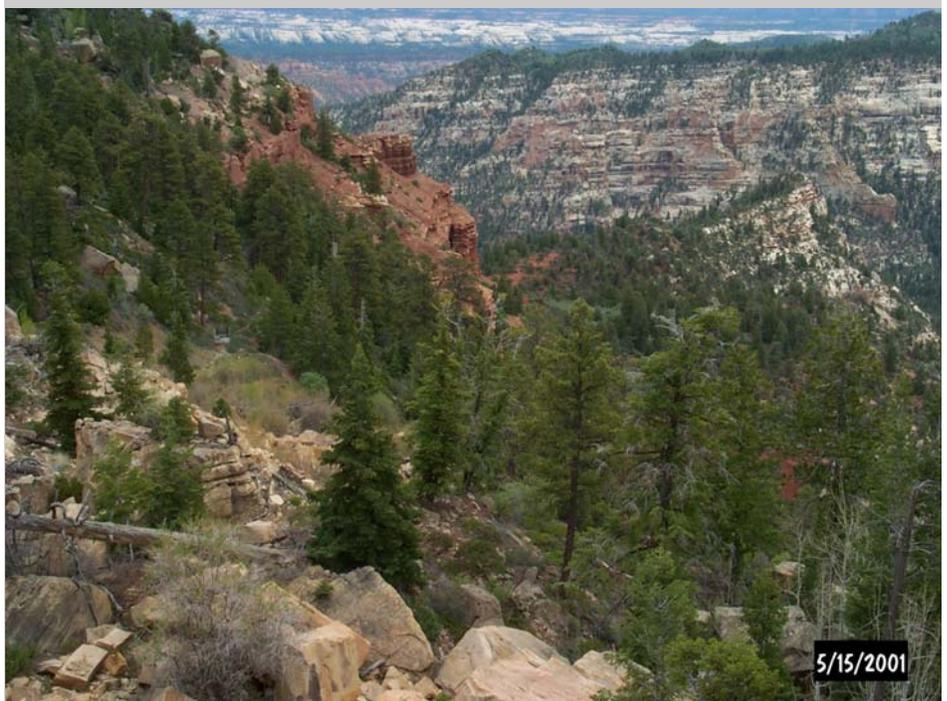
Figure 1. Overview of Cottonwood Wash Area

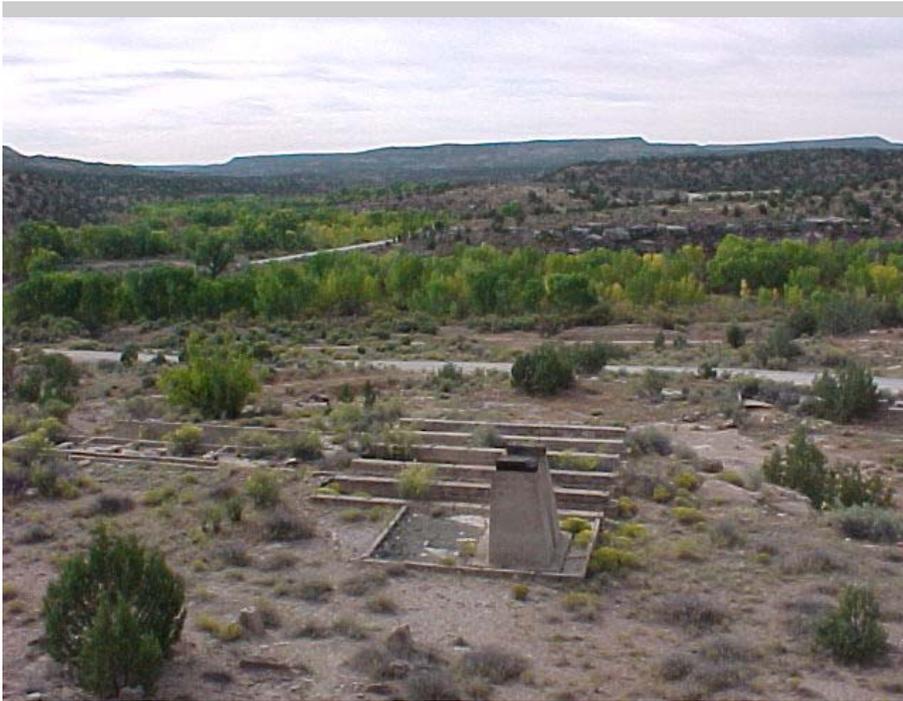
Figure 2 Vanadium mill site.

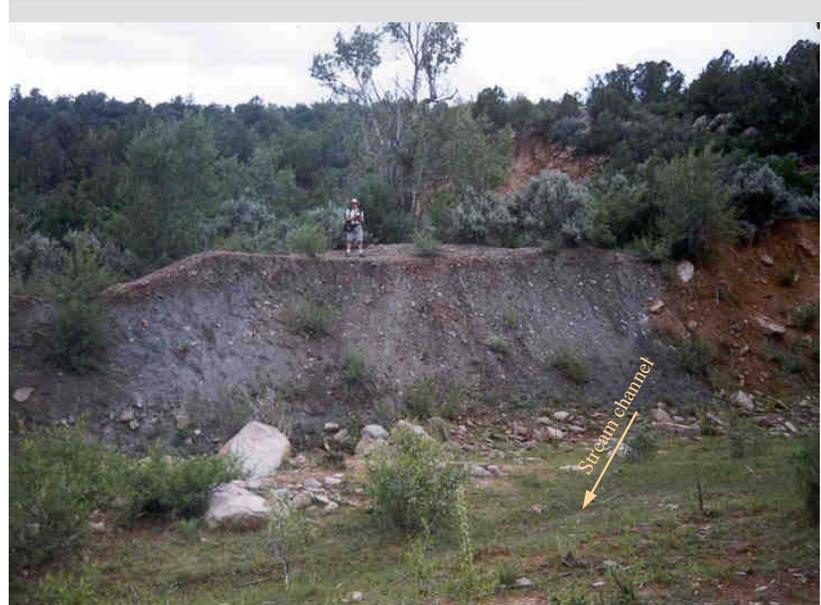
Figure 3. Before reclamation, uranium dump material is in the stream channel.

Physical and environmental hazards were mitigated in one step by removing portions of mine dumps located in stream channels for use as backfill material for hazardous openings and face-up areas. This material was also incorporated into existing dumps to be regraded, or covered with topsoil to be seeded (see Figures 3 and 4). On FS land, 64 miles of exploration roads were reclaimed and all roads were seeded. Dry drill holes were backfilled with dirt and wet drill holes incorporated bentonite into the closure to contain the water. Overall, the following reclamation was completed:

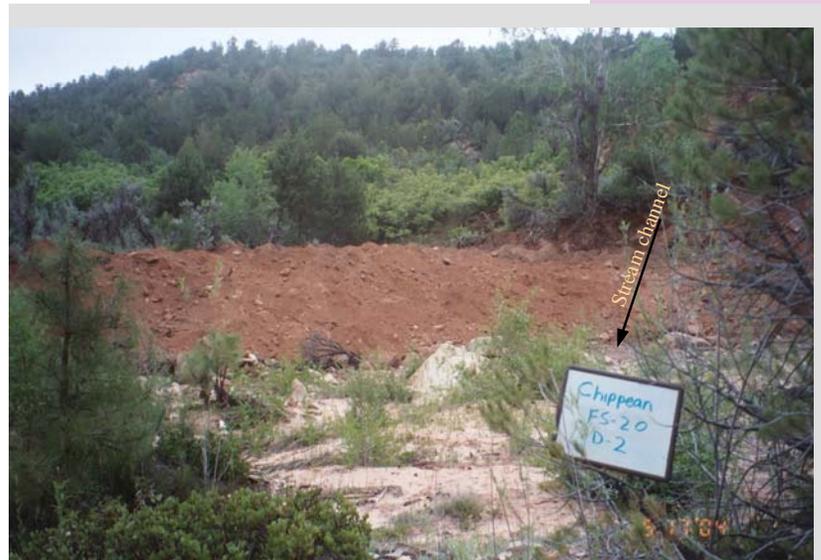
Figure 4 Completed reclamation, uranium dump material has been removed from stream channel and replaced with clean soil. Note the tree is much closer to the stream, showing how much material was removed.
