**YEAR 2003
ABANDONED MINE LAND RECLAMATION AWARD
NOMINATION**

**AML PROJECT 8-II
SEAN CARROLL AND GOOSE CREEK SPOILS**

Sheridan, Sheridan County, Wyoming

**DEPARTMENT OF ENVIRONMENTAL QUALITY
ABANDONED MINE LAND PROGRAM**

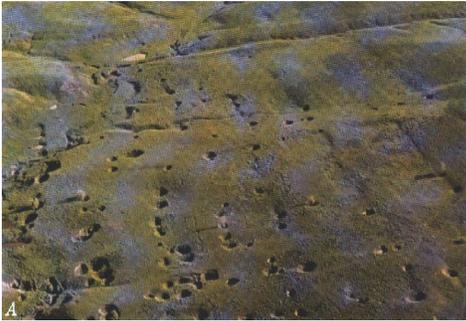
Sean Carroll - Before (Photo 1)
Aerial View of Site

At the ***Sean Carroll*** site, public hazards were related to mine openings and subsidence features associated with underground coal mines (See Photo 1). Extensive subsidence had occurred in these areas and ground conditions were locally unstable. Coal mine fires, ignited by spontaneous combustion, were active in the vicinity at the Monarch and Acme mines as recently as 1979. No mine fires were active during the Sean Carroll Project but reignited in the vicinity of Monarch, Wyoming in 2001. These fires were successfully extinguished by Wyoming AML as part of this overall project in 2001. This occurred in Aug. 2001 and was a result of a range fire which started the coal slack on fire, surrounding the Old Monarch Mine (See Photo 5). This site is located of the AML Project 8-II Phase I area and on the John Buyok and Ramon Legerski properties. AML mobilized equipment to contain the coal slack fire and isolate the fire from the surrounding ranch buildings. A trench was dug around the fire and an encapsulation pit was dug to push the burning slack into and cover to smother (See Photo 6). The Wyoming Abandoned Mine Land Division had men and equipment on site within 24 hours of notification of the danger. As a result of the fast action, the Wyoming Governor sent out a letter of commendation, (a copy is attached).

More than 500 vertical subsidence features and three horizontal adits were closed during the course of this project. Most of the vertical subsidence features were identified. Closure of these features included over excavation and backfill. Exploratory excavation was completed ahead of grading operations to expose unstable conditions. As a result of exploratory excavation, 17 additional unstable subsidence features were discovered and closed. Despite the effort to identify unstable areas prior to grading, on five separate occasions grading operations initiated subsidence. More than 500 underground coal mine related subsidence features were reclaimed in all, including 34 which were very unstable and hazardous.

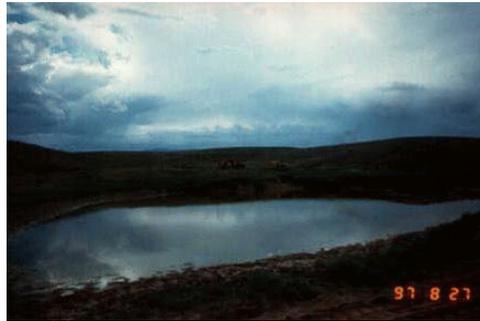
Sean Carroll - After (Photo 2)

The project did complete the construction of three surface water impoundments (See Photo 2) permitted by the State Engineer's Office. The engineering purposes of these impoundments were to provide erosion control along approximately one mile of a tributary drainage of the Tongue River which had been adversely impacted by the mine subsidence. Prior to construction the site had no wetland values. Since construction, these impoundments have provided wetland and wildlife enhancement. No Threatened or Endangered species were identified near or within this project. No archeological or cultural features were impacted and wherever possible trees and shrubs were left undisturbed since the revegetation seed mixture was dominantly native grass. A stormwater Permit was also obtained and all conditions were met.

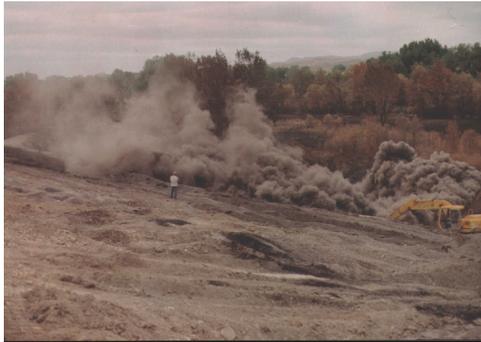
Goose Creek Spoils - Before (Photo 3)

At the ***Goose Creek Spoils*** site, a two million cubic yard mine spoil pile was located in a natural meander path of the stream (See Photo 3). Consequently, bank erosion was threatening the integrity of the spoil pile. If erosion of the spoil pile were allowed, it would cause: (a) direct sediment loading from the pile to Goose Creek; (b) chemical degradation to the waters of Goose Creek and the Tongue River by introduction of carbonaceous and/or other deleterious wastes; and (c) a localized health and safety issue due to mass wasting and slope instability. An additional environmental consequence was the loss of habitats and fisheries.

The *Goose Creek Spoils* project focused primarily on improvement of bank stability of Goose Creek near the town of Acme. Channel realignment, due to past mining operations, railroad construction and other man-induced modifications, created geomorphic instability of the lower reaches of Goose Creek causing excessive

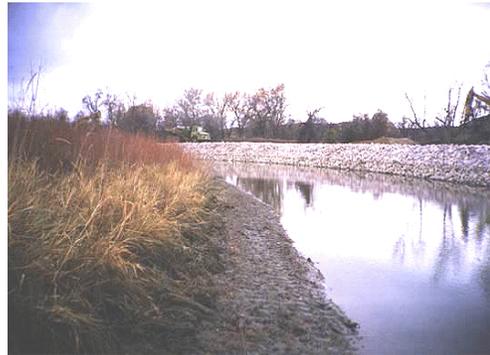
Goose Creek Spoils - After (Photo 4)

bank erosion and excessive sedimentation. Direct sediment loading from Goose Creek Spoil pile resulted in annual sediment loss from the pile and delivery to waters of the creek. This in turn resulted in reduced stream length and sinuosity, elimination of local flood plain terraces, and in some areas, created artificially high channel banks and the environmental degradation of Goose Creek. The scope of this project was limited to four sections (reaches) along Goose Creek. Other benefits resulting from the work have included removal of trash and debris along the banks of the creek (See Photo 4), addition of fish habitats in the creek bed and expansion of wetlands promoting a wildlife habitat in the reclaimed area. The project enhanced wetland, wildlife and habitat values and has been designated by local landowners and the Wyoming Game and Fish as a walk-in recreation area..
