Mid-Continent Regional and National Awards

Sunshine Mine, Site 291

Bicknell, Indiana

Indiana Department of Natural Resources

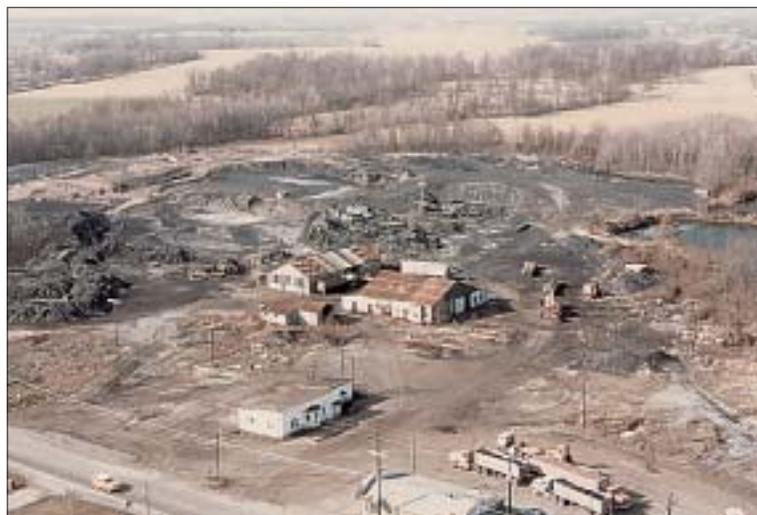
Abandoned since 1959, this mine site contained derelict buildings, coal refuse that was causing sedimentation, and acid mine drainage pollution of nearby streams. In addition, frequent coal fires at the site were the source of significant air pollution and danger to unsuspecting visitors to the site.

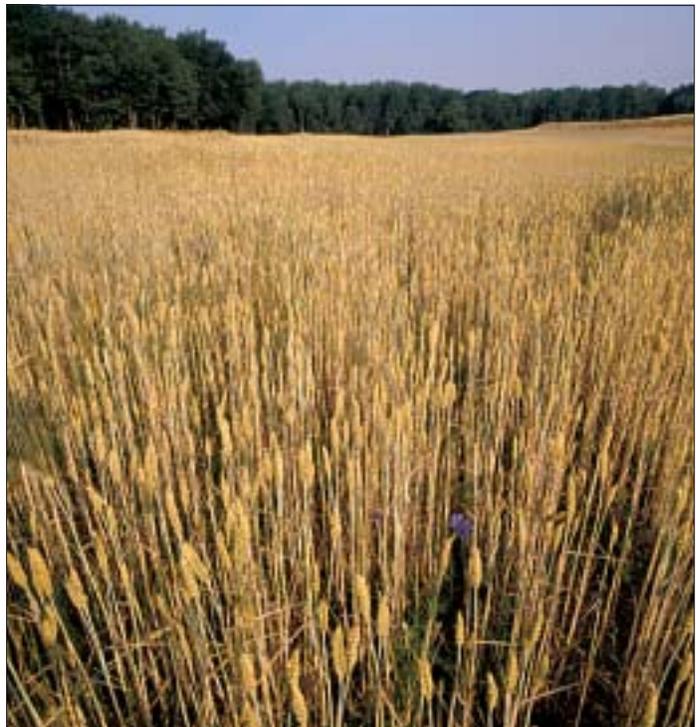
The designated borrow area contained a small shallow pond that was not wanted by the landowner. It is believed that this pond may have been the primary source of water that seeped through the gob, producing acid mine drainage in the adjacent creek. Removal of the impoundment eliminated a water source, thus improving the off site impacts. The water in the pond met water quality standards, and therefore needed no treatment prior to discharge.

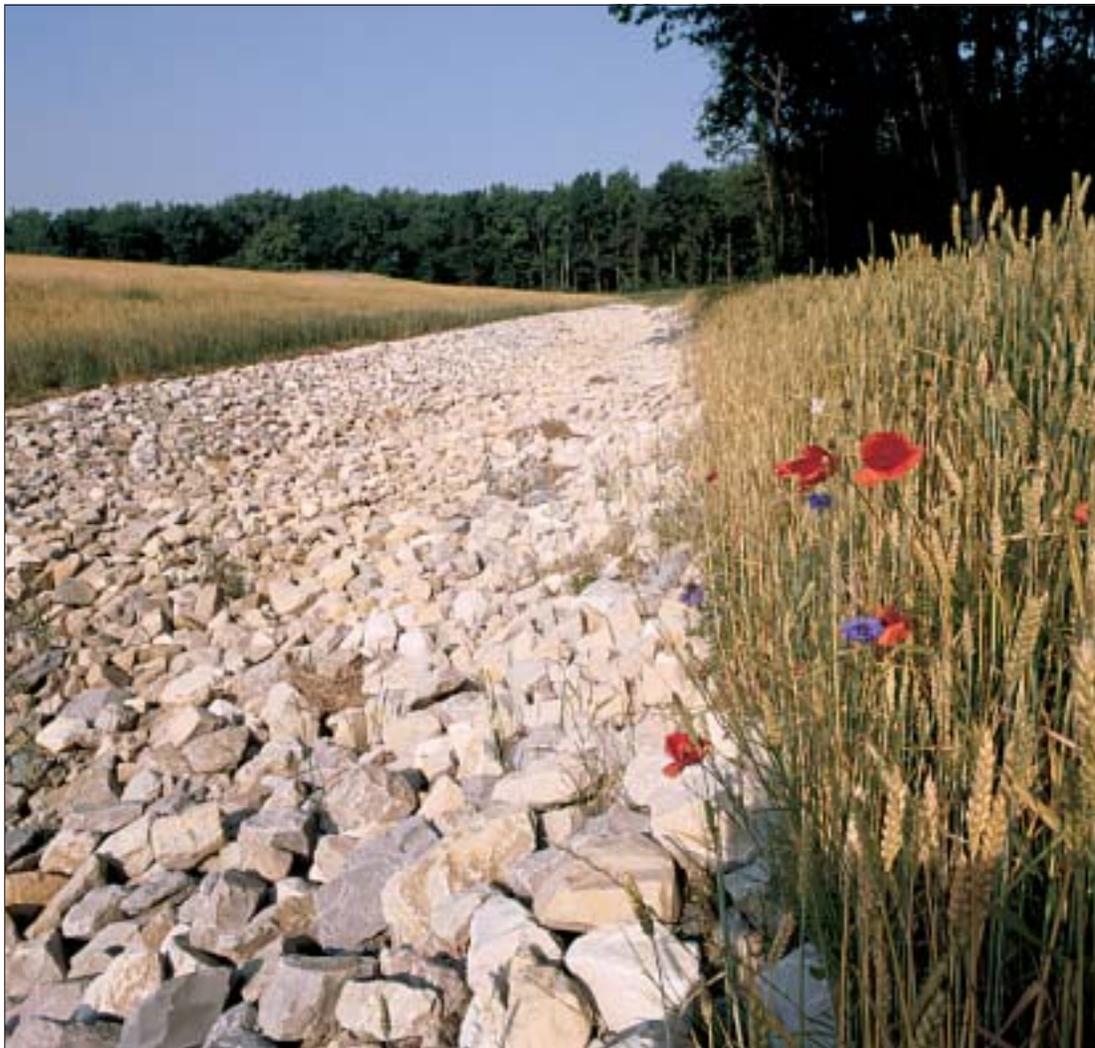
Reclamation of the site included almost 5,000 linear feet of erosion control structures. Here rock-lined ditches carry water off the site without causing soil erosion.

The soil cap and the establishment of permanent vegetation across this site have greatly reduced offsite sedimentation. In addition to the soil cap, 4,985 linear feet of various erosion control features were installed. These included grass waterways, rock lined ditches, and terraces. Most drainage from the site and the immediate surrounding area is directed into a small wetland. This wetland improved the site aesthetics, eliminated offset sedimentation, and has enhanced the water quality of adjacent Indian Creek.

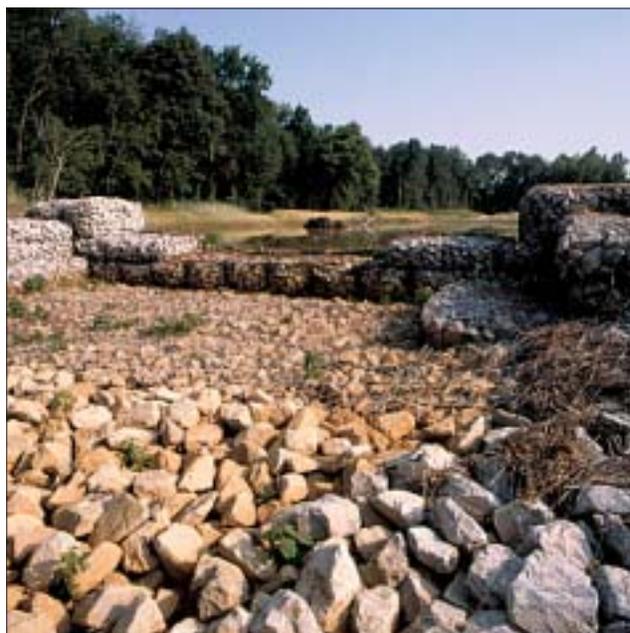
Most drainage from the site and the immediate surrounding area is directed into a small man-made wetland. This wetland improves aesthetics, eliminates off-site sedimentation, and enhances the water quality of adjacent Indian Creek.
