**NOMINATION  
2004 ABANDONED MINED LAND RECLAMATION AWARD**

Huntsman and Bear Creek Coal Refuse Reclamation Project  
Western Pitkin County, near Redstone, Colorado

Project Name: Huntsman and Bear Creek Coal Refuse Reclamation Project;  
Western Pitkin County, near Redstone, Colorado

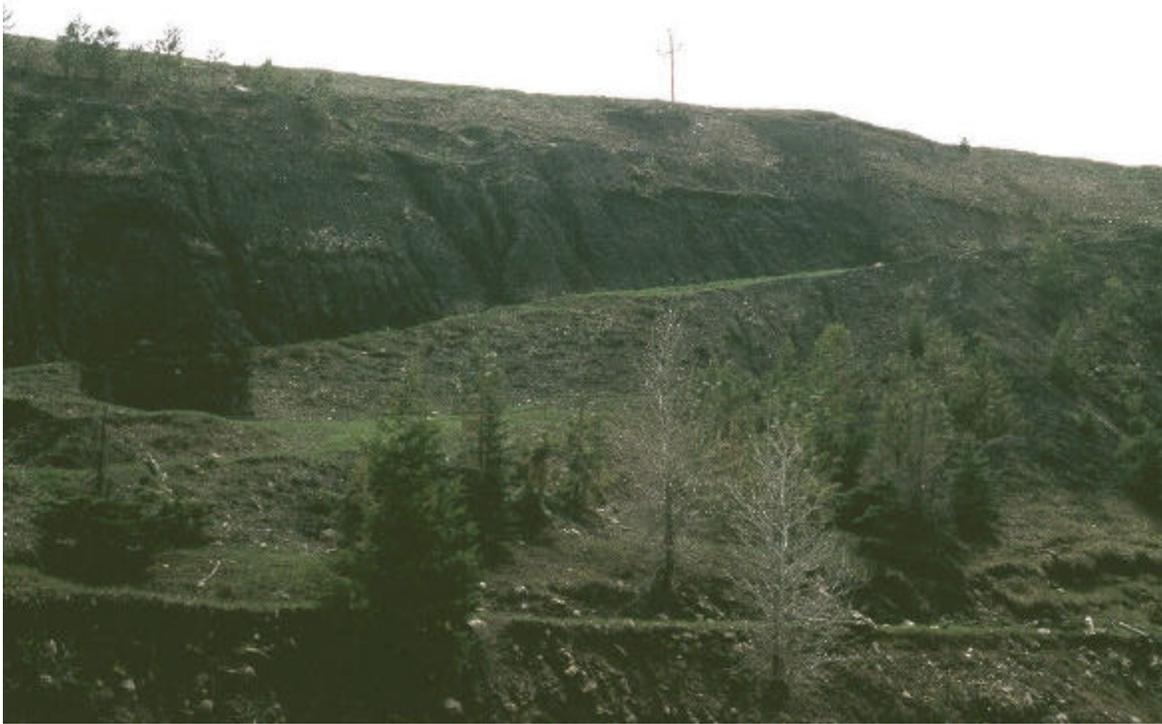
Steep slopes, refuse creep and refuse erosion at Huntsman prior to construction

The purpose of the Huntsman Project was to alleviate potential refuse pile instability. Prior to the project this portion of the larger refuse pile was severely over-steepened and had little, if any plant growth medium on it. Portions of the slope approached vertical, while other areas were closer to 1H:1V. As a result, vegetative cover was negligible, and surface erosion of the refuse material was significant. More importantly, however, the lower portion of the area presented evidence of potential mass instability. Surficial bulging, drainage from the base of the pile and mid-slope tension fractures had been observed. These features indicated that a deep-seated failure of the refuse facility could occur. This portion of the larger refuse facility is located immediately adjacent to Coal Creek, a significant tributary to the Crystal River. Coal Creek is incised, in a narrow valley. Failure of the refuse facility could cause temporary blockage of Coal Creek. A breach of the temporary blockage could lead to downstream flooding and large-scale erosion. To alleviate these concerns, stabilization of the Huntsman area slopes was required.

Stabilization of the Huntsman slopes required removal of the steep upper portion of the area. Due to the proximity of the refuse toe to Coal Creek, the slope length could not be extended toward the creek. Therefore, the upper portion of the project area had to be excavated to achieve the project goals of unloading surcharge, and creating a moderated slope. A limiting factor at the upper portion of the project area was a boundary between the pre-Title V portion of the facility, and the portion of the facility permitted under the Title V program.

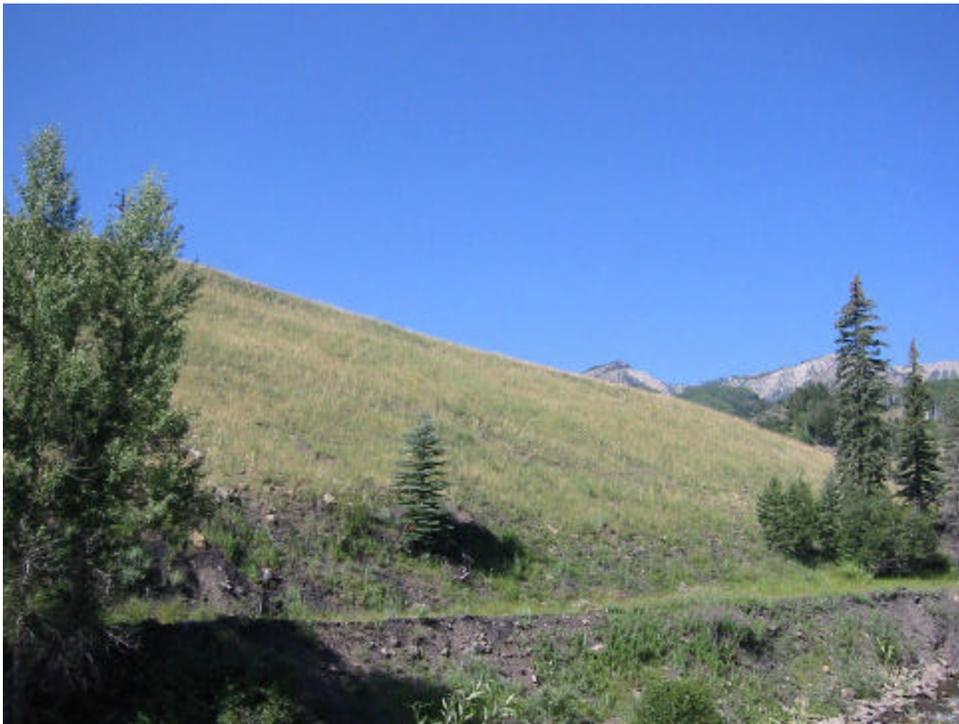
Stabilized and revegetated Huntsman Project Area, year following biologic weed control project at the site

Two years following project completion, the area suffered an invasion of various species of thistle, a listed noxious weed in Colorado. In order to control the weed invasion, an integrated pest management program was developed for the site. In partnership with the U.S. Forest Service and Pitkin County, the Division received a grant from the Colorado Department of Agriculture to control the weed invasion. Biologic controls were used the first year to greatly reduce the weed seed population. 500 goats were allowed to graze the property. The goats, if moved in an appropriate rotation, preferentially consume the thistle flowers, thus eliminating the seed source. In following years, spot spraying of remnant weeds served to essentially eradicate the problem. The area was reseeded in conjunction with the grazing program, and now supports a diverse vegetative community.

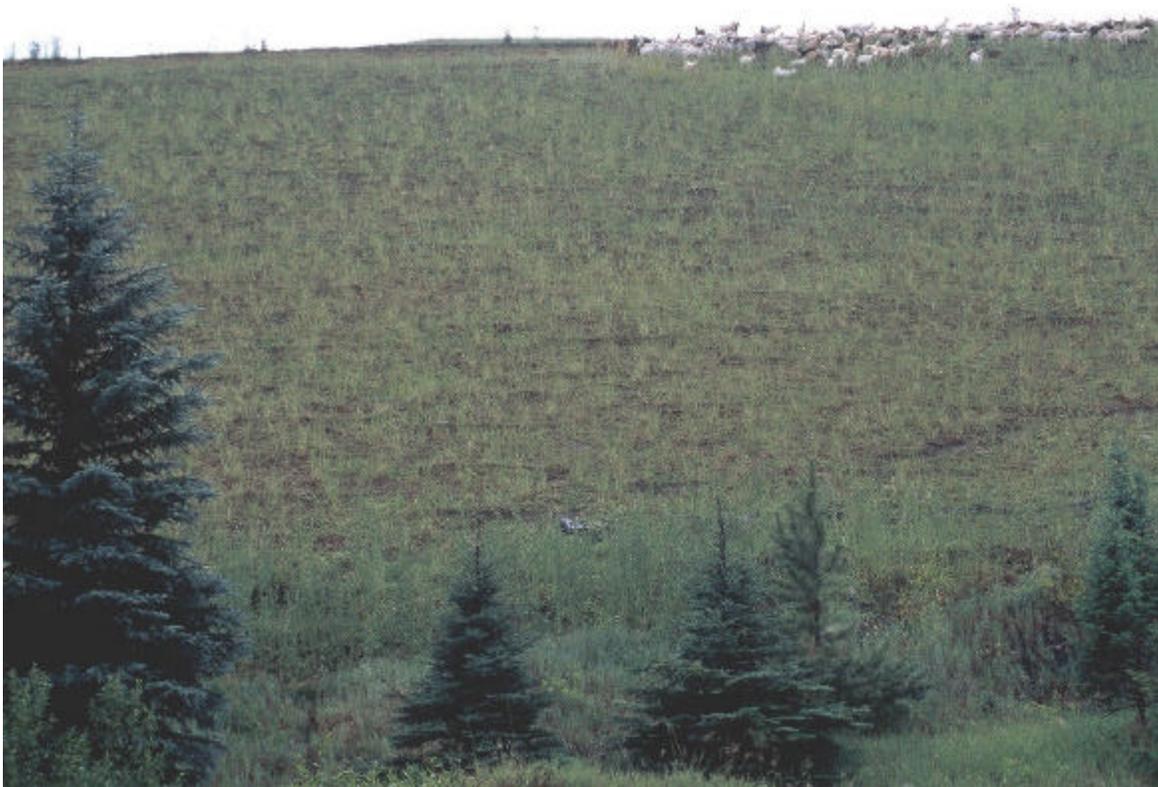
Goats grazing revegetated area to reduce weed infestation. Note dozer benches still in place, third year following construction.

The method used to interrupt the slope was to create hundreds of small dozer terraces on the newly created Huntsman slope. The terraces were created by positioning the dozer at the base of the slope, and backing the dozer upslope approximately one-dozer length. The operator would then lower the dozer blade, and push downhill until approximately six to eight inches of soil had accumulated in front of the blade. This action resulted in the creation of a gently sloping terrace approximately eight inches tall, twelve feet wide (parallel with contour) and four feet long (perpendicular to fall of the slope). Following construction of a terrace, the dozer would back up the hill two lengths, drop the blade and push forward one length to create an up-slope terrace. This process was repeated across the entire face of the project area.

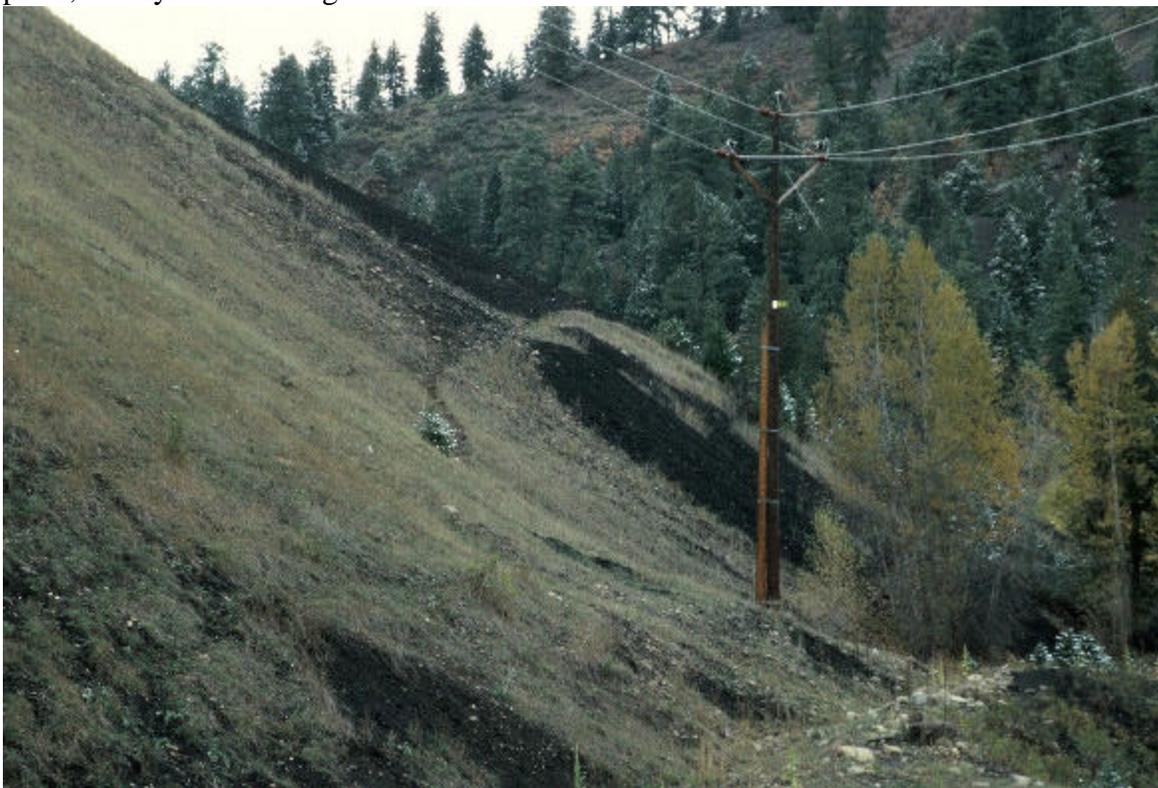
View toward west parallel with contour at Bear Creek showing slope instability, steepness and refuse failures prior to construction.

The purpose of this project was to enhance the stability of the area located east of the Huntsman project area. Slope stabilization was accomplished by reconstructing the slope of the facility through excavation and placement of refuse. Approximately 90,000 cubic yards of coal refuse was excavated from the upper half of the refuse disposal facility, and pushed down hill to create the design slope of 2.1 H:1V to 2.5 H:1V. The material was
