**Indiana Department of Natural Resources
Division of Reclamation**

**AML Site 380
Lowland Western
Pike County, Indiana**

2005 Abandoned Mine Land Reclamation Award

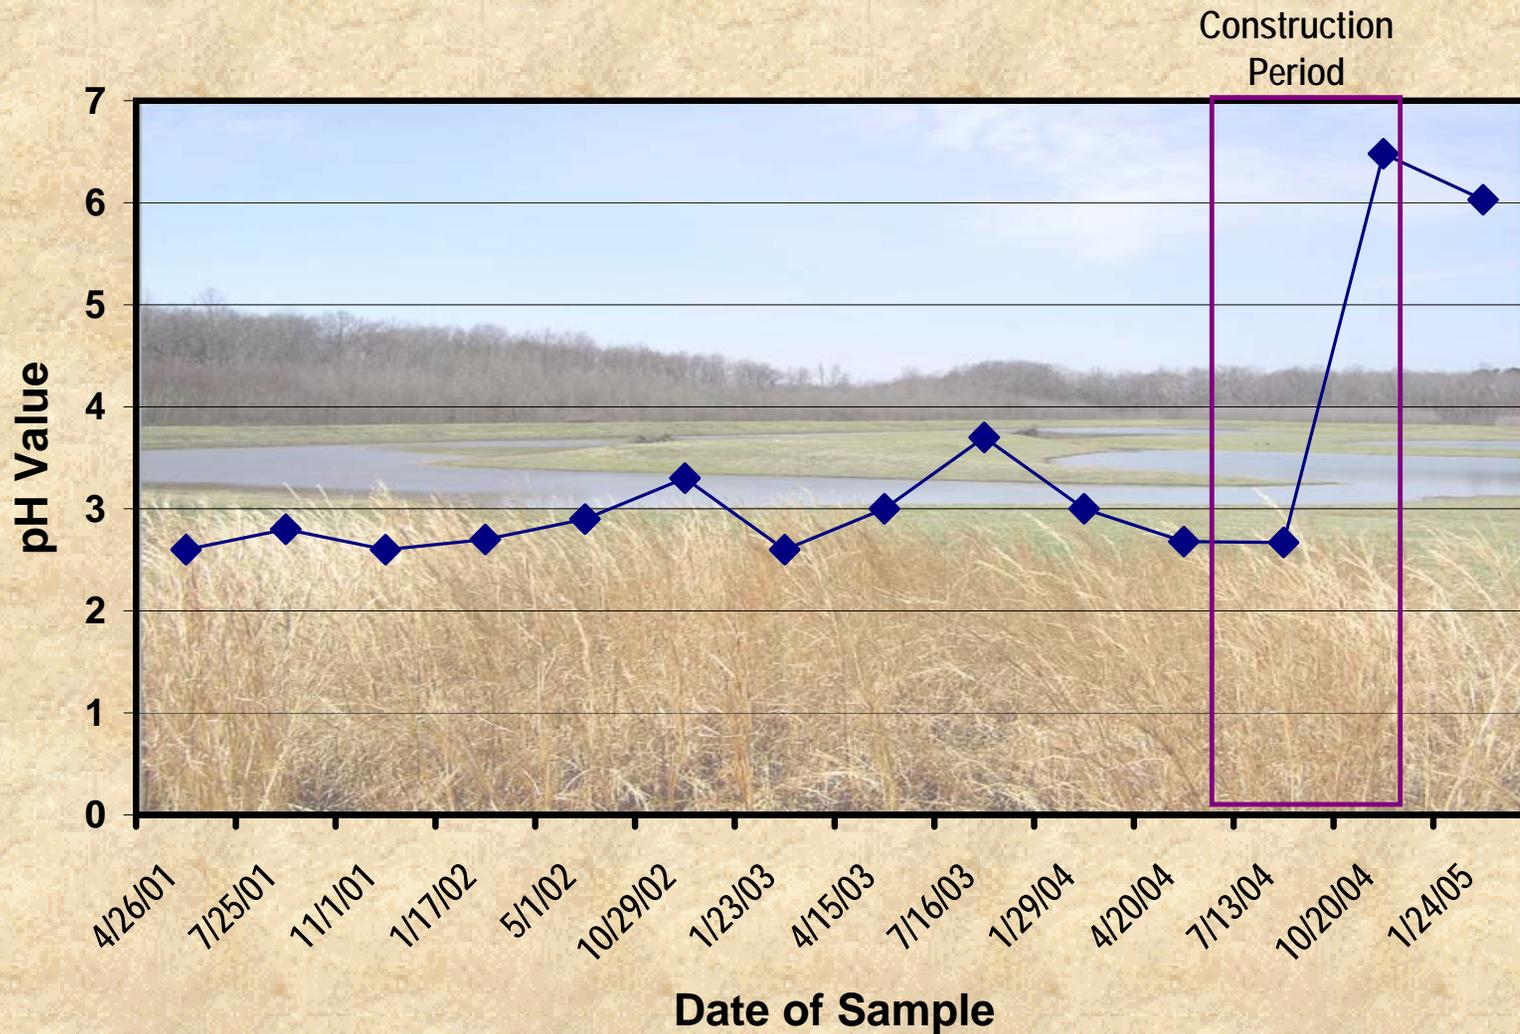
Site 380 pH

Photo 1: This graph shows the immediate water quality improvement in pH following reclamation. The sample point is located at the outfall of the passive treatment wetland, just prior to where it enters the receiving stream.

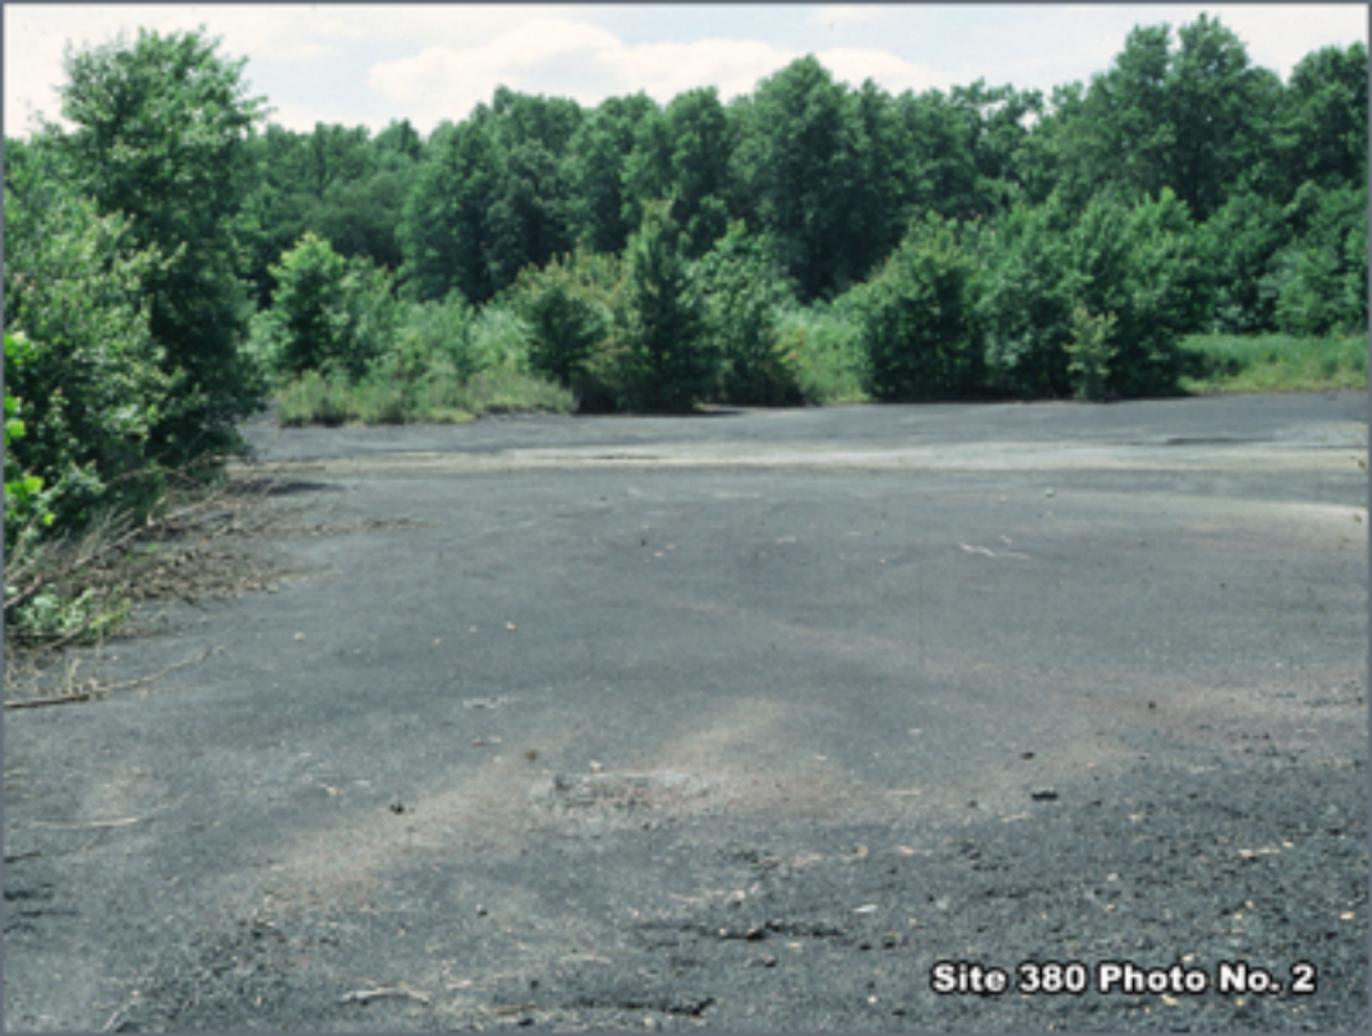
Site 380 Photo No. 2

Photo 2: This shot shows one portion of the main refuse area, obviously before reclamation, showing the barren coal refuse surrounded by well vegetated spoils.

All the coal refuse that was scattered throughout this site was gathered up and consolidated into the refuse disposal area. The refuse was heavily limed and then covered with two feet of high quality clay in an effort to encapsulate the acid forming material and reduce, if not eliminate, the production of acid mine drainage. This part of the site was shaped so that drainage will flow off of this area and into designated channels, reducing sedimentation as well as recharge of the acid forming materials down below.

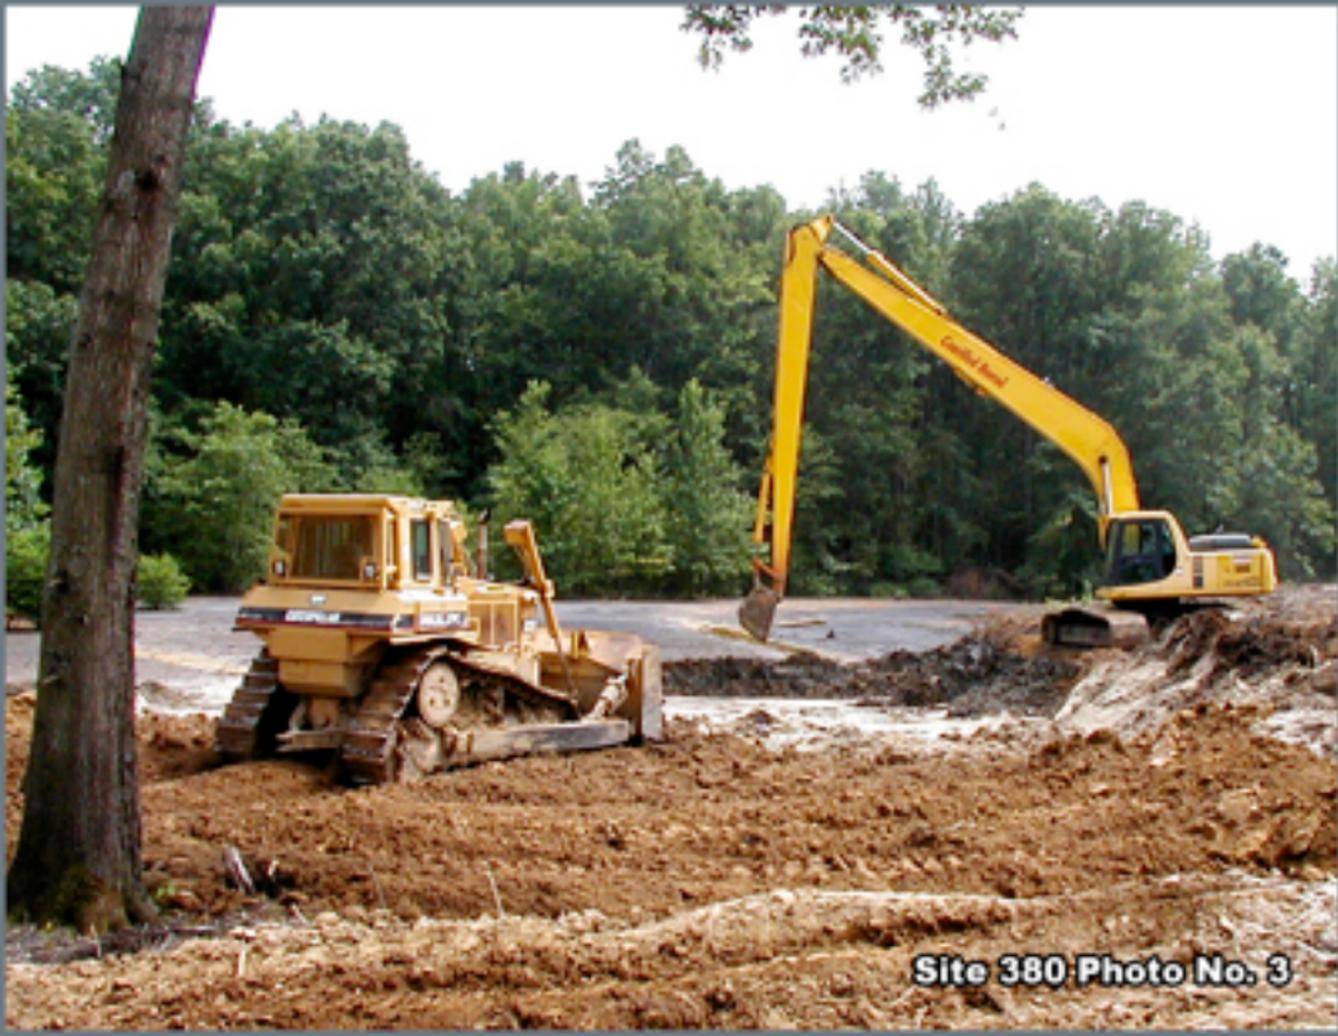
Site 380 Photo No. 3

Photo 3: Here the contractor is removing the coal refuse with the long-reach excavator while the bulldozer is spreading cover material on an adjacent area. Cover Photo.

The contractor originally attempted to excavate the borrow using scrapers, but this was mostly unsuccessful because the wet clay soil would “plow” out in front of the machinery, making excavation nearly impossible. The method that proved most successful was using large excavators and trucks, however, this required a major revision of the contractor’s equipment. With a little ingenuity and a lot of persistence, he was finally able to excavate the required yardage and shape the final contours.

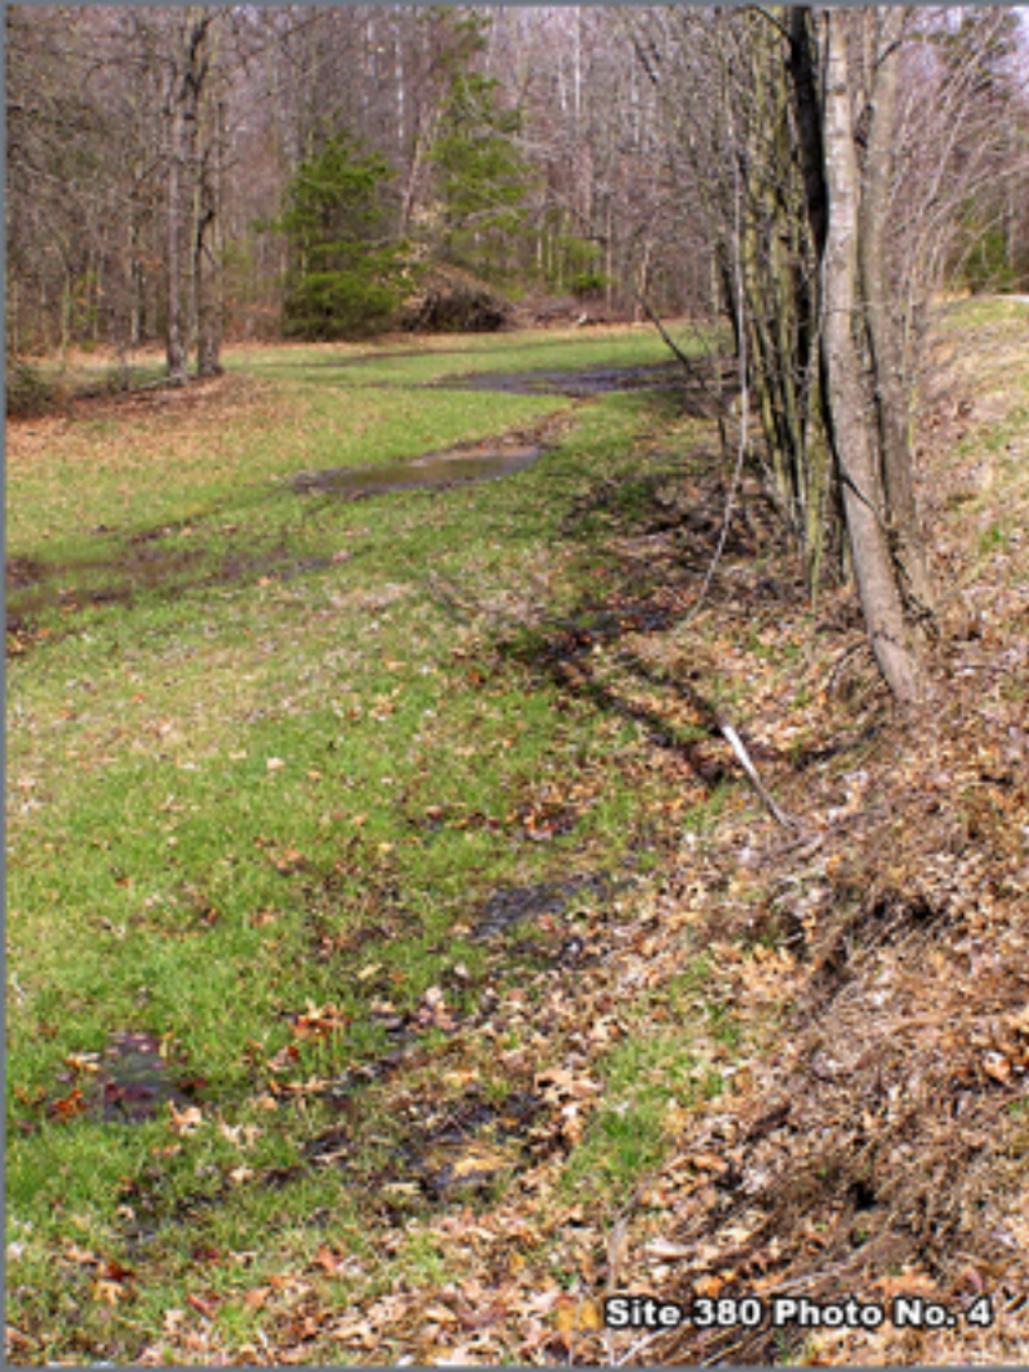
Site 380 Photo No. 4

Photo 4: Here is an example of one of the alternative design drainage channels with standing water in “vernal pools” within the shallow channel itself.

In addition to the two wetland areas, where practical, several drainage channels were developed using an alternative design to promote wildlife habitat while still providing drainage. Typically, a flat-bottom, riprap lined channel is used to convey water through the channel as quickly as possible, with minimal sedimentation. In areas of shallower slopes and/or less flow, a parabolic, grass-lined channel is often used, but is still designed not to impound any standing water. The alternative channels used at this site were typically shaped but left rough graded to purposely create small puddles of water within the channel. These areas were then seeded with a “wet meadow” seed mix specifically designed for these occasionally wet areas. These small “vernal pools”, sometimes only a few square feet in size, provide vital habitat for numerous wildlife species including reptiles, amphibians and even birds such as the American Woodcock. This is just another prime example of a creative reclamation technique that accomplishes the goals of the AML Program while taking environmental restoration to the next level.

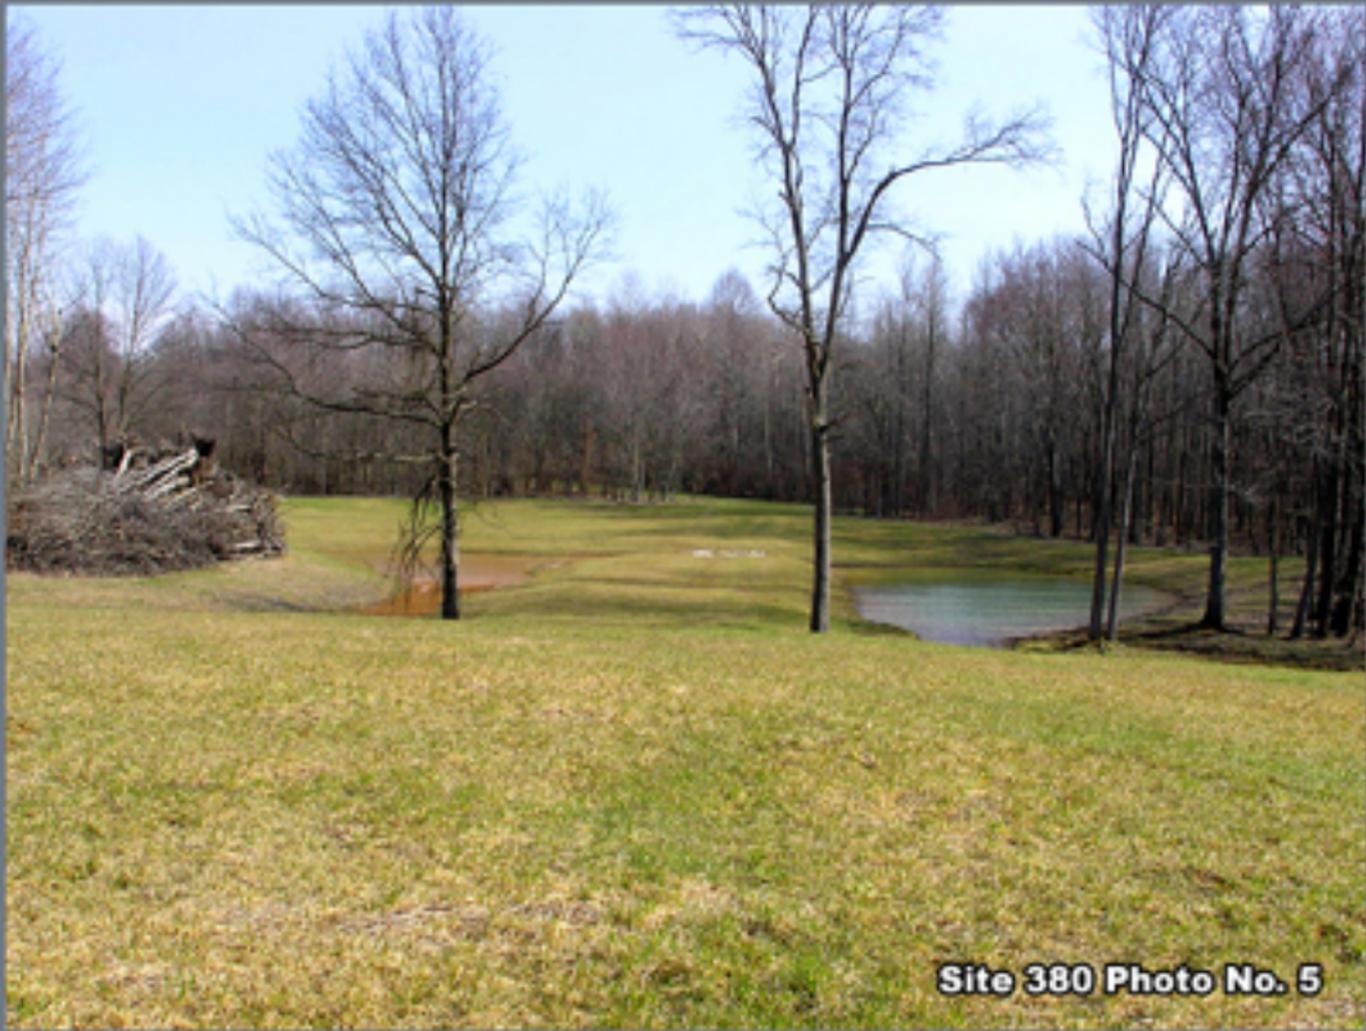
Site 380 Photo No. 5

Photo 5: This is a view of the first two cells of the passive treatment wetland clearly showing, even at the very initial stages of development, water quality improvement from the first cell on the left to the second on the right. Two additional cells are just to the right of this photo.

As a final attempt to improve water quality, a small passive treatment wetland was developed in the main drainage channel just prior to where it leaves the site.

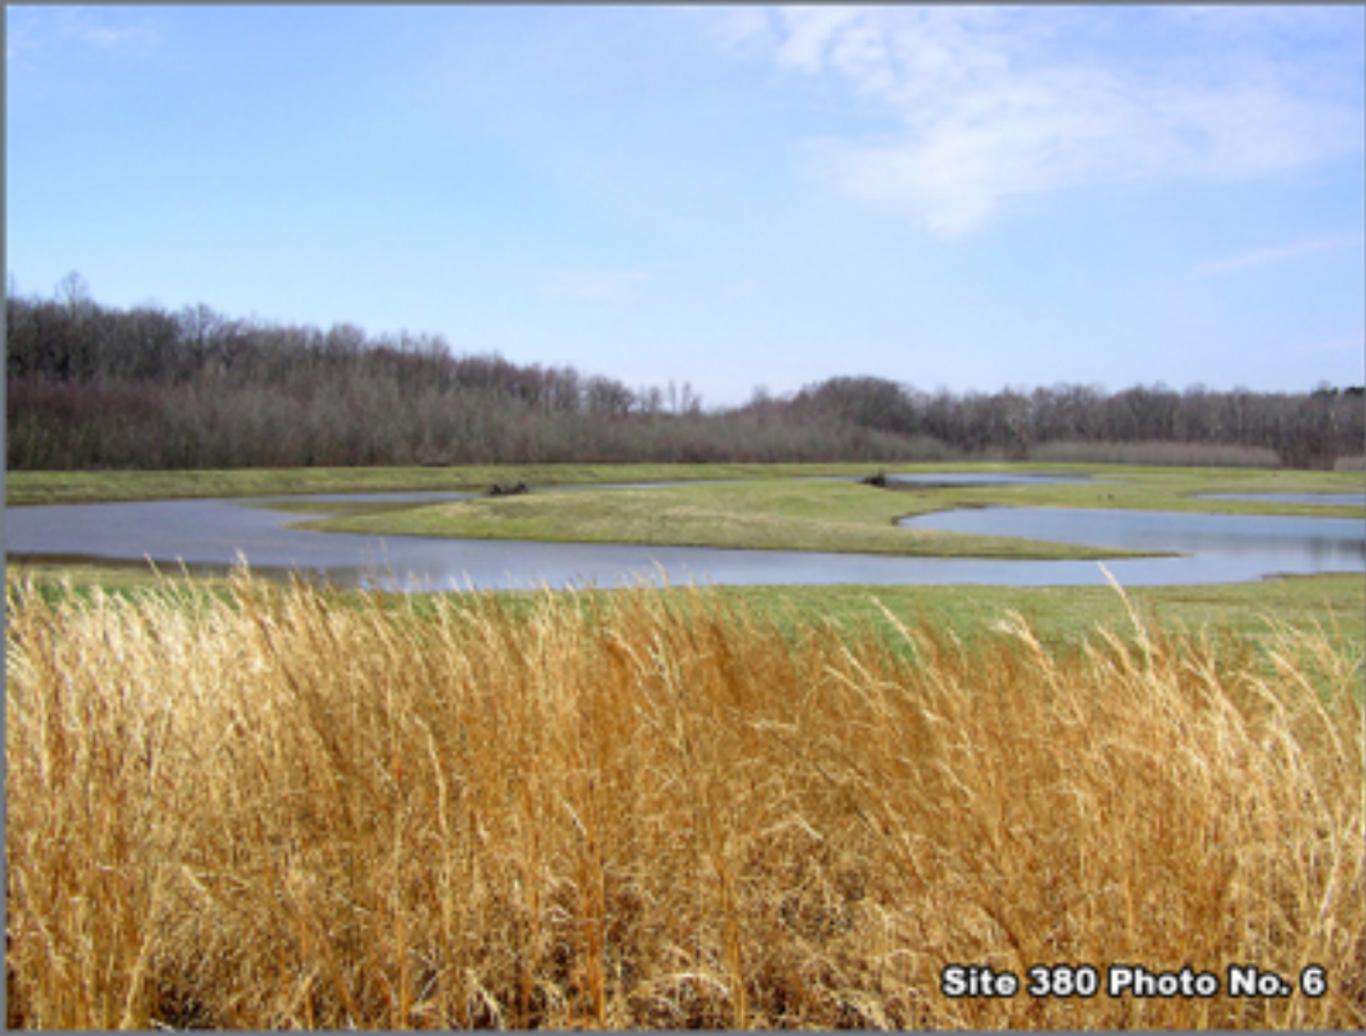
Site 380 Photo No. 6

Photo 6: This final shot shows a portion of the wildlife wetland shortly after revegetation and depicts the sinuous design of the wetland cells.

A major part of this project was the excavation of cover material from the borrow area and the subsequent development of the wildlife wetland. The fallow field where the borrow area was developed consisted of a very heavy, very deep clay soil. This heavy clay was an ideal cover material, as it would form a barrier to water infiltration into the coal refuse. However, excavation of this material proved to be extremely difficult. Not only was this a naturally low lying field, but an unusually wet spring and summer season only exacerbated the situation.
