Nomination
of the
SUGAR CREEK
Coal Refuse Pile and Mine Drainage Discharge Reclamation Project
for the
United States Department of the Interior
Federal Office of Surface Mining
2004 AML Reclamation Award

Sugar Creek Coal Refuse Pile and Mine Drainage Discharge Reclamation Project
Project No. AMD 03(1937)101.1

THE SUGAR CREEK COAL REFUSE PILE AND MINE DRAINAGE DISCHARGE RECLAMATION PROJECT

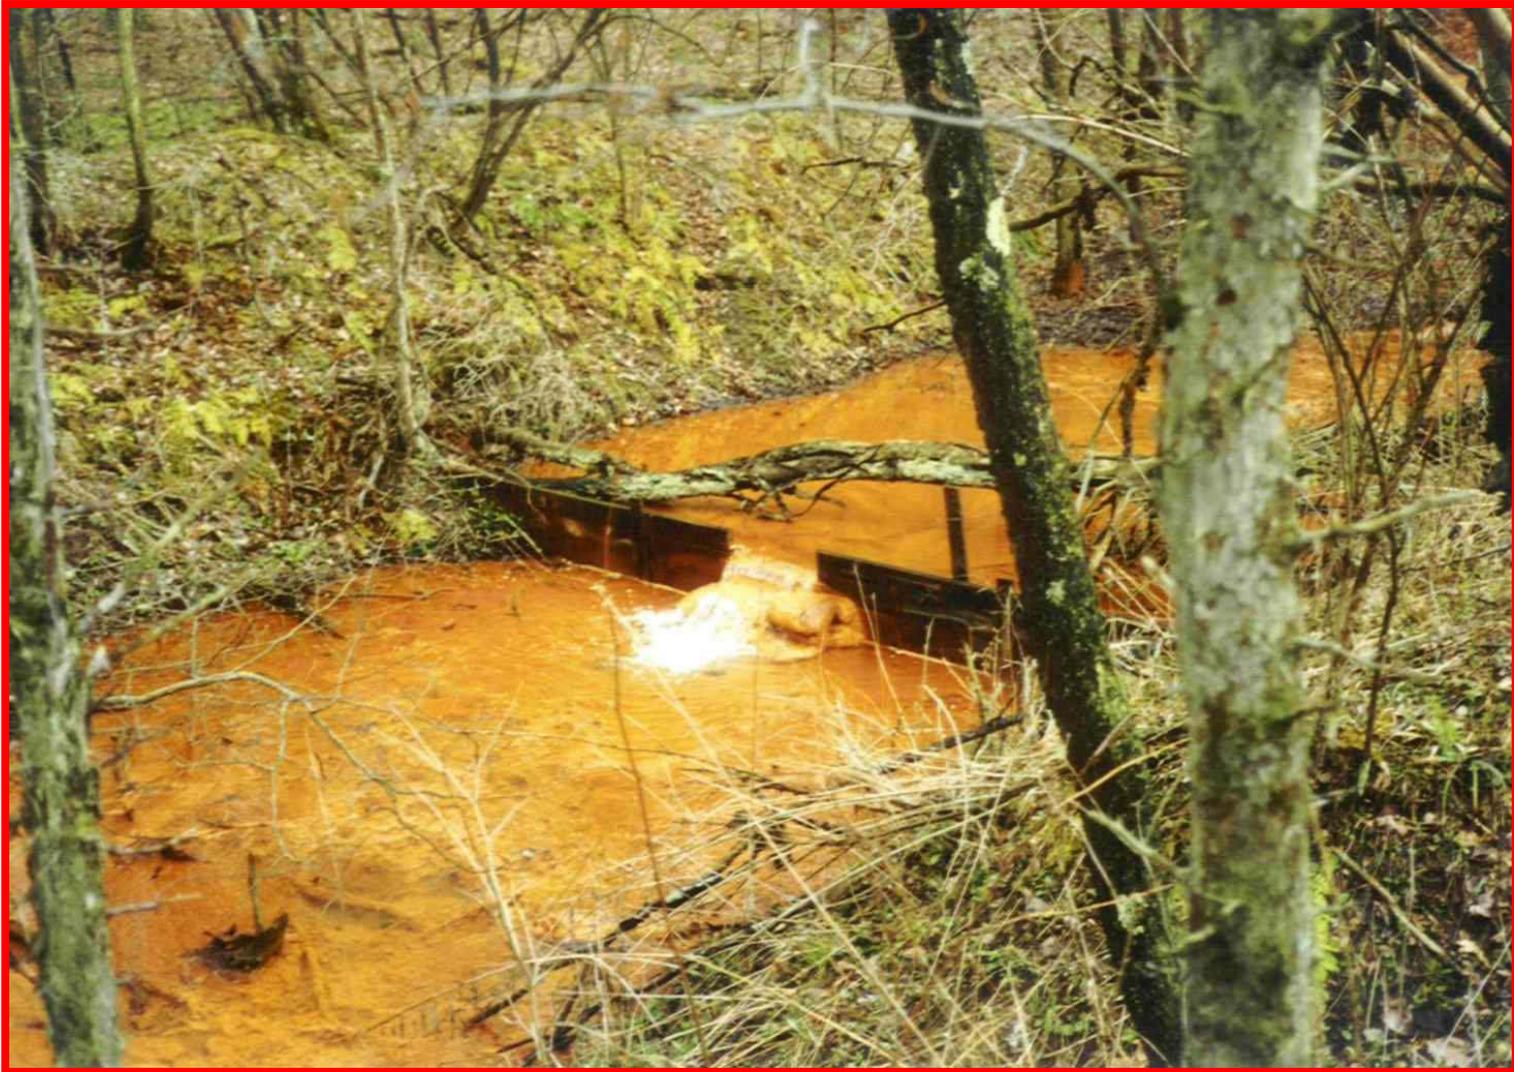
FIGURE 3 – Photograph of Mine Drainage Discharge from the Abandoned North Penn Coal Company, Snow Hill Mine, Showing the Flow Monitoring Weir

Analysis of the mine drainage discharges consistently indicated that the mine water was net alkaline with a moderate to high concentration of dissolved iron. The discharge did however periodically become net acid. In order to offset these periodic episodes of mine water discharge that was net acid, a small anoxic limestone drain (ALD) was planned to provide alkalinity during those periods. The ALD was not constructed due to elevation constraints discovered during construction. Other engineering difficulties at this site involved the complete capture of the discharge and the very limited space to construct a passive treatment system. A small tributary to Sugar Creek had to be relocated to accommodate construction of the treatment system.

Using the discharge monitoring data collected during the evaluation and planning phase of the project, a design flow rate of 170 gpm (the 80th percentile) or 0.25 MGD was selected. A decision was also made to target the 80th percentile of the total iron concentration observed during the pre-design discharge monitoring which was 37.6 mg/L.

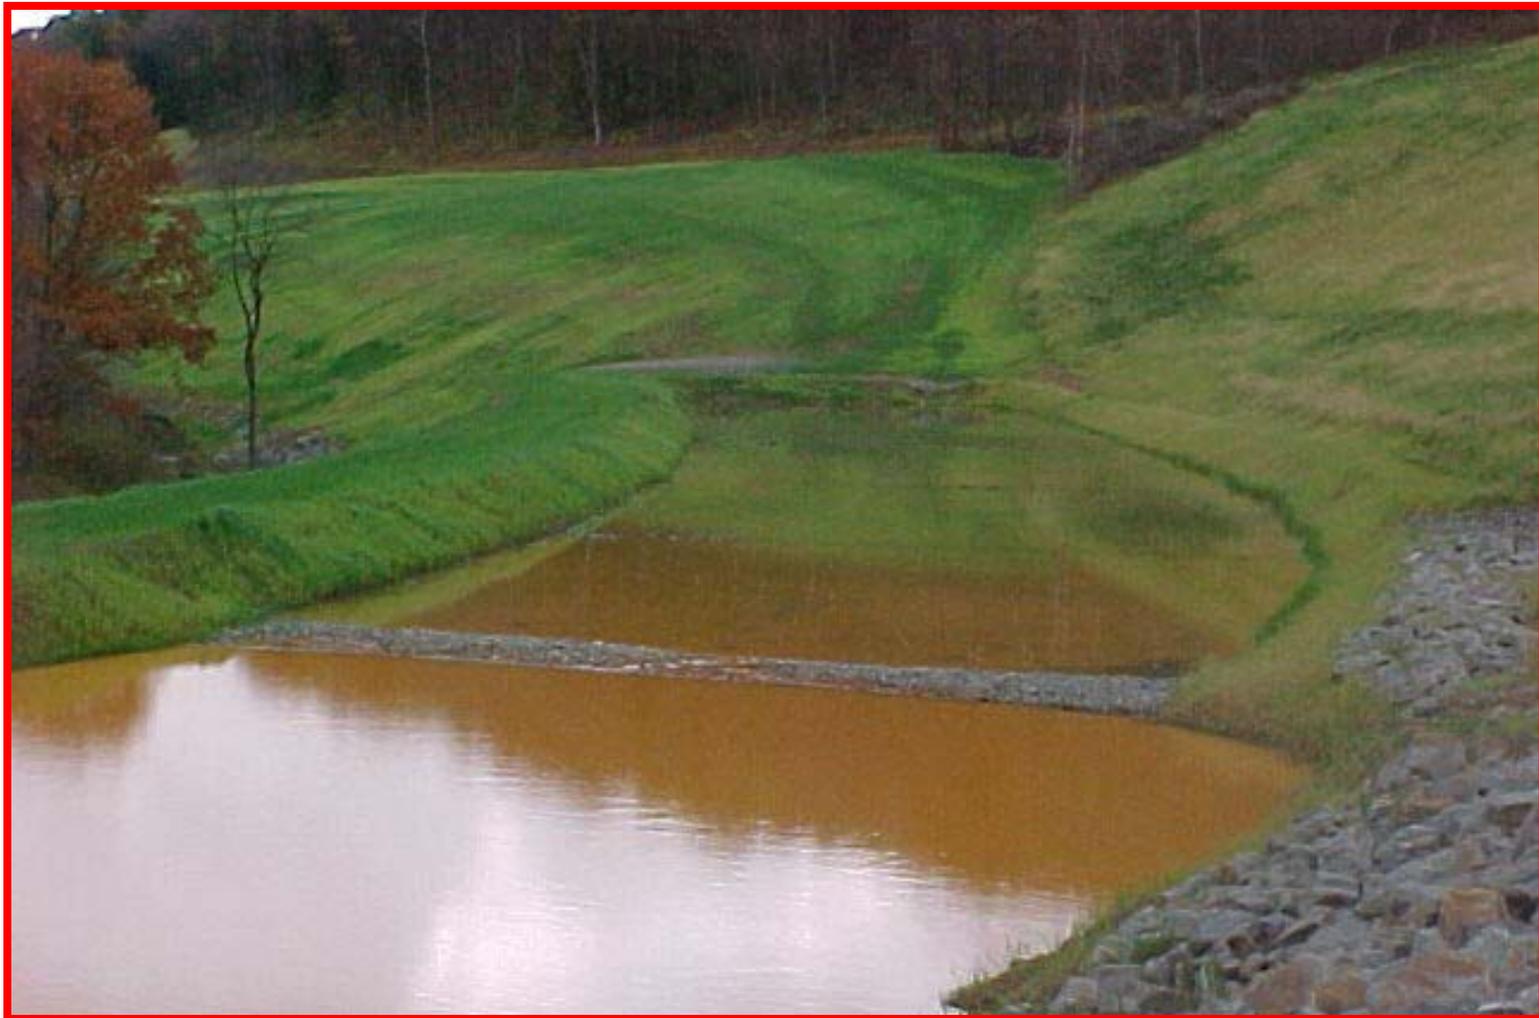
FIGURE 5 – Photograph of the Completed Passive Treatment System and the Reclaimed Coal Refuse Pile Restored as Part of the Sugar Creek Project

The principal items of work included 63,314 cubic yards of grading to re-contour the dangerous refuse pile slopes, 9,706 cubic yards of excavation for construction of the passive treatment system cells, placement of 22,748 cubic yards of soil cover material, construction of a new mine seal, 336 tons of high calcium carbonate (CaCO_3) content limestone (originally planned for use in the ALD) used for construction of limestone diversions, construction of several permanent channels, and placement of R-7 riprap for rock toe buttress to stabilize the toe of the regraded refuse pile. Figure 5 shows a photograph of the completed project with the passive mine drainage treatment system in the foreground and the re-contoured and reclaimed refuse pile in the background.
