## Appalachian Regional Award

Kempton Coal Waste Stabilization and Doser Installation  
Kempton, Maryland

**Completed by:**  
**Maryland Department of the Environment**  
**Bureau of Mines**  
**Abandoned Mine Land Section**

Project date: May 1, 1998 - December 1, 1998 at a cost of \$394,524.16

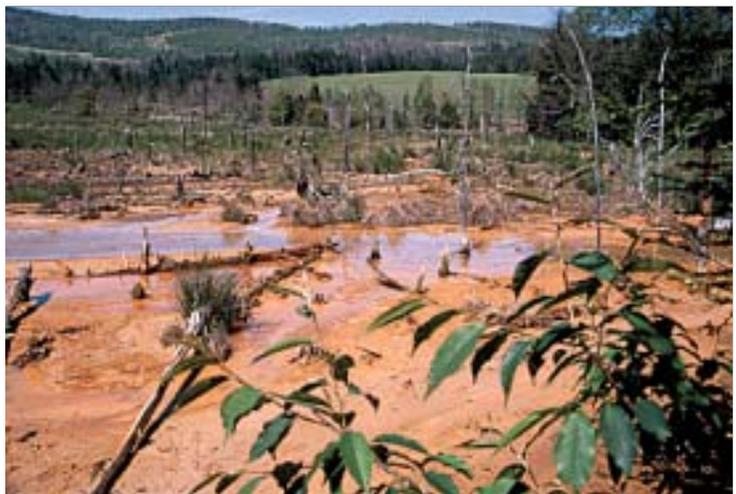
Water discharges from the abandoned mine flowed at an average of 3.5 million gallons per day. This flow of highly acidic mine drainage went directly into Laurel Run and the Potomac River.

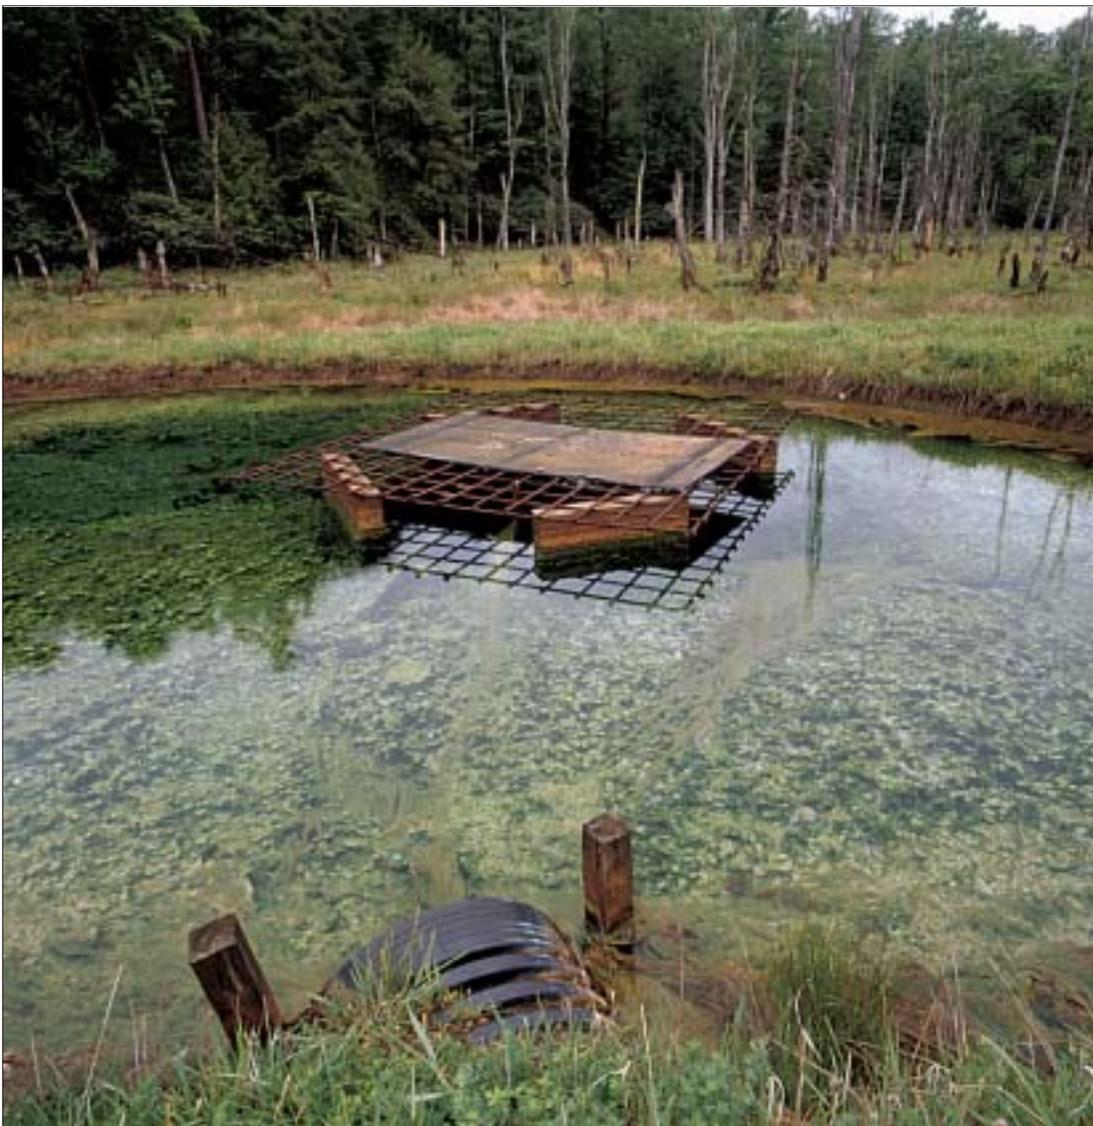
This 420 feet deep, 12 foot in diameter abandoned ventilation air shaft is the primary water discharge point for all the water collected in the 12 square mile underground mine complex. Reclamation included removal of the existing deteriorating caps and construction of 36 inch thick reinforced concrete seals, extending 3 feet horizontally beyond the limits of each shaft in all directions.

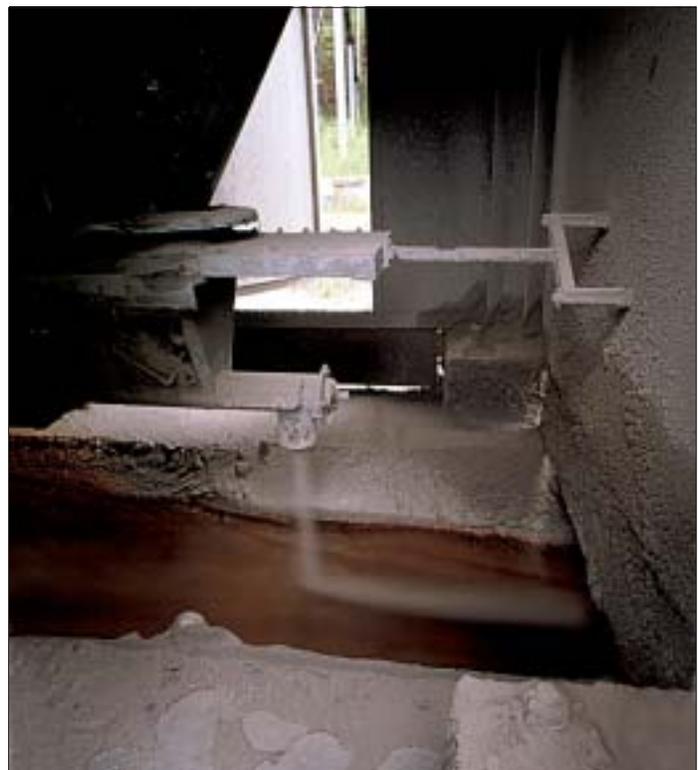
The water driven lime doser delivers a continuous flow of lime that is proportional to the volume of water passing through the doser. Inside the doser, the small flow of lime can be seen dropping into the water and being carried off as it goes downstream into Laurel Run.

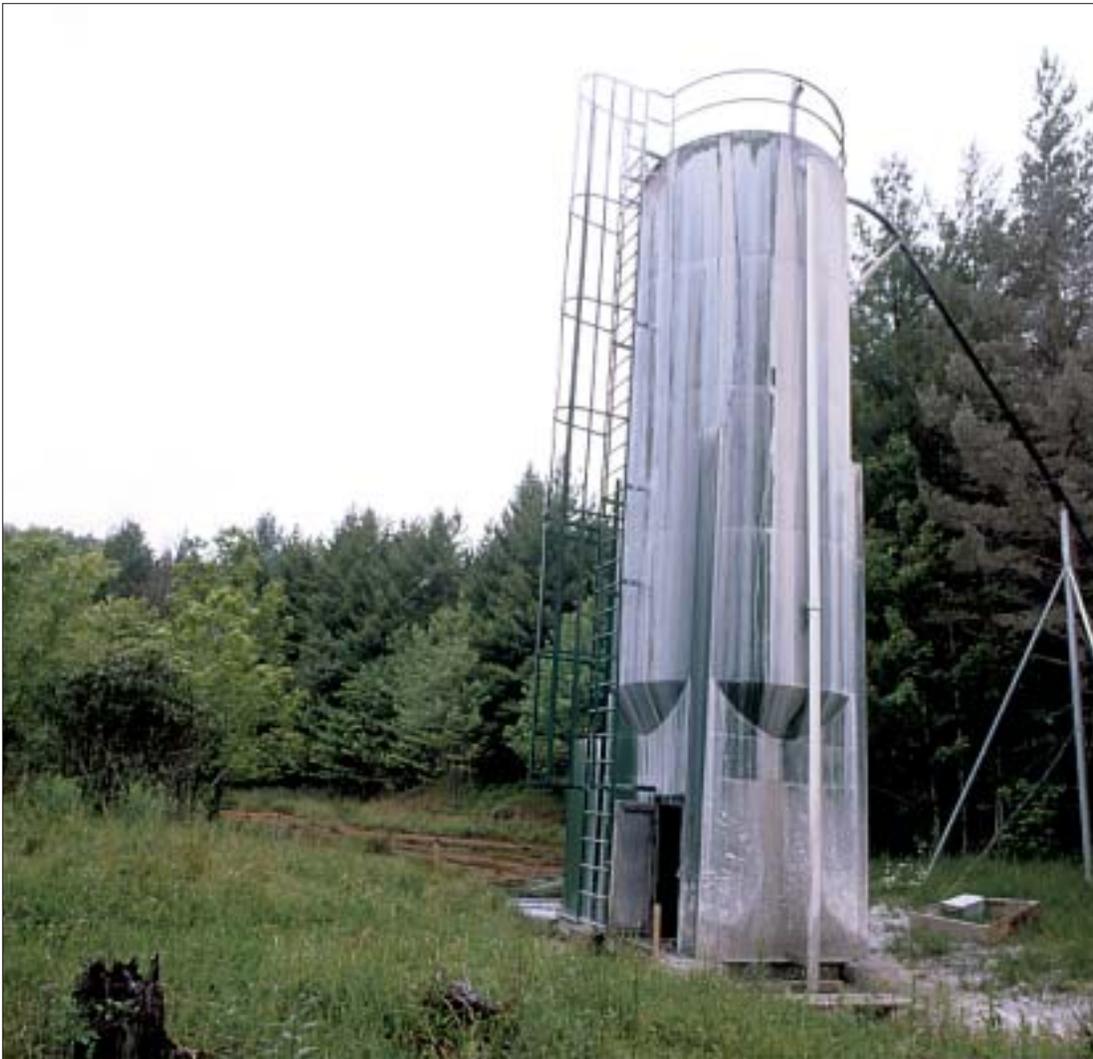
The acid mine drainage emanating from the entire 12.2 square mile mine complex discharges at an average of 3.5 million gallons per day. This water-powered lime doser, located just below the ventilation shaft, provides the primary treatment for acid mine drainage flowing from the mine. It protects over 4.5 miles of Laurel Run and 35 miles of the Potomac River.

destroy the recovery in the event of mechanical failure to the existing automated doser. Additionally, there was no recovery to Laurel Run and its extensive wetland systems since treatment of the acid mine drainage was occurring well downstream of the mine discharge. Considering these factors, the project design included development of a water powered dosing system to be installed immediately adjacent to the air shaft discharge. Installation of the doser would be reliable, given the limited accessibility of the site during inclement weather. The doser would also function as the primary treatment system for the acid mine drainage discharge. The existing doser, located two miles downstream, would then become a backup system, dispensing lime only if sensors detected a dip in pH, indicating technical problems at the primary system.

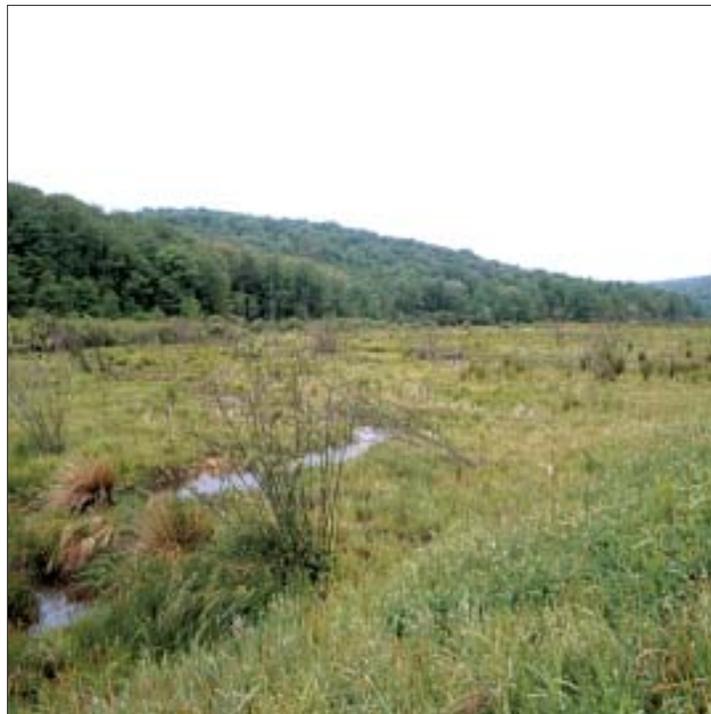
Prior to reclamation the Kempton Glades was covered with coal refuse. Today with native wetland vegetation reestablished this site is once again a biological diverse wetland environment.

Kempton Glades. The 5.2 acres of restored wetland was lightly planted with annual grass species to allow migration of native plants into the disturbed area. Native vegetation disturbed during construction was transplanted within the restoration area. The restored and ecologically healthy wetland has now become an appropriate beginning for the long journey downstream to our Nation's Capitol, and the Chesapeake Bay.
