**OSM NATURAL STREAM DESIGN  
WORKSHOP MID-CONTINENT  
REGION TECHNOLOGY TRANSFER  
May 2011 Mt. Vernon IL**

**Major  
Natural  
Stream  
Restoration  
Projects  
In the  
Midwest**

# How sediment load and particle size affects natural design

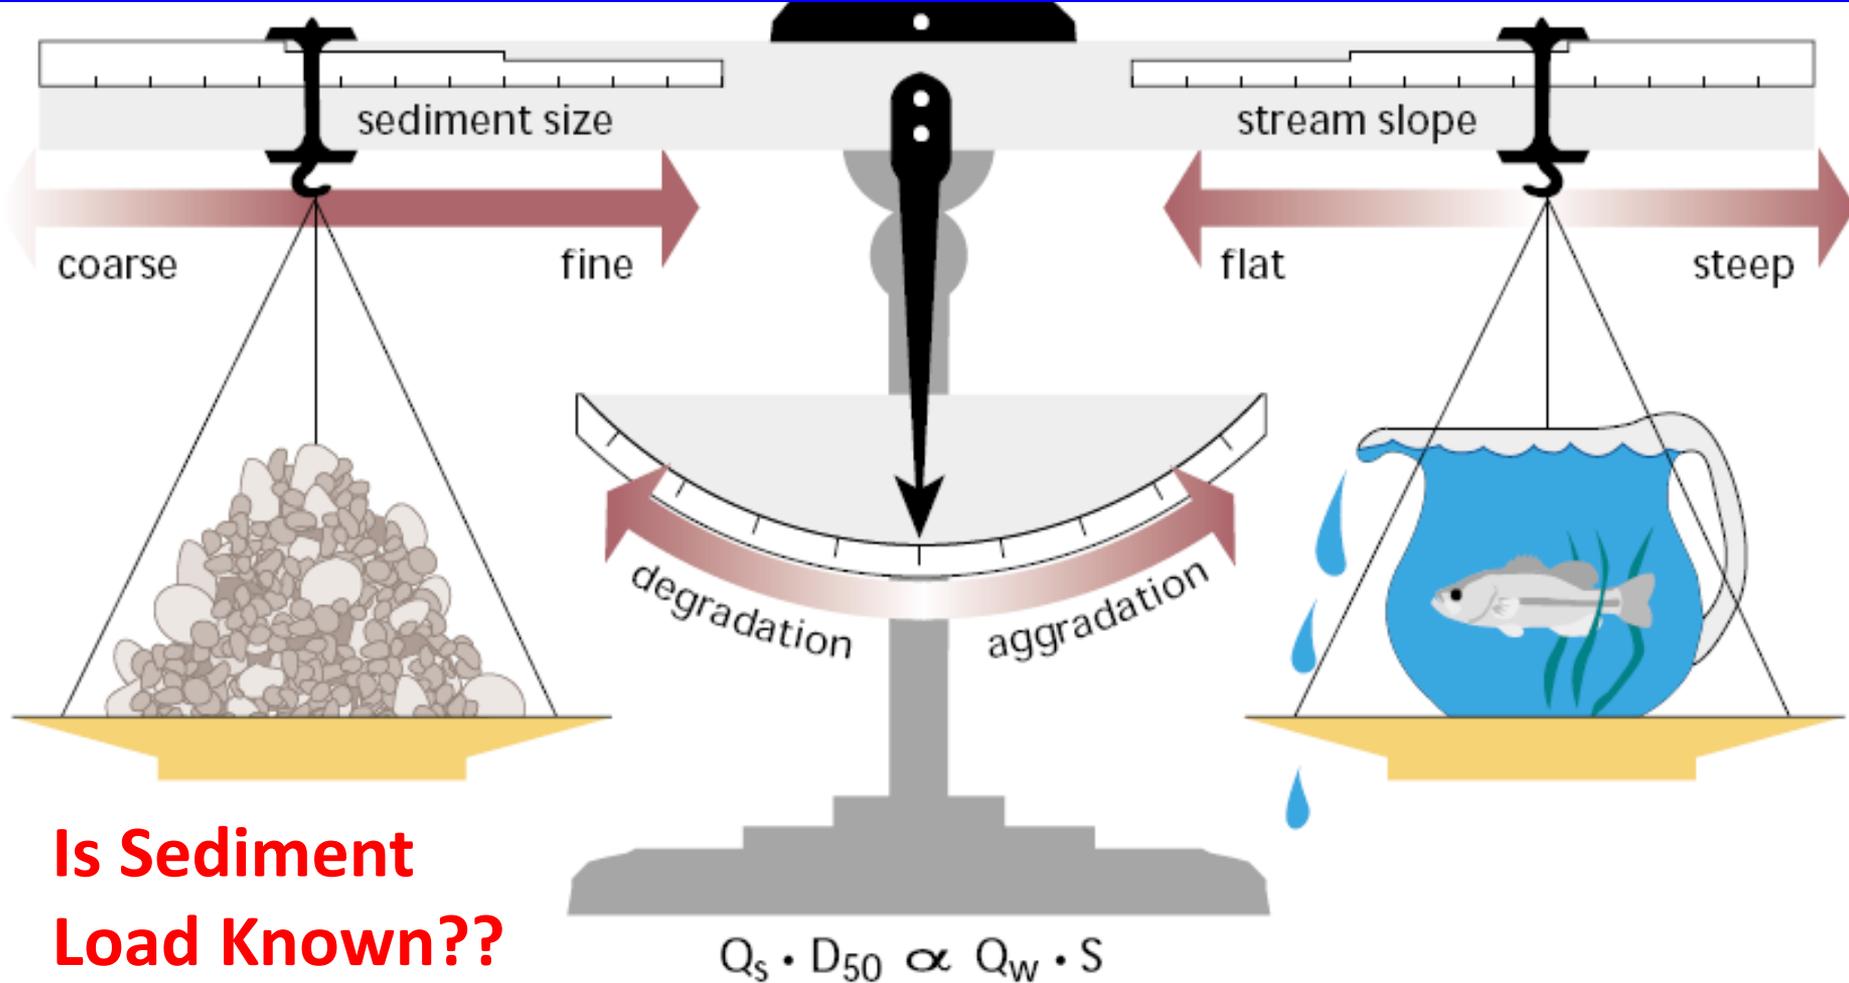
*Figure 1.13: Factors affecting channel equilibrium. At equilibrium, slope and flow balance the size and quantity of sediment particles the stream moves.*

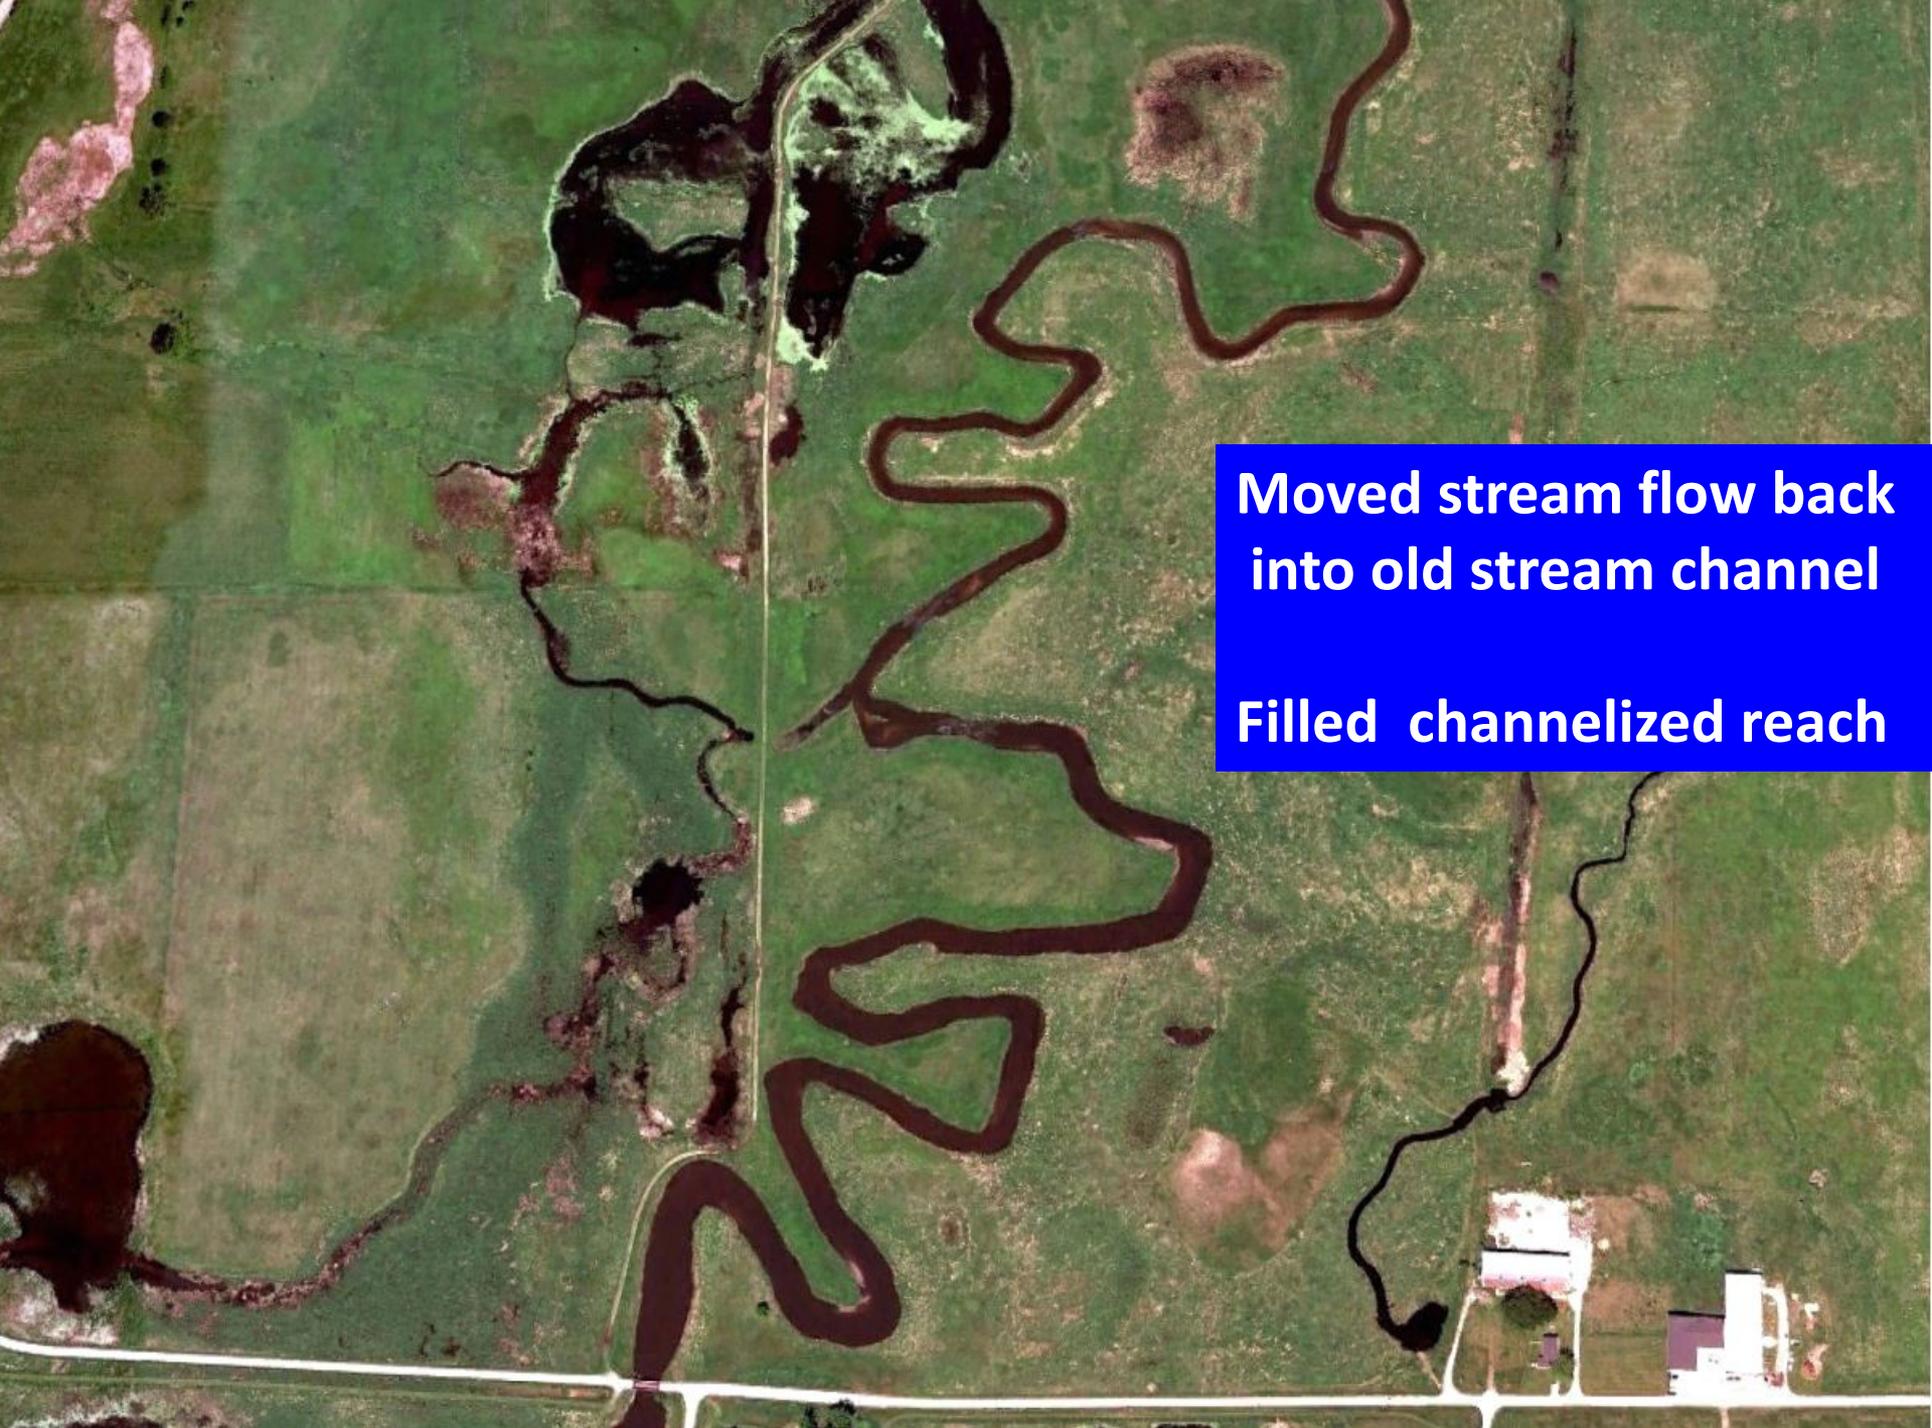
**Moved stream flow back  
into old stream channel**

**Filled channelized reach**

**Geomorphologist from NIU  
determined excessive  
erosion in meanders -**

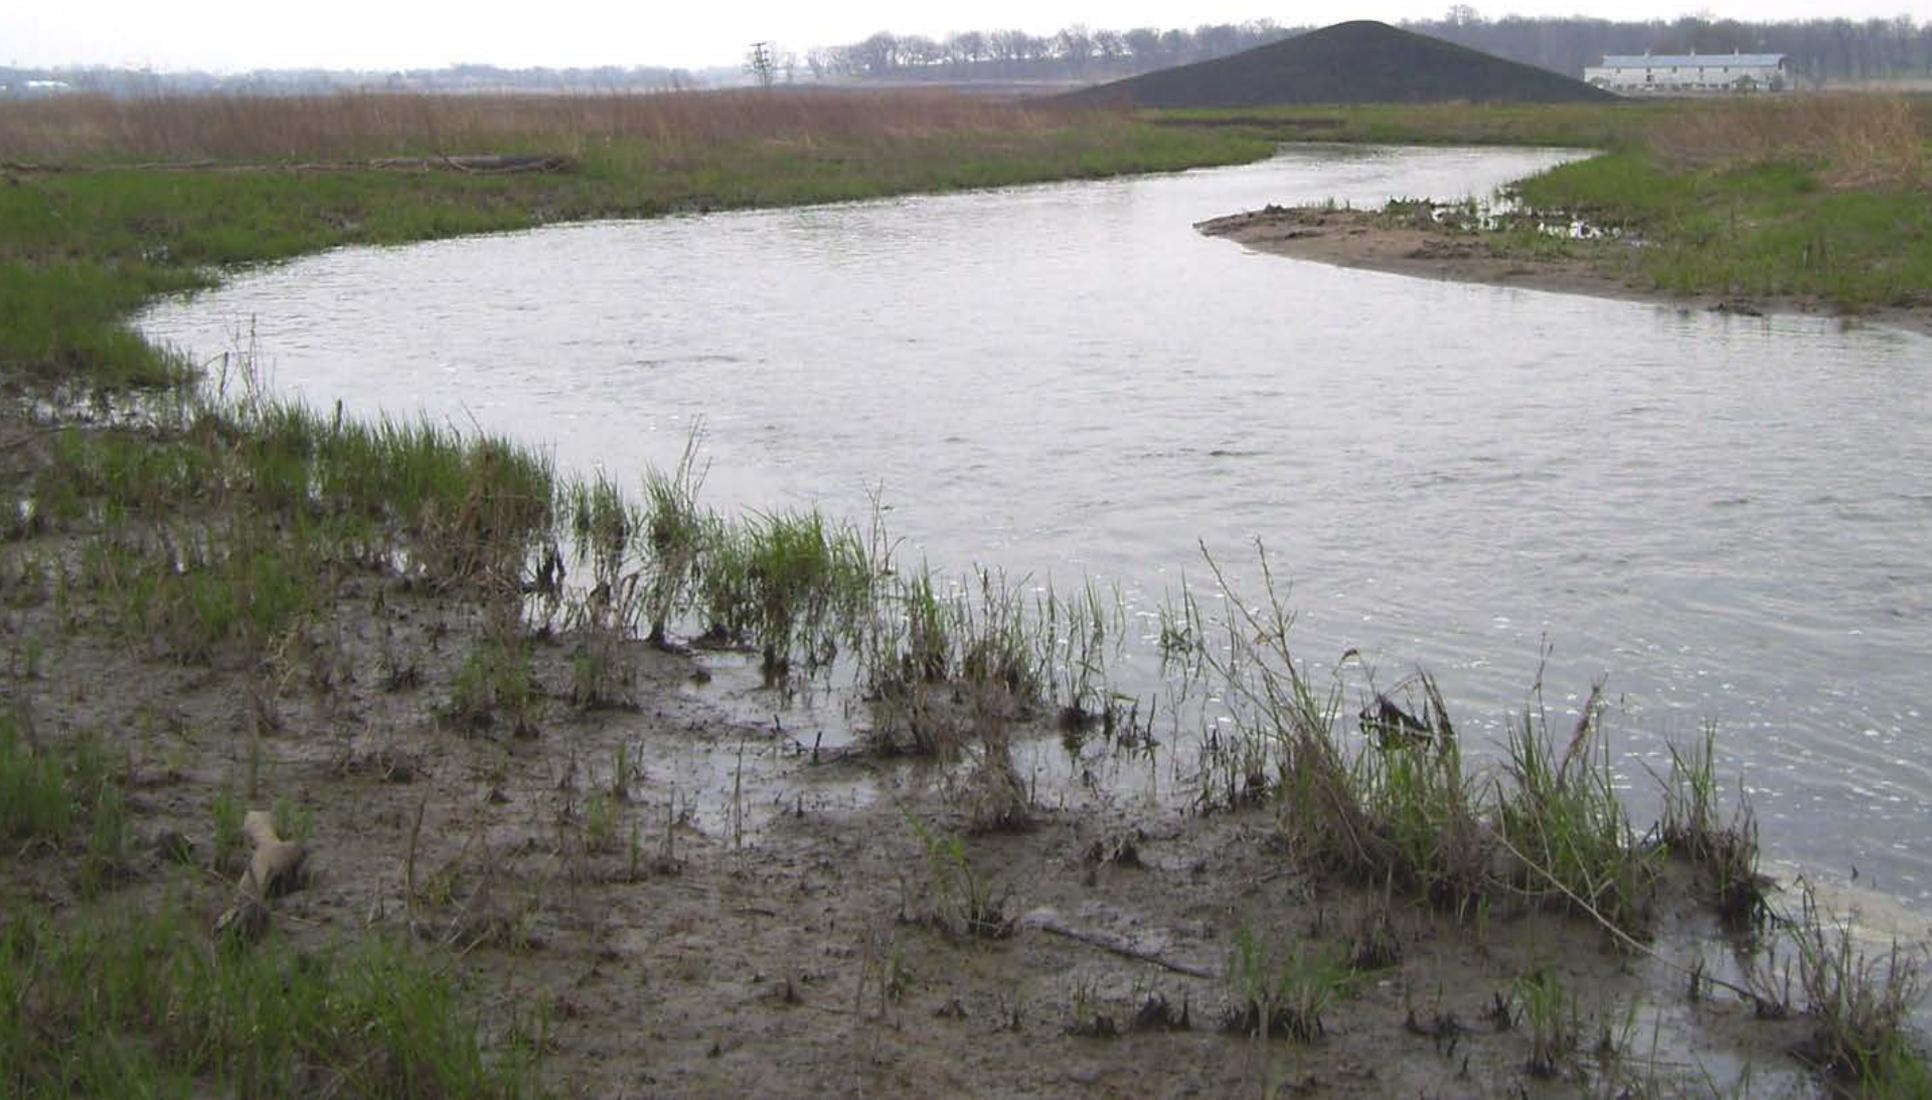
**Sand deposition builds on point bars from channel scour since Wonder Lake Dam traps over 90 percent of sediment**

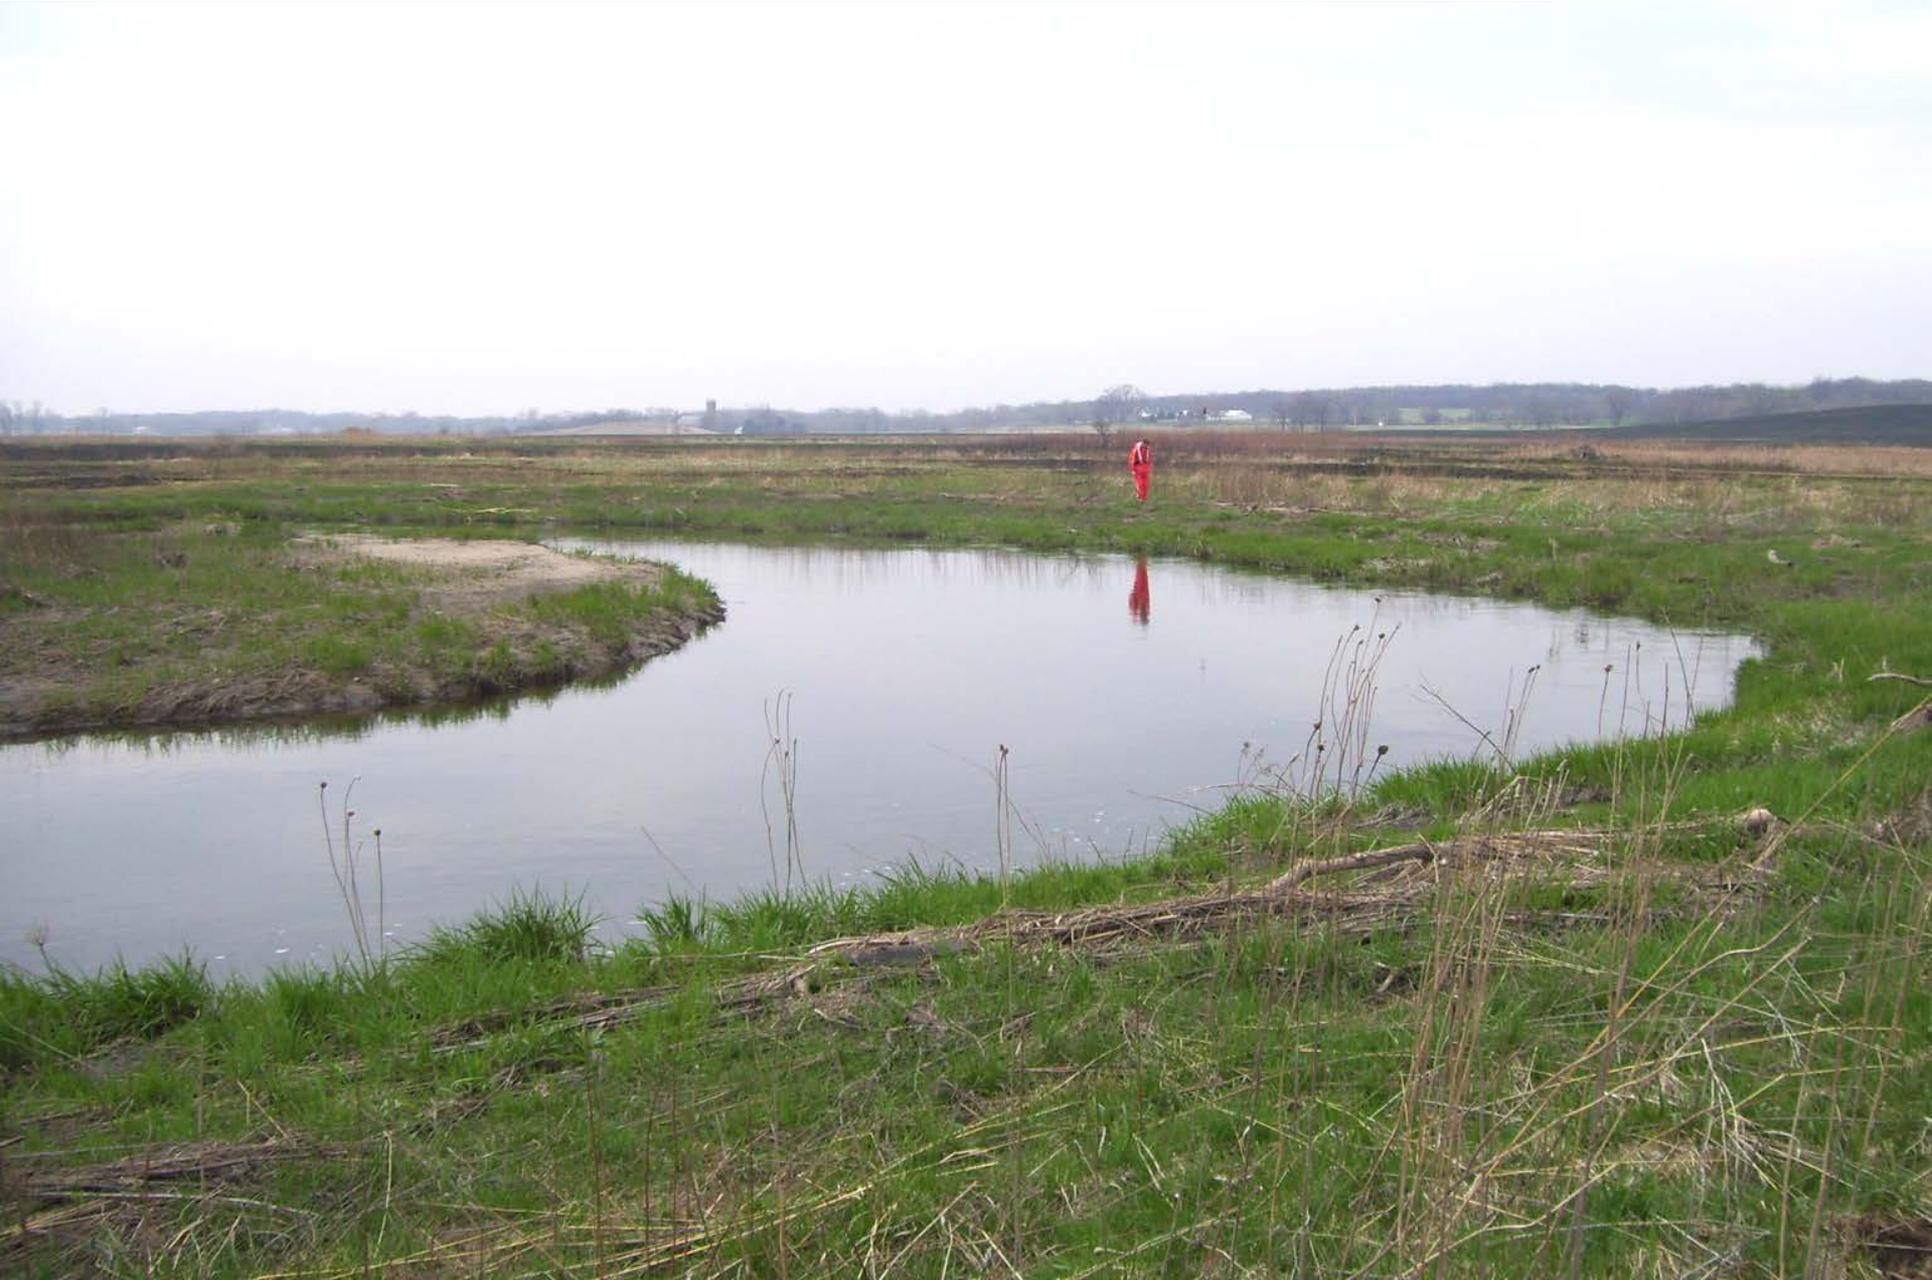
**USCOE added riffles after flood discharges  
from upstream Wonder Lake  
increased channel erosion in meanders**

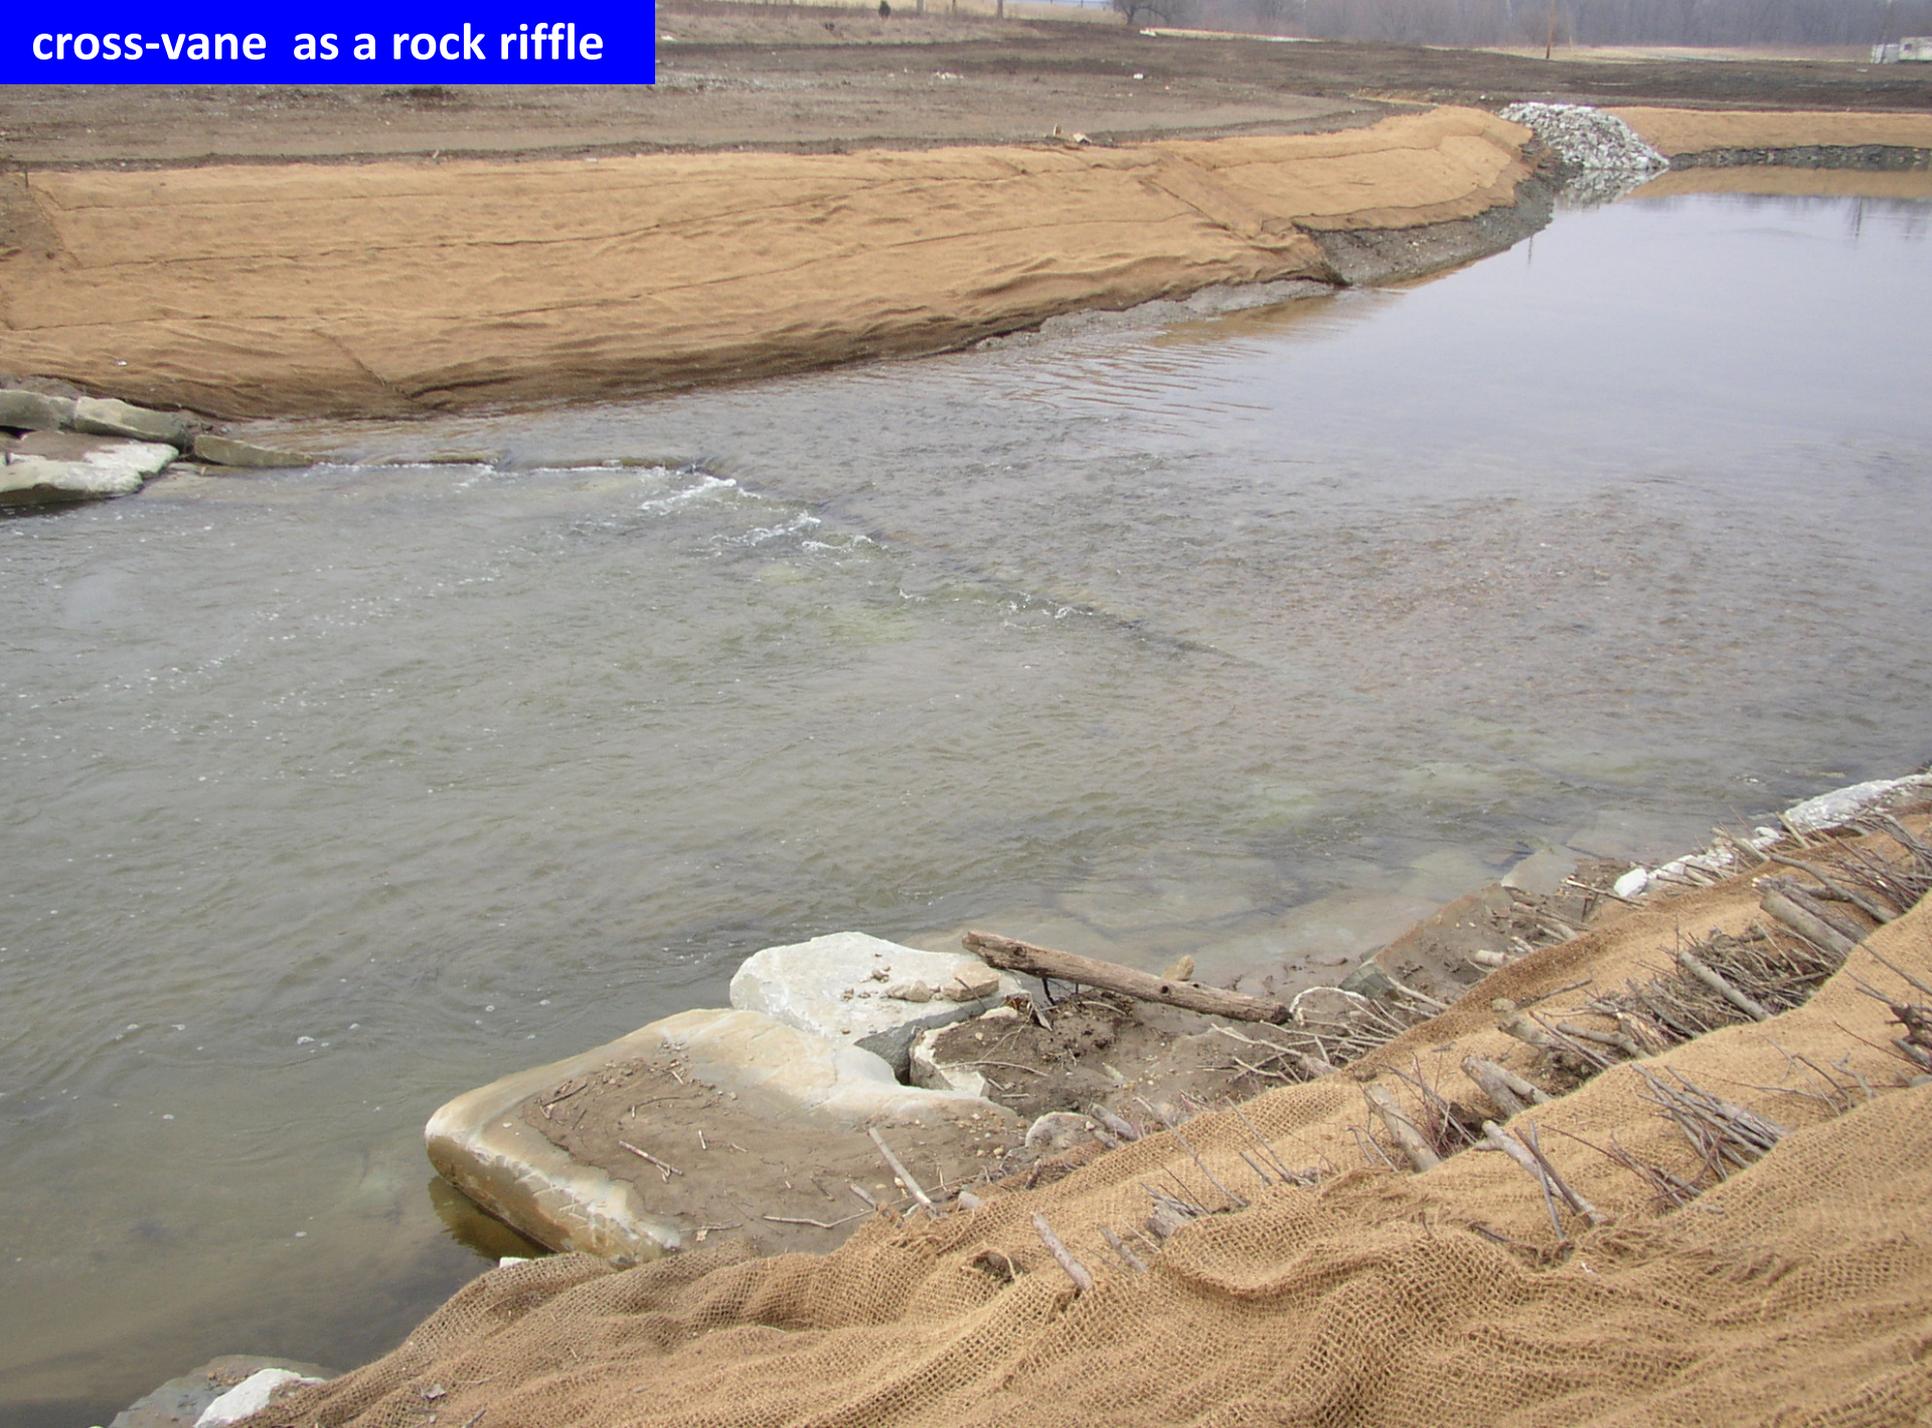
cross-vane as a rock riffle

**Bankfull channel dimensions at riffle  
do not transport bed materials  
and recreate instream habitat**

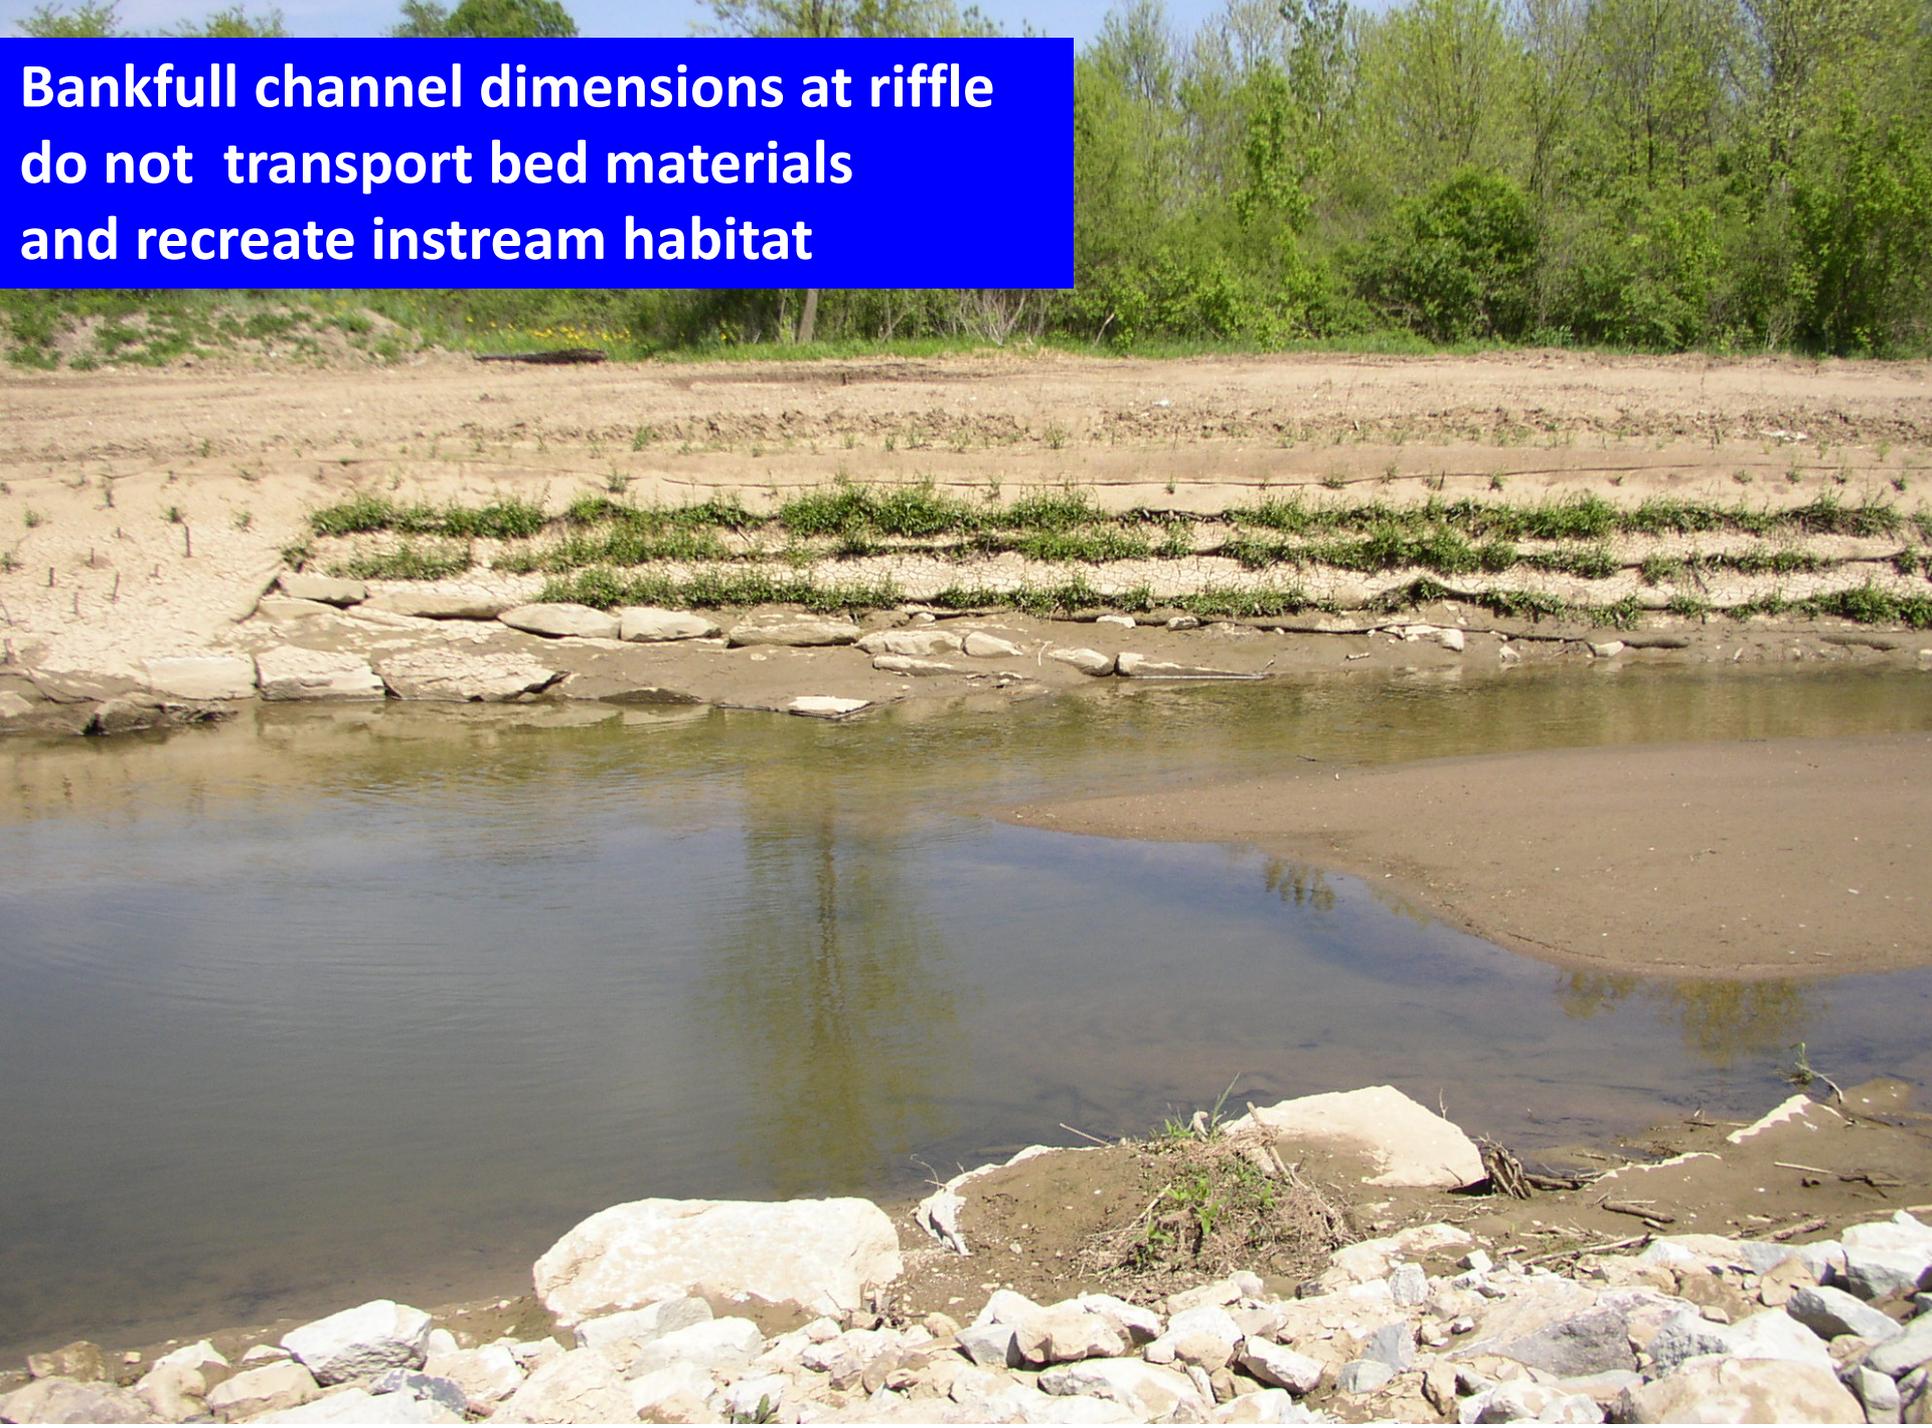
**Note bedload deposition over cross vane and bank scour around mid channel bar**

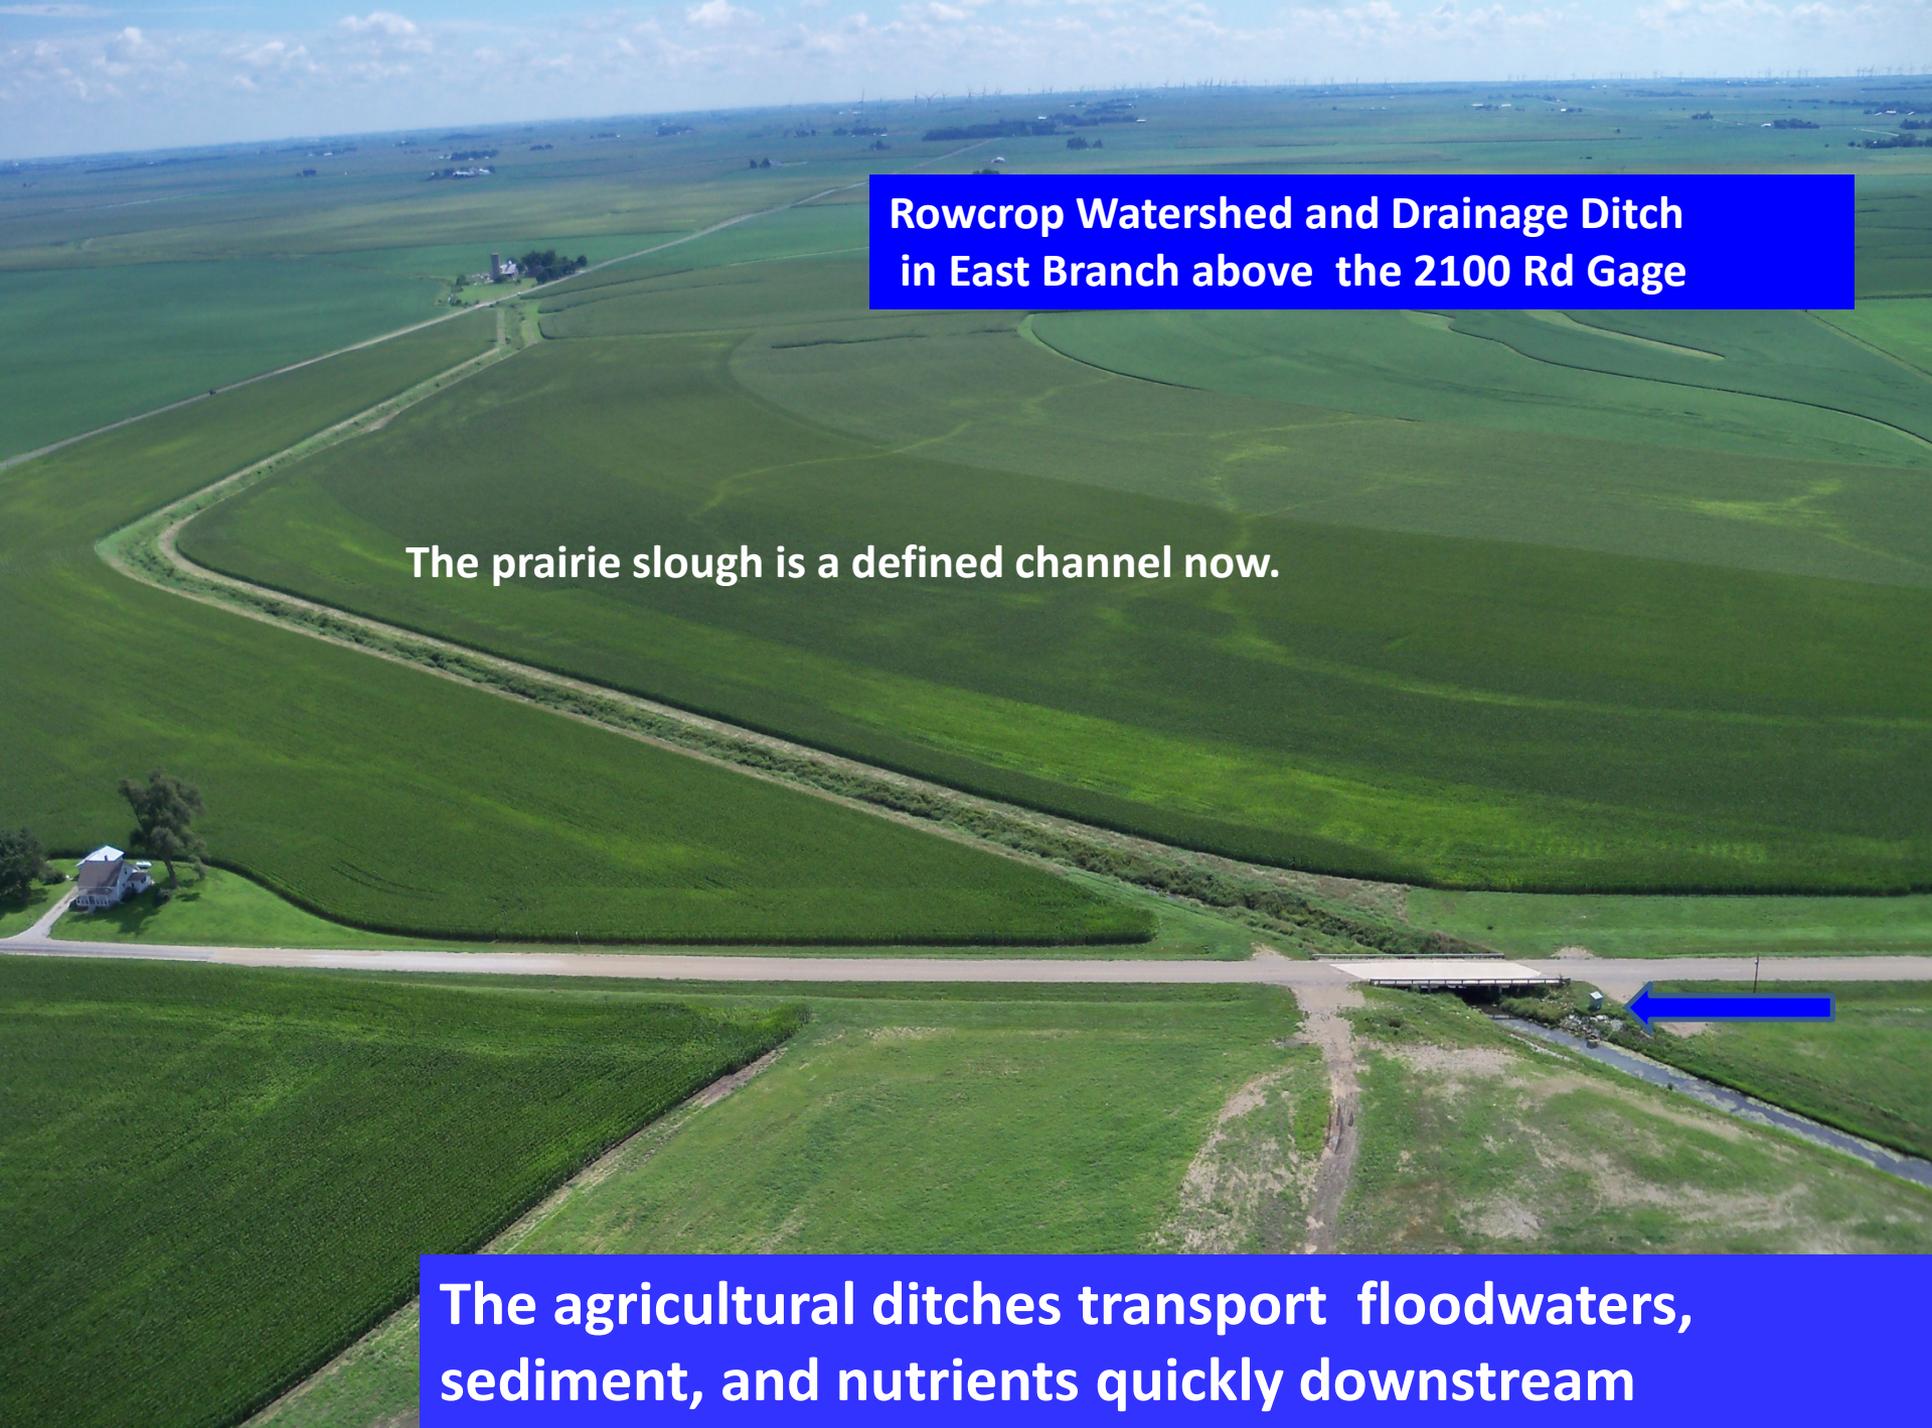
An aerial photograph showing a vast agricultural landscape. A prominent drainage ditch runs diagonally across the frame, with a prairie slough branching off to the right. The fields are lush green, and a road is visible in the lower third of the image. In the distance, a line of wind turbines is visible against a blue sky with scattered clouds. A blue arrow points to a structure on the drainage ditch in the lower right quadrant.

**Rowcrop Watershed and Drainage Ditch  
in East Branch above the 2100 Rd Gage**

**The prairie slough is a defined channel now.**

**The agricultural ditches transport floodwaters,  
sediment, and nutrients quickly downstream**

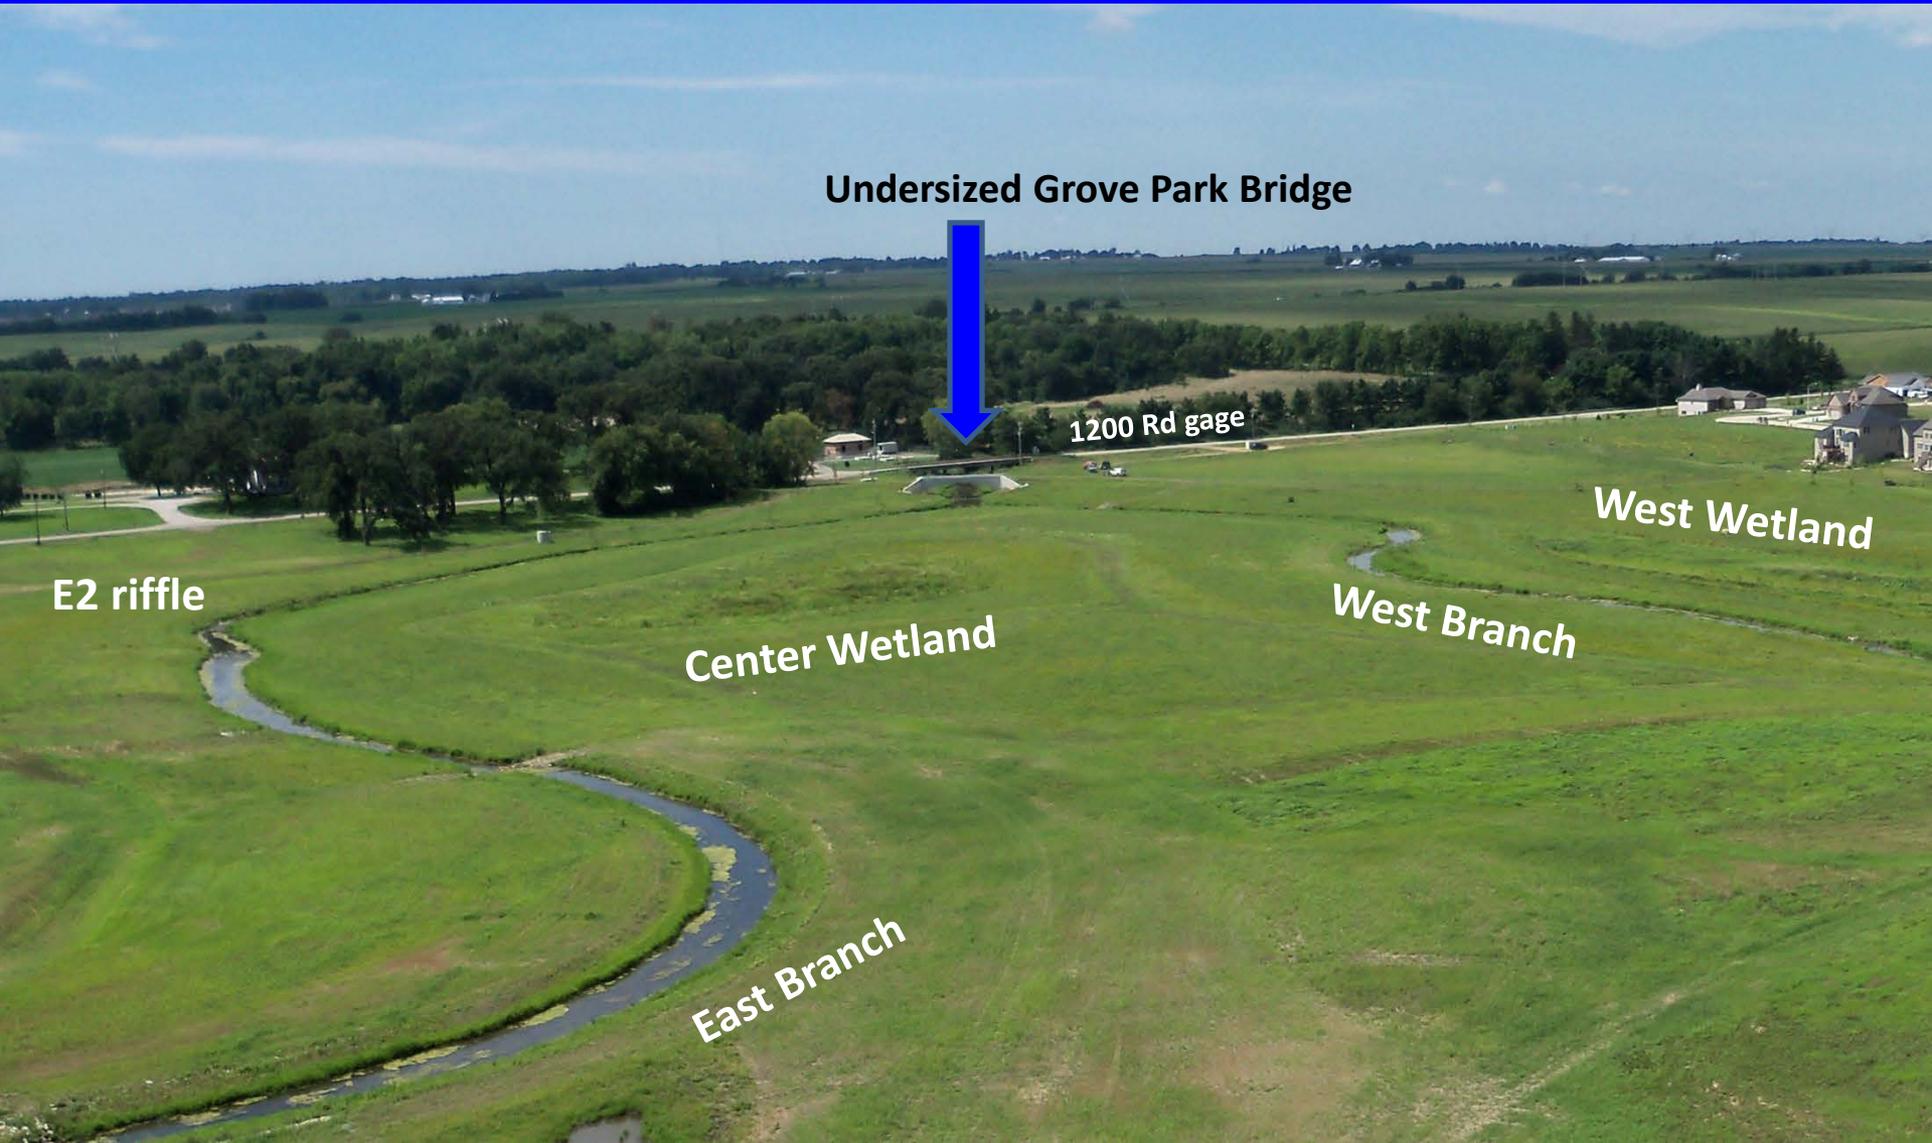
# Phase 1: Temporary wetland basin storage above the undersized Grove Park Bridge. Pictured during second summer of prairie/wetland growth

Undersized Grove Park Bridge

**To reduce downstream flooding, runoff is detained  
in the park floodplains and wetlands by the undersized bridge**

**Shave the peak off larger floods but reduce sedimentation**

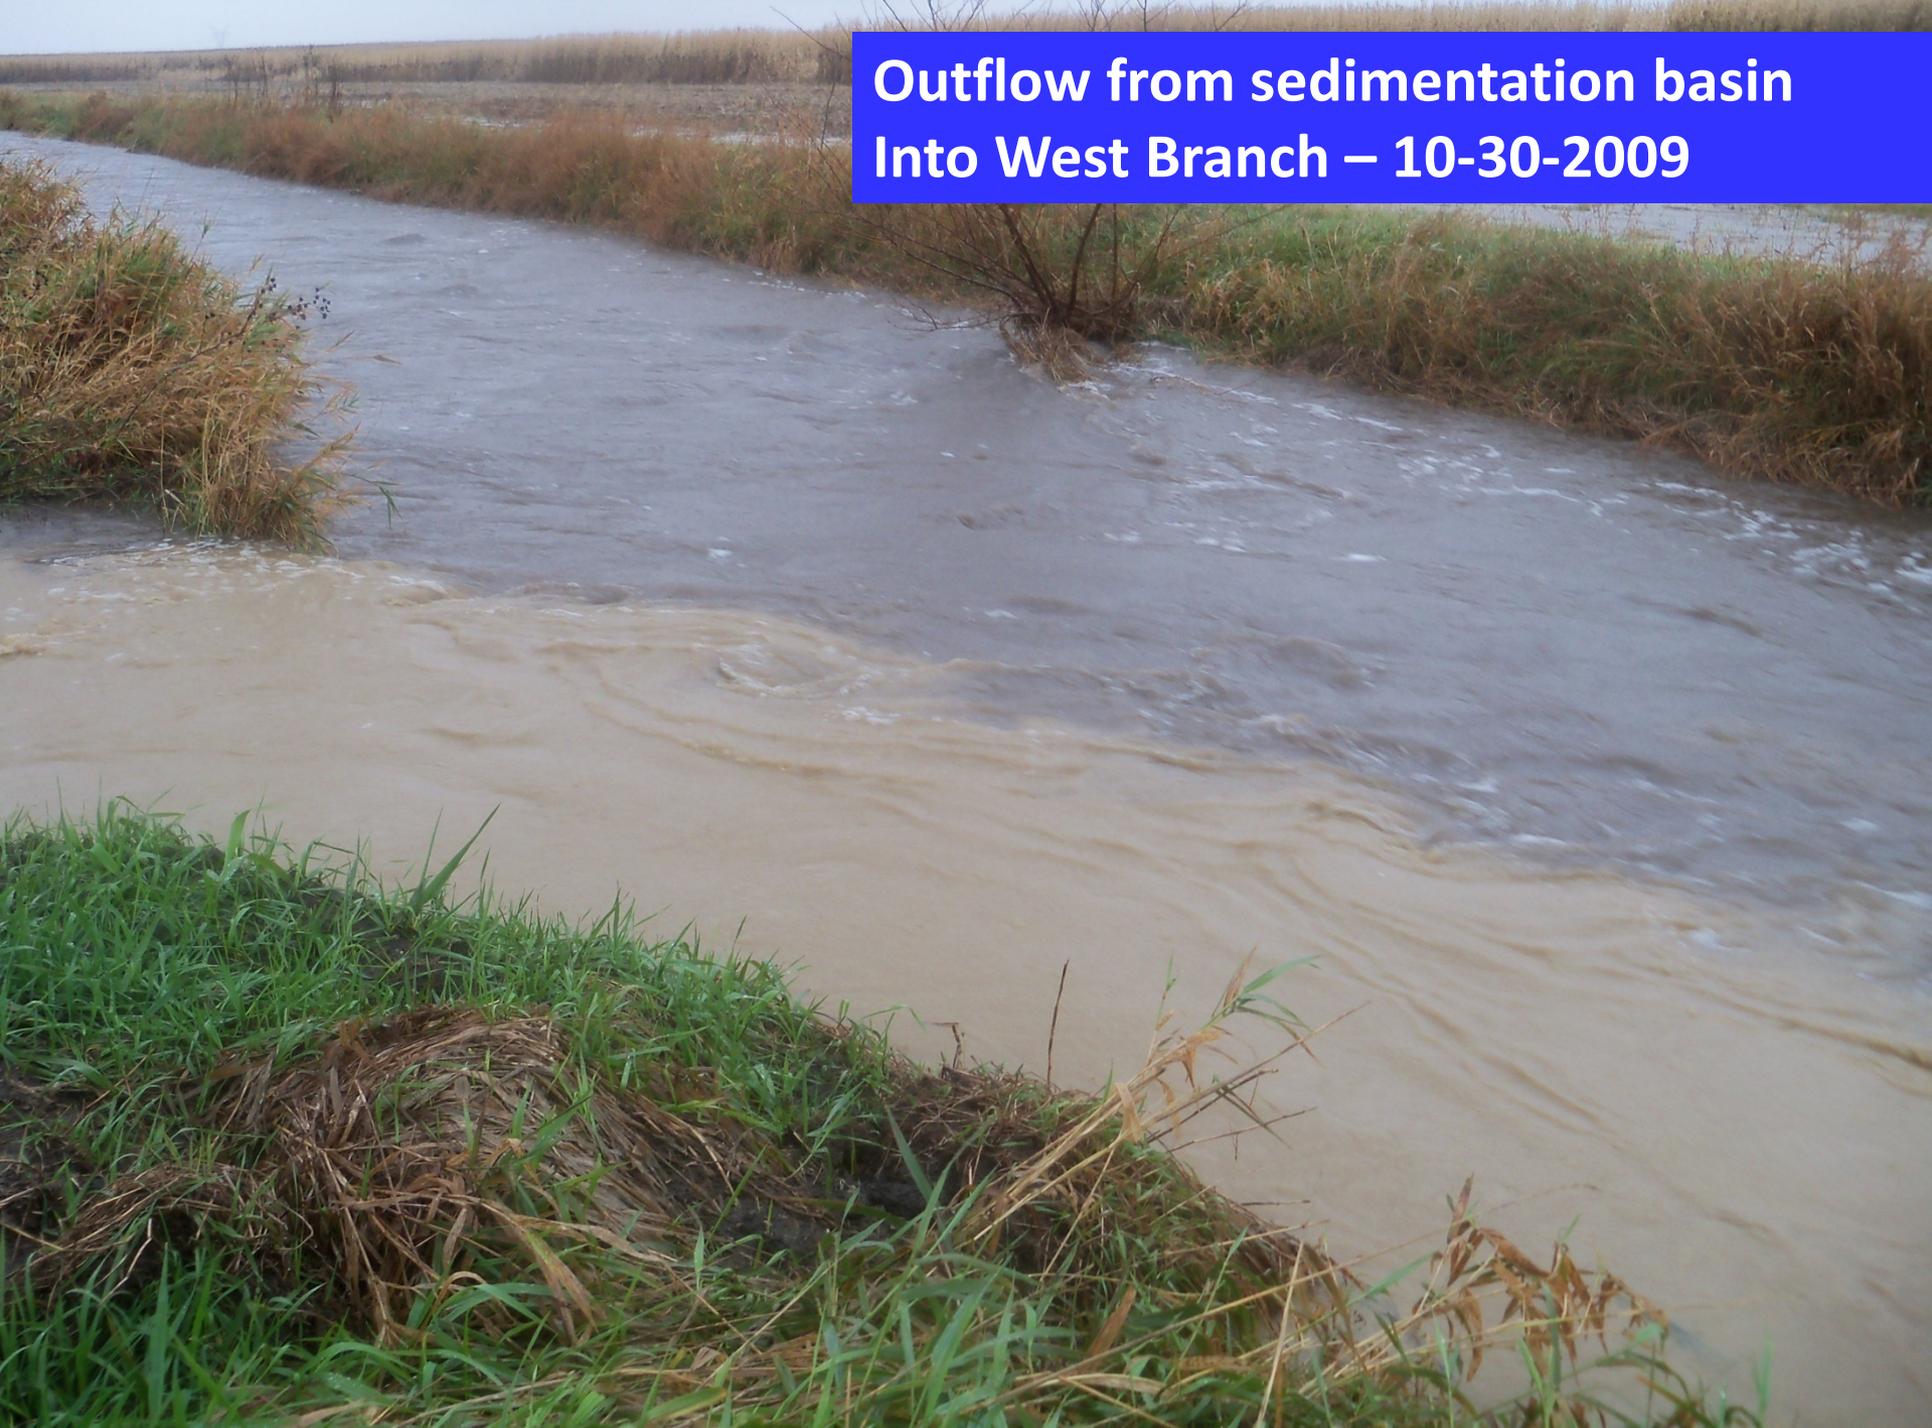
Kickapoo Creek-West Reach

**Stream should move sediment load through wetland prairie detention basin**

**HEC-RAS 4 beta mobile bed sediment transport**
