**OSM NATURAL STREAM DESIGN  
WORKSHOP MID-CONTINENT  
REGION TECHNOLOGY TRANSFER  
May 2011 Mt. Vernon IL**

**Major  
Natural  
Stream  
Restoration  
Projects  
In the  
Midwest**

# How sediment load and particle size affects natural design

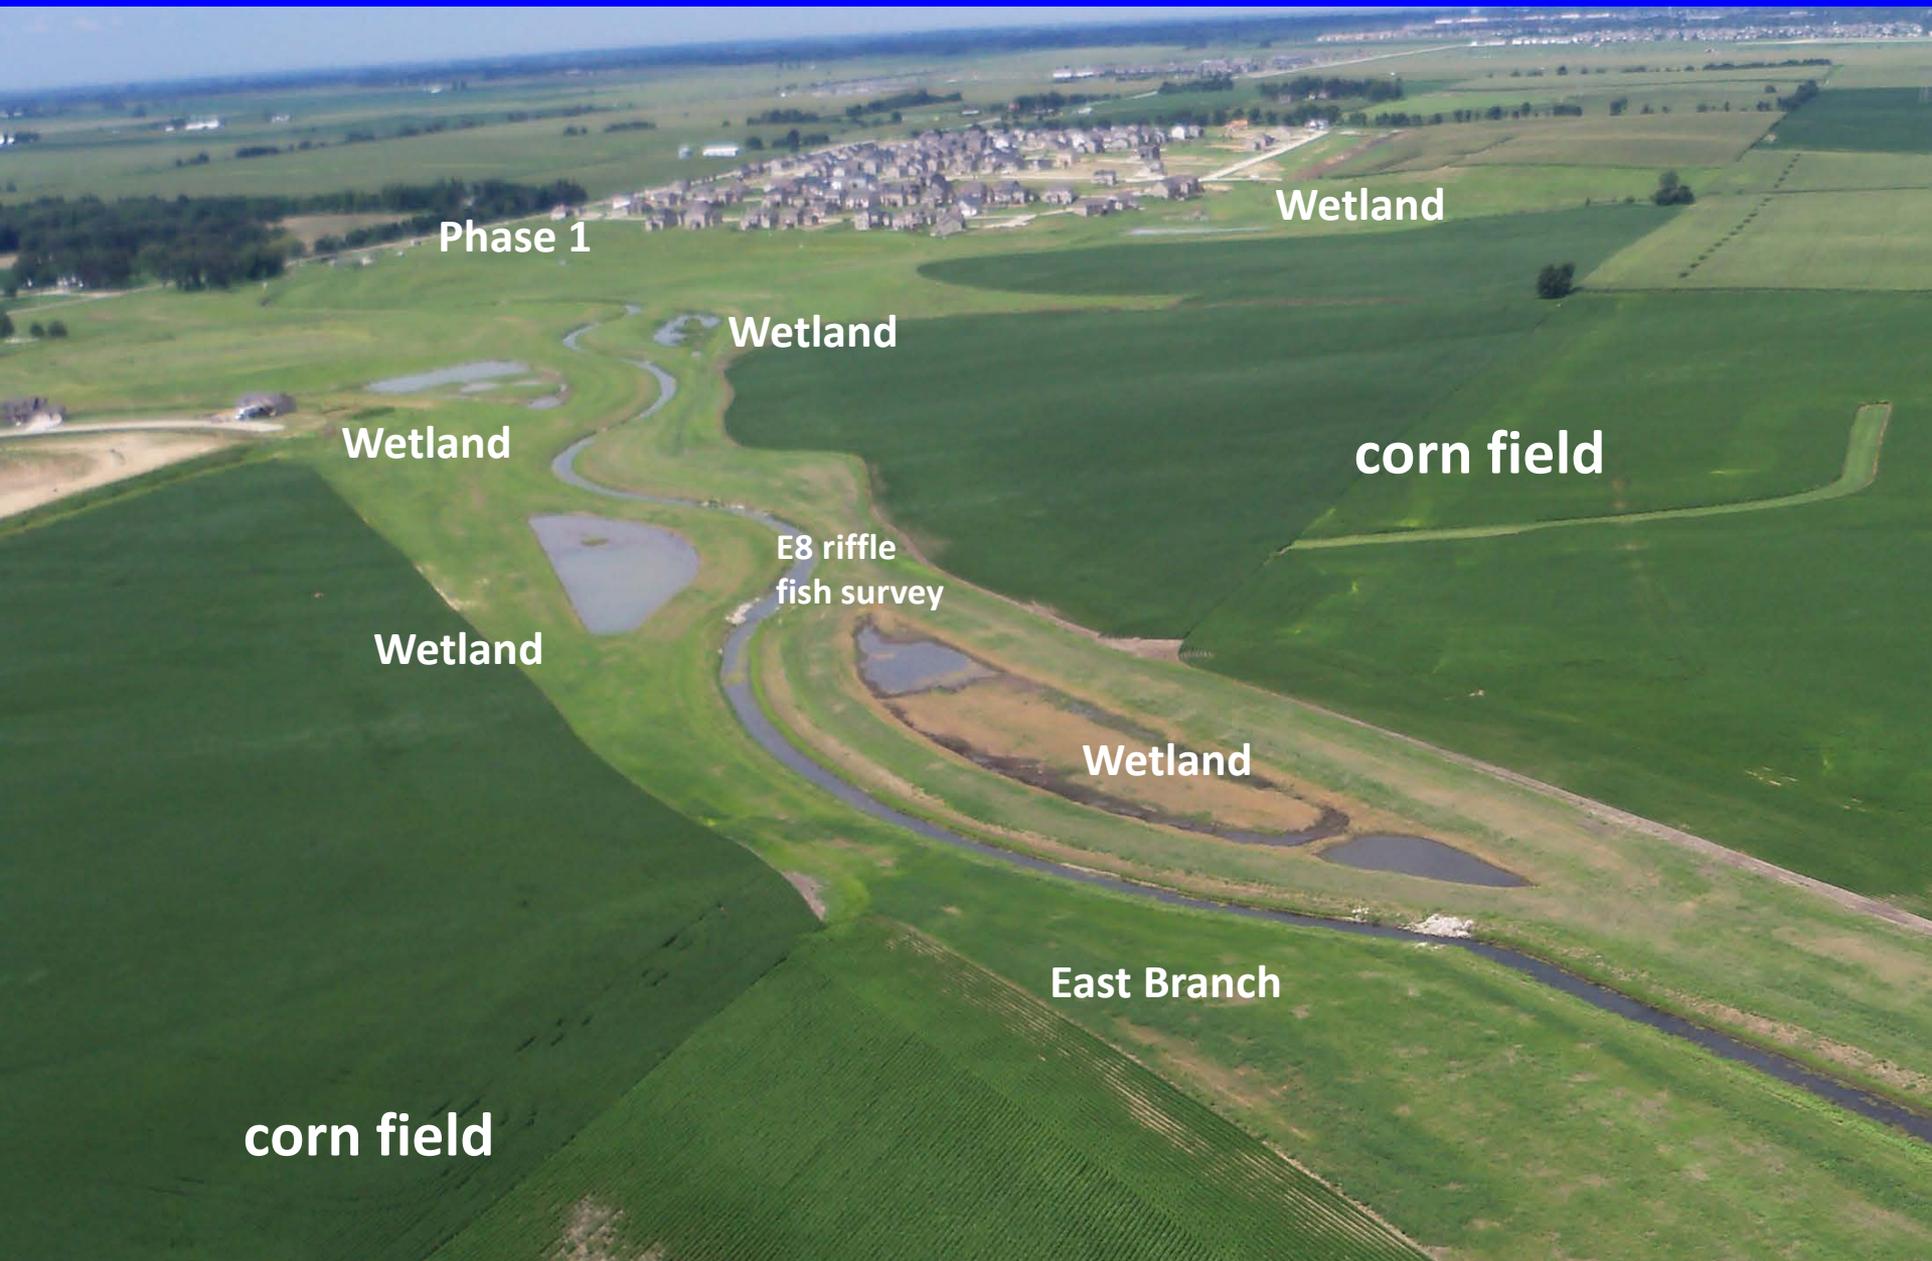
# Phase 2: East Branch remeandered and wetlands pictured (7-26-2010) in the first summer of prairie/wetland growth

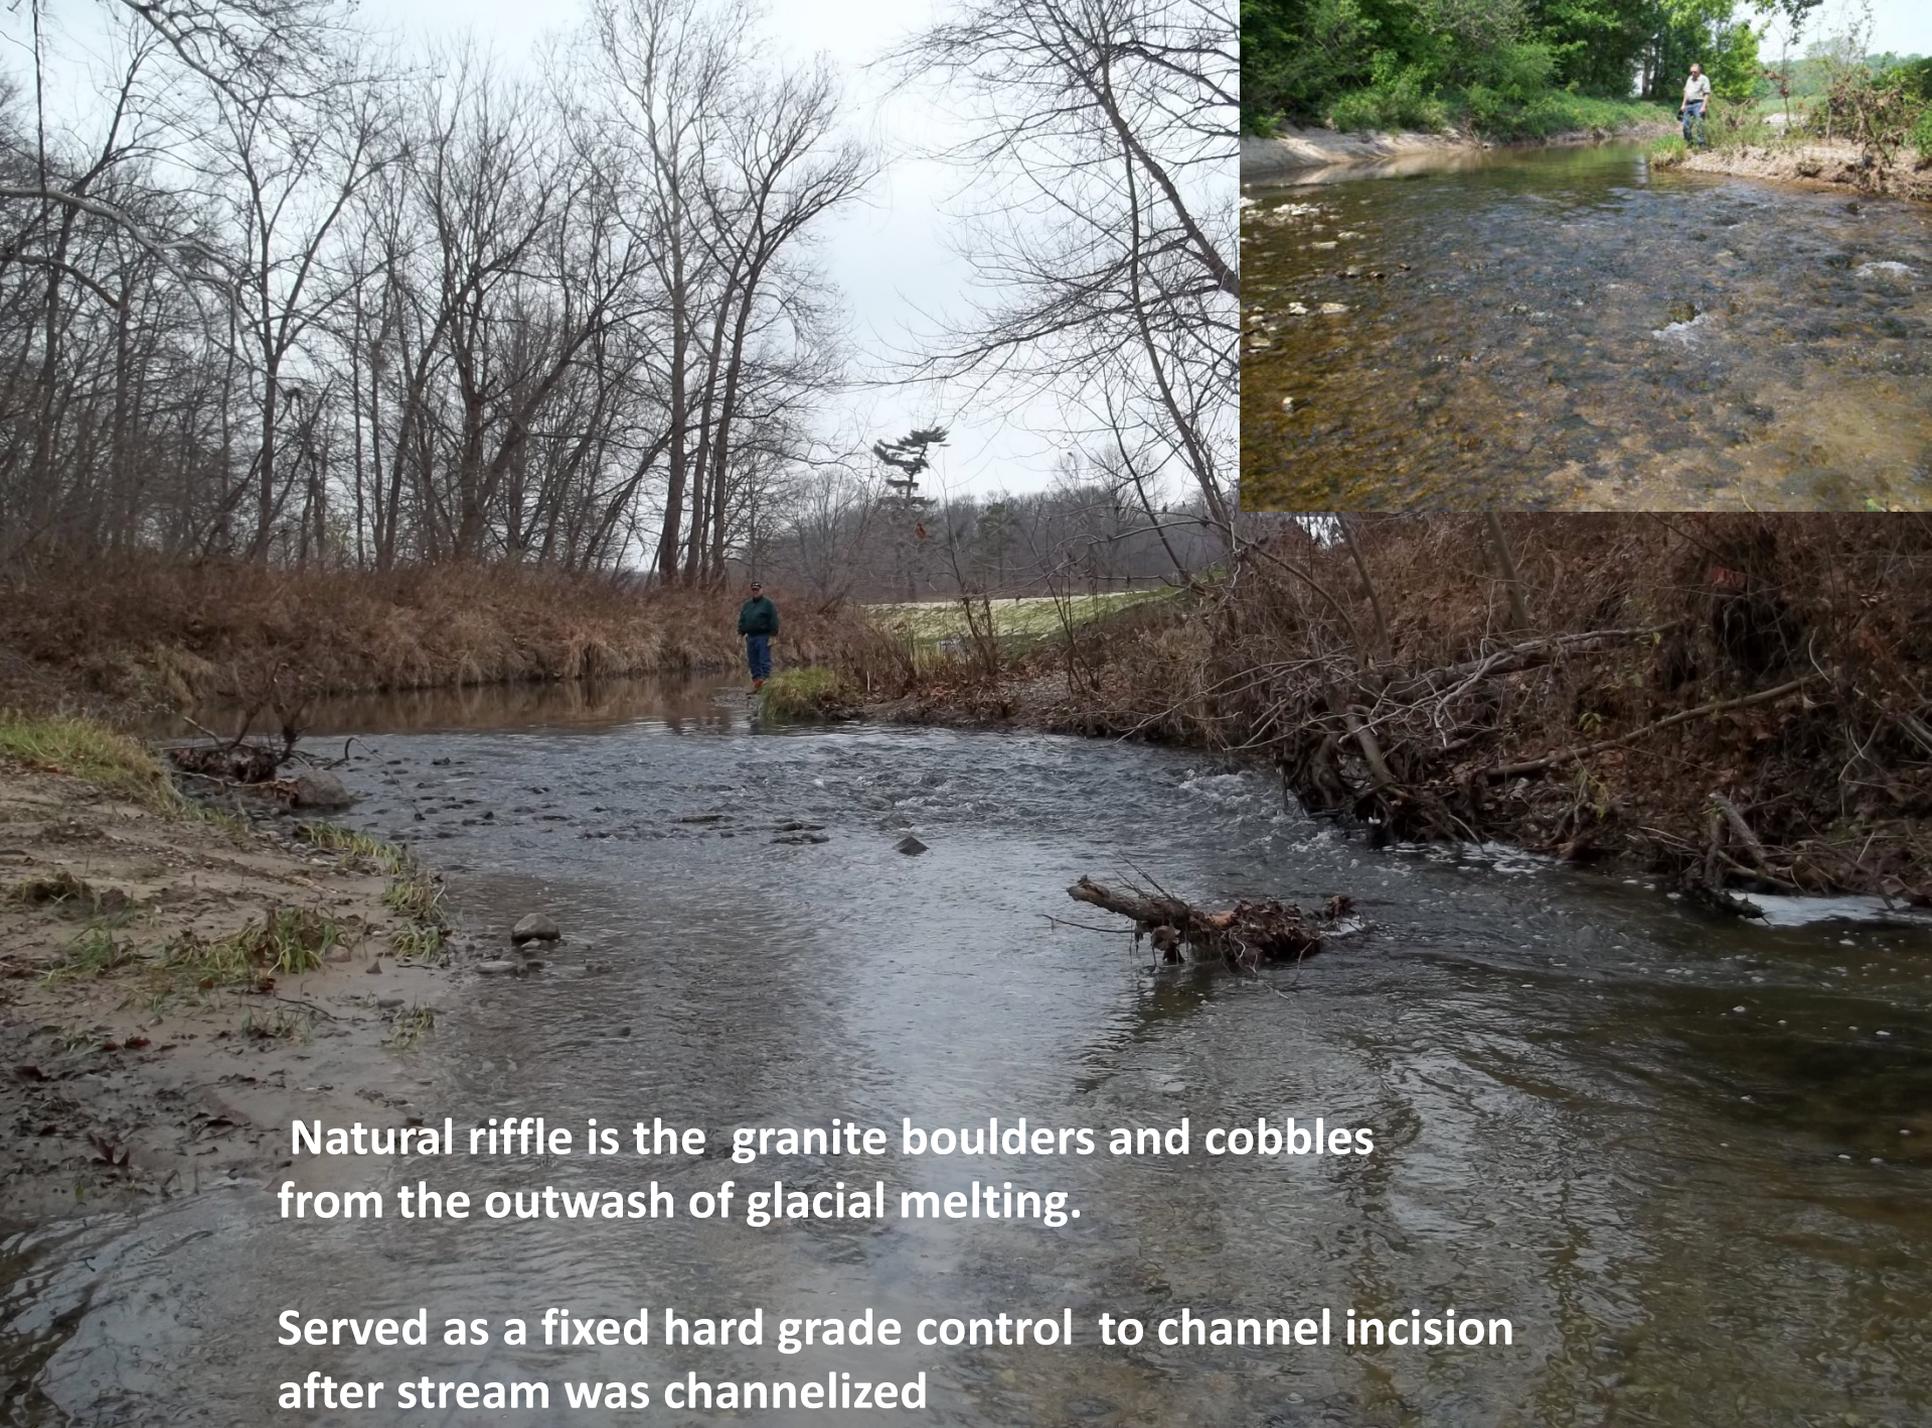
Natural riffle is the granite boulders and cobbles from the outwash of glacial melting.

Served as a fixed hard grade control to channel incision after stream was channelized
