Evaluating Sediment Production from Watersheds at La Plata Mine¹

N. Bugosh², E. Epp

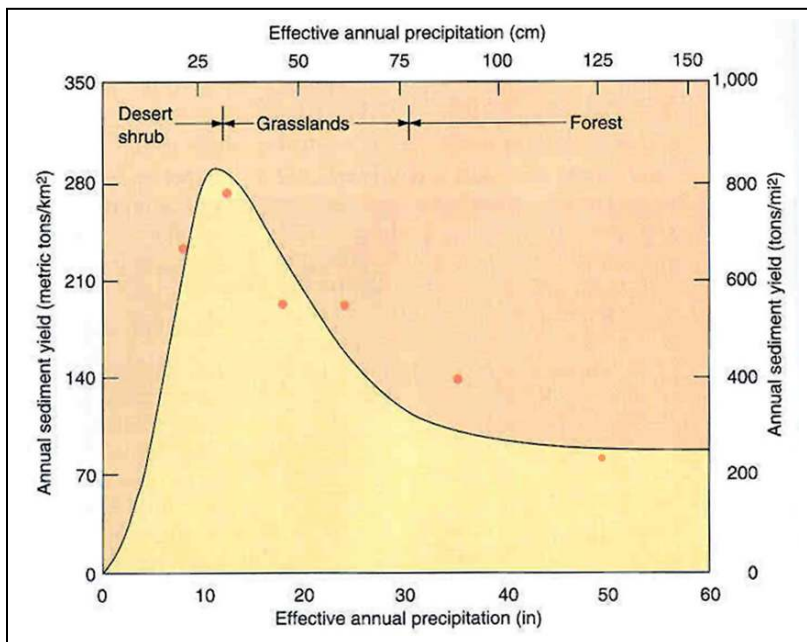
Figure 1. Graphic representation of the relationship between precipitation, vegetation, and sediment yield. (Langbein and Schumm, 1958)

The study site is in an extremely erosive environment that provides a rigorous test of the landform rehabilitation design. Greater precipitation does not directly lead to greater erosion as researchers have long known because greater precipitation generates thicker soils and more abundant vegetation that intercept precipitation, promote infiltration rather than runoff, and make a through flow hydrologic condition. Conversely, lesser precipitation forms thin soils over bedrock with little intervening vegetation and makes for flashy runoff and overland flow conditions. The figure above shows that the La Plata Mine site conditions are those that lead to the maximum erosion and sediment yield.

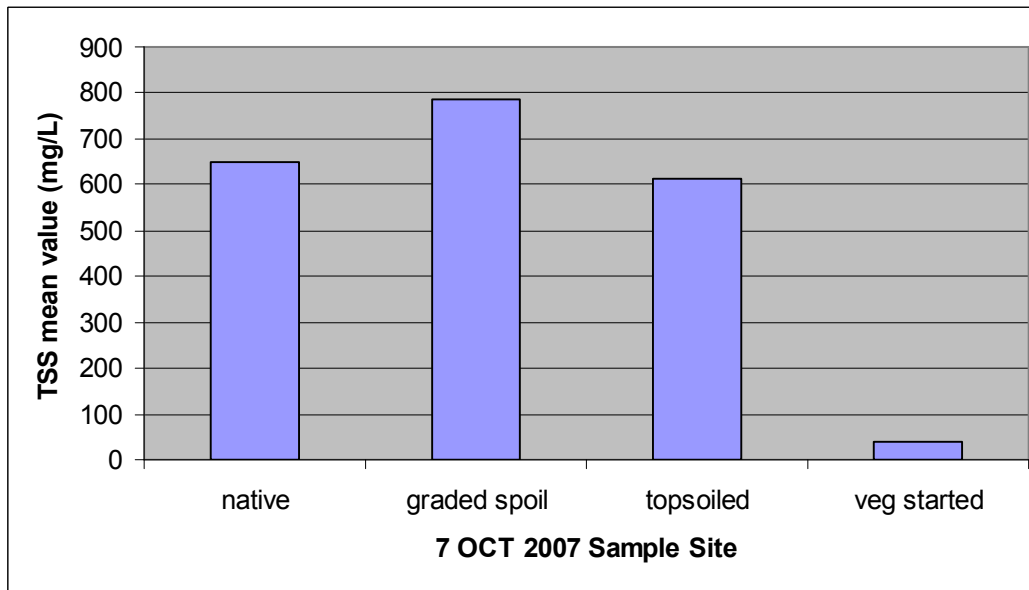
Figure 2. Graph of 7 October 2007 synoptic storm water runoff sampling from native and constructed GeoFluv reclamation.

The synoptic total suspended solids results presented graphically above show that the constructed fluvial geomorphic designs without vegetation generated suspended sediment loads similar to the undisturbed native land. The constructed fluvial geomorphic site with vegetation established generated suspended sediment at an order of magnitude lower concentration than the undisturbed native land. This lower concentration can be explained by the fluvial geomorphic reclamation having taken critical design input values from geomorphically “mature” reference areas that are relatively stable against erosion. The undisturbed native land is more geomorphically “youthful” and tends to erode at a greater rate. The synoptic sampling results indicate that the fluvial geomorphic designs generate sediment discharge equal to, or less than, natural undisturbed land, but they do not quantify the total volume of sediment. The total suspended sediment results show only a “snapshot”, i.e., the sediment discharge concentration at the moment of sampling. They did not tell the soil volume or tonnage involved.

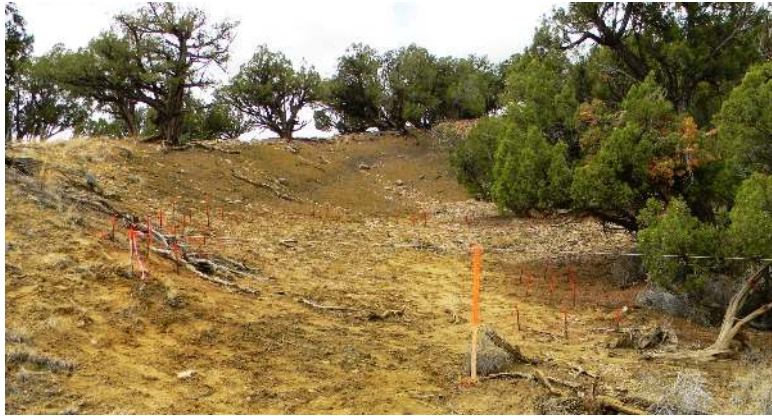
Figure 3. N7 sediment dam site with survey in progress and sediment pins installed.

The dam sites were located in the field and site personnel constructed the dams according to the design. The surveyor used a hand level to locate the full-pool elevation based on the dam spillway elevation. The sediment pins (lengths of steel reinforcement bar stock) were located below the full pool elevation along the valley walls and channel and pond bottom upstream of the dam. After the construction was completed, the surveyor returned to the sites and accurately surveyed each project site. The mine hydrologist installed a recording rain gauge at each site to augment the long-term mine meteorological station that was located approximately 3.5 miles (5.6 km) from the sediment project study sites. It was important to capture site specific precipitation information because the precipitation events in the region are extremely localized.

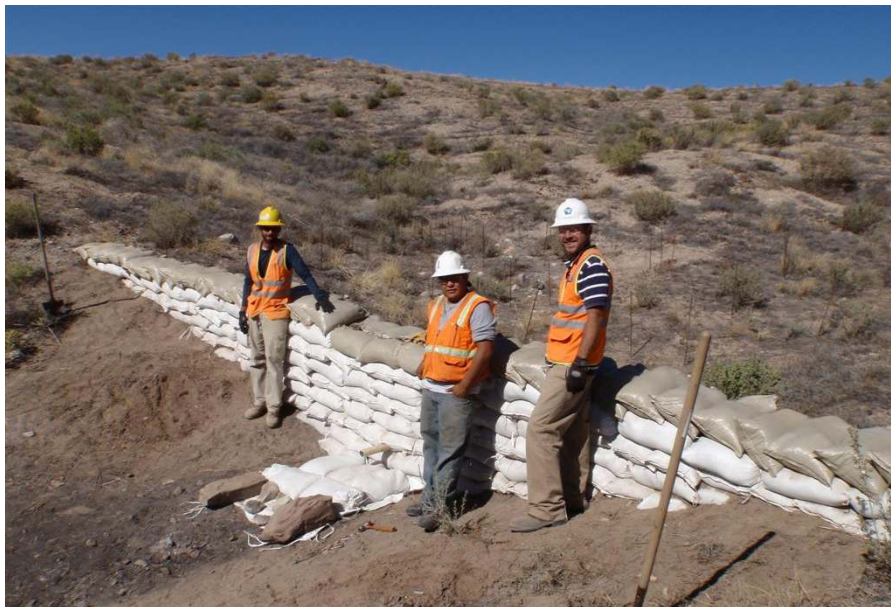
Figure 4. WV3 study site after construction of temporary sediment dam.

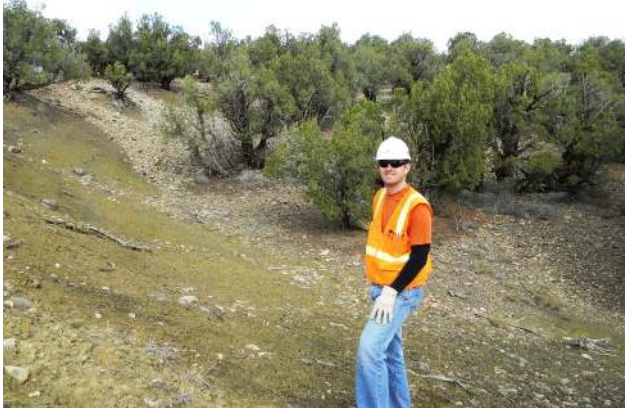
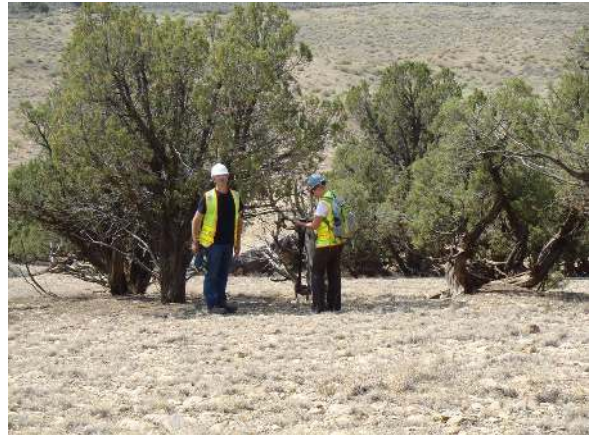
Figure 5. N7 native subwatershed site.

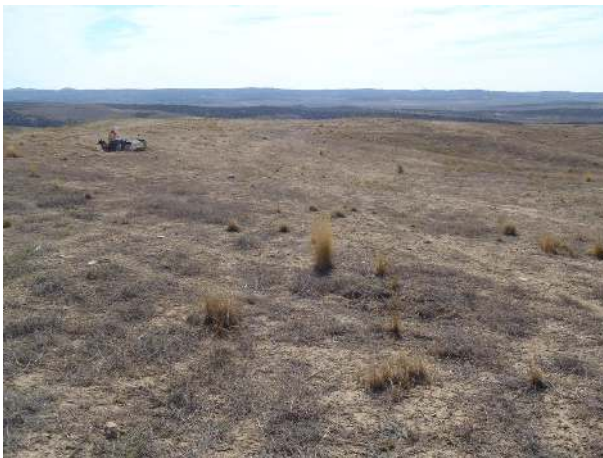
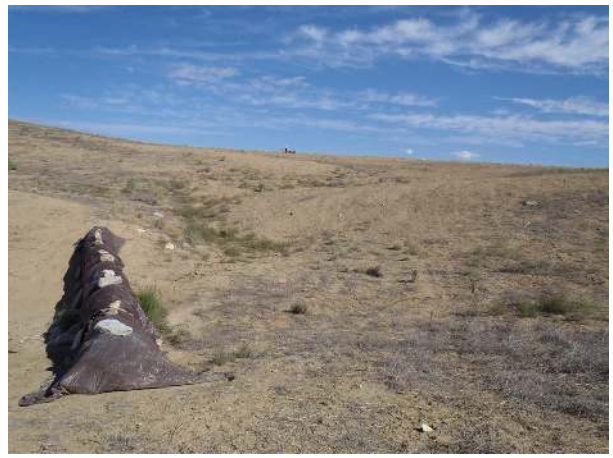
Figure 6. MV5 GeoFluv design with topdressing and poor to moderate vegetation establishment.

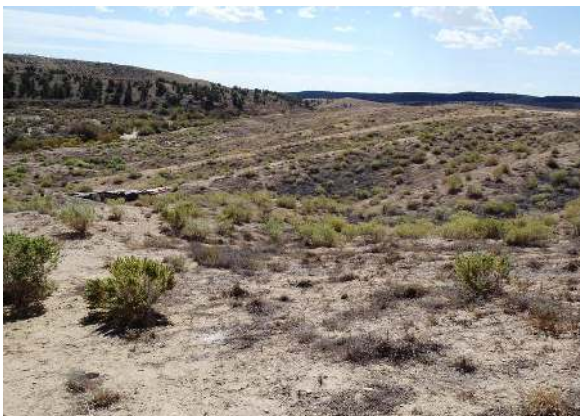
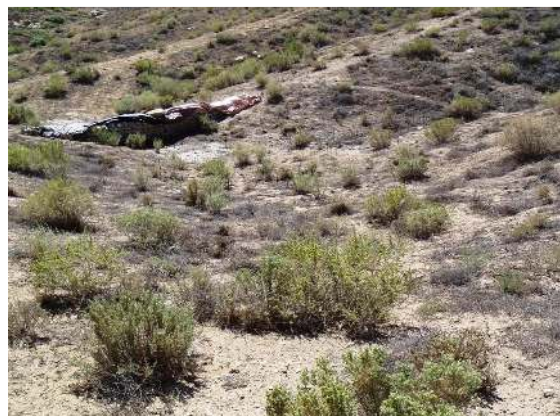
Figure 7. WV3 GeoFluv design with topdressing and significant vegetation establishment.

Challenges to the study sites arose as the project continued. The grade of the access road directed road runoff into the top of the well vegetated site and had to be intercepted by installation of coir logs. Seepage was observed between the sand bags from which the dam was constructed and the sand bags were subject to rapid deterioration from the intense sun; both of these problems were resolved by covering the temporary dams with plastic sheeting. The sheeting both helped seal the seepage and protected the sandbags from sunlight. Additionally, the sheeting was easier to replace than the sandbags. When arriving on site to measure the sediment elevation after some storms, the sediment surface at some sampling stakes or the top of the stakes was sometimes immersed by pooled water and could not be measured until the water had been fully drained. Frost heave was observed to occur around the survey stakes in the extremely cold periods and this elevated sediment surface affected the measurements until the sediment subsided again during moderate weather. Each of these challenges was overcome by adjusting the site construction, making additional site measurement visits, or recognizing the effect in the data.

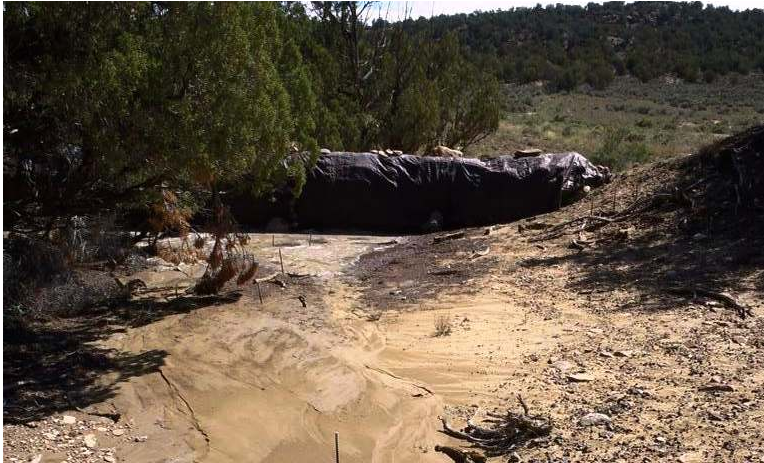
Figure 8. View downstream to the N7 temporary sediment dam after the first sediment event.

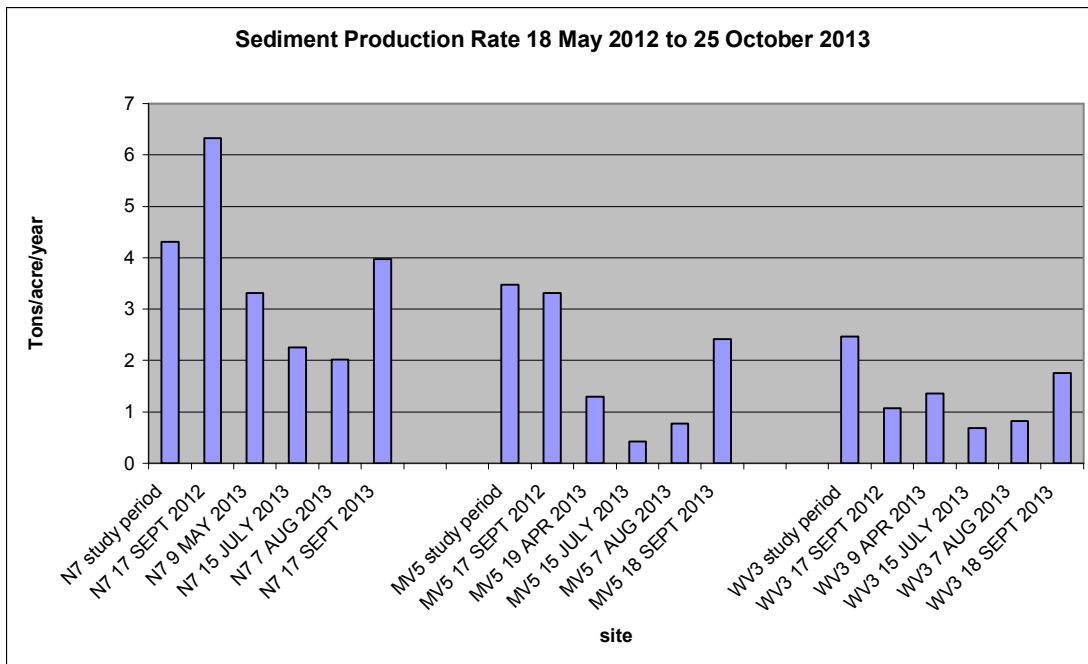
Figure 9. Bar graph of tons per acre sediment rate for six different periods for each of the three sites.

A bar graph can be used to compare the resulting values among the three sites and helps visualize the trends in sedimentation. The graph below shows six different periods for each of the three sites. The bar on the left side of each site's grouping shows the tons per acre per year value for the entire study period, from the baseline site sediment measurement on 18 May 2012 through the last sediment event measurement on 25 October 2013. The N7 native site had the greatest sedimentation rate at 4.3 tons per acre per year, followed by the MV5 fluvial geomorphic design with topdressing and little to moderate vegetation site at 3.47 tons per acre per year, and the WV3 fluvial geomorphic design with topdressing and well-established vegetation site had the lowest sedimentation rate at 2.46 tons per acre per year.

The remaining five bars in each site grouping show the average sedimentation rates at various times throughout the study period. They are the result of comparing the starting surface with the sediment surface at the date on the graph's horizontal axis label. The rates among the sites are not seen to change at fixed rates. This would be expected because some periods experienced greater or lesser storms and resulting runoff, vegetation changed during the year, degree of soil moisture content varied at the onset of storms, etc. The overall trend for all the periods is similar

with both of the fluvial geomorphic sites having sedimentation rates better than or equal to the native, undisturbed site.

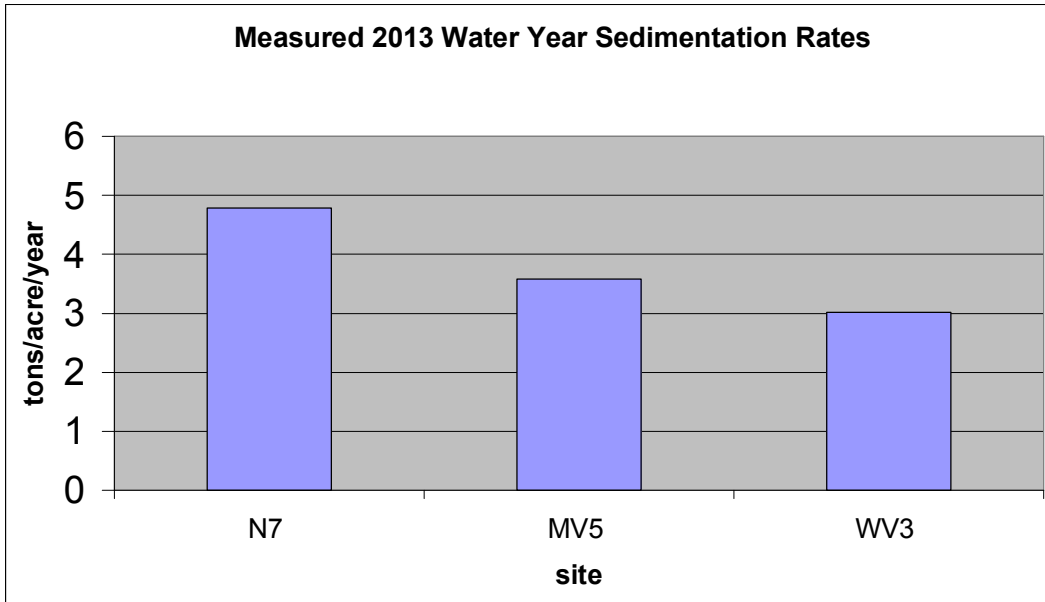
Figure 10. Bar graph of sedimentation rates calculated from 17 September 2012 and 25 October 2013 3D surfaces. The data include the entire 2013 water year.

Given the information above, the chart below displays what the authors believe are the values most representative of the conditions on site because they use values directly measured rather than inferring what happened at the end of the year between measurements. They compare the sediment surface that existed on 17 September 2012 with the 25 October 2013 surface that existed 403 days later. The entire 2013 water year is contained within these measurements. The tons per acre values are divided by the 403 day (1.1 years) period to calculate the tons per acre per year values shown.

The tons per acre per year values shown are: N7 4.79, MV5 3.58, and WV3 3.02. The relative differences can be more readily seen in this simpler chart. The GeoFluv design with topdressing and poor to moderate vegetation site, MV5, produced 25 percent less sediment than the native, undisturbed land site, N7. The GeoFluv design with topdressing and well-established vegetation site, WV3, produced 37 percent less sediment than the native site. These results suggest that the fluvial geomorphic landform accounted for a greater portion of the sediment reduction (the initial 25 percent) than the vegetation effect (the additional 12 percent).
