Non-Destructive Testing of Historic Structures to Establish Vibration Criteria

Mohamad Sharif PE¹
Charles Jaworski²
Vibra-Tech Engineers, Inc.

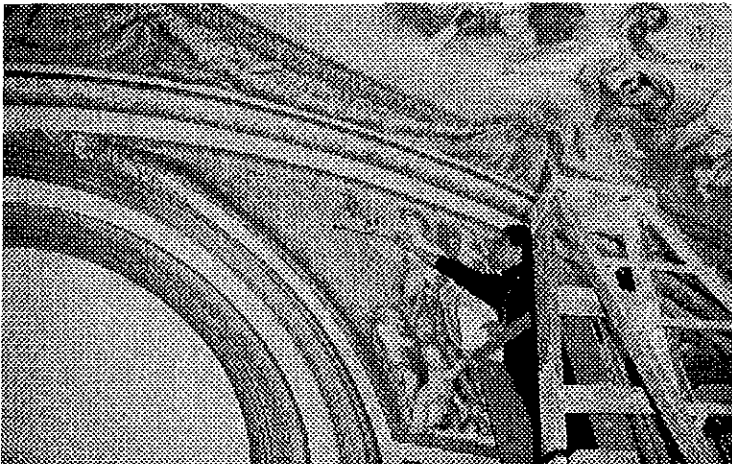
Next, an acoustic examination is conducted using a small, lightweight percussion mallet. Figure 1 illustrates the acoustic examination.

Figure 1 - Identification of Under Surface Defects by Percussion and Auscultation

The percussion and auscultation process is implemented in approximately 1 foot by 1 foot increments. Fully adhered and internally well-bonded plaster and stucco sounds different from weakened and loose material.

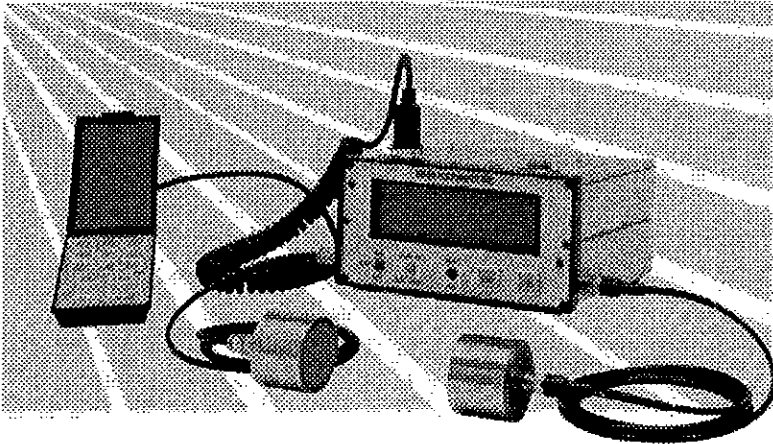
The ultra-sonic wave test method uses wave propagation to identify basic characteristics of the structural material. The testing equipment shown in Figure 2 includes a source sensor, instrument, and a receiver sensor.

Figure 2 - Ultra-Sonic Wave Instrumentation

The source and receiver sensors are placed on the structure at a known distance. The source induces an ultra-sonic wave that travels through the building material and is recorded by the receiver. The instrument determines the travel time through the building material. Using the distance and travel time, the propagation velocity within the building material can be calculated. Either shear propagation velocity or compression propagation velocity can be measured by selecting the appropriate sensor.

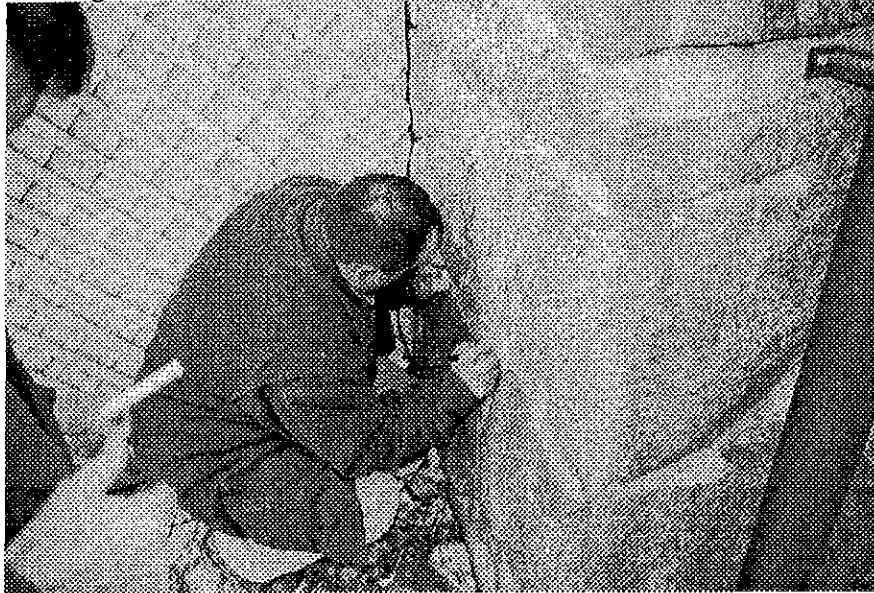
Due to the hardness and quantity of the rock, controlled blasting techniques were selected. Different parts of the church were visually inspected for paint failure, open cracks, delamination, and any visible deformity. The tactile assessment and ultra-sonic wave techniques were used to identify the condition of the subsurface of the stucco and the mortar between masonry units. In this study no voids were located. The following graph shows one of the ultra-sonic wave test areas on the foundation wall.

Figure 4 - Ultra-Sonic Test Location of Foundation Wall

To achieve the objectives of this project, the shear wave velocity at different parts of the foundation wall was calculated. The calculated minimum, average, and maximum shear wave velocities were 713 ft/s, 1,478 ft/s, and 2,259 ft/s, respectively. The allowable shear stress was 23 psi. Therefore, the allowable shear strain was:
