Report of Investigations 9455

Blast Vibrations and Other Potential Causes of Damage in Homes Near a Large Surface Coal Mine in Indiana

By David E. Siskind, Steven V. Crum, and Matthew N. Plis

BUREAU OF MINES

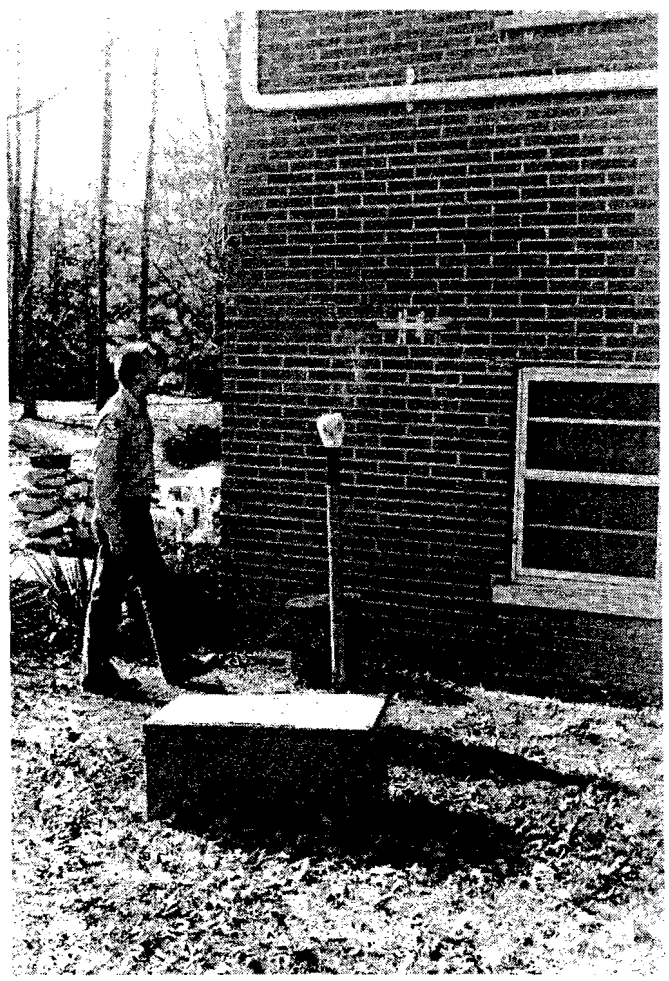
Figure 23.—Displacement gauge placed across outside crack in house 108 prior to Bureau's study.

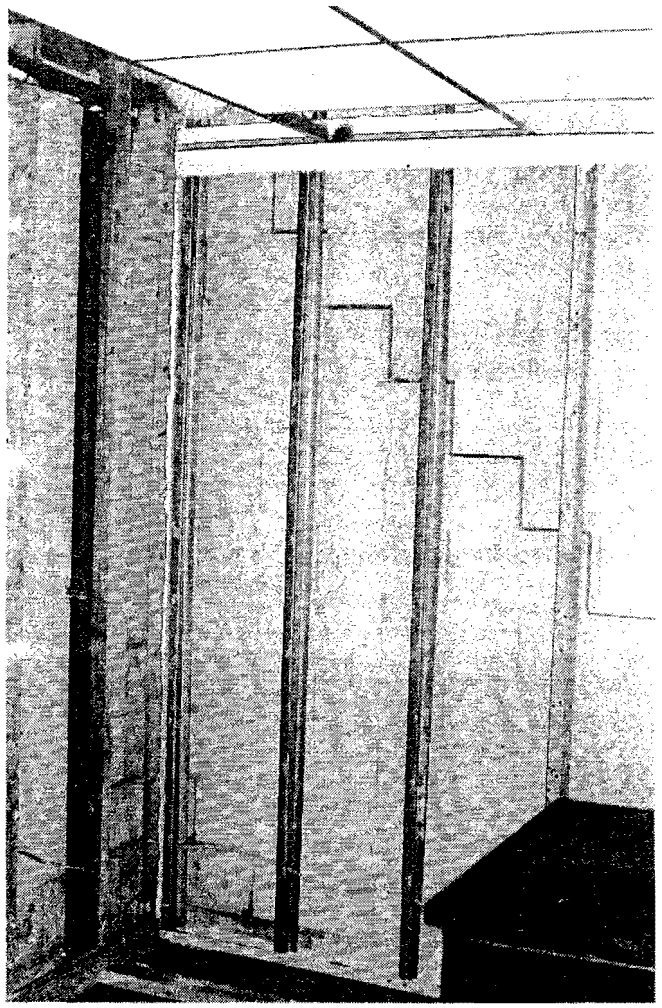
Figure 24.—Basement block wall crack on east wall of house 201.

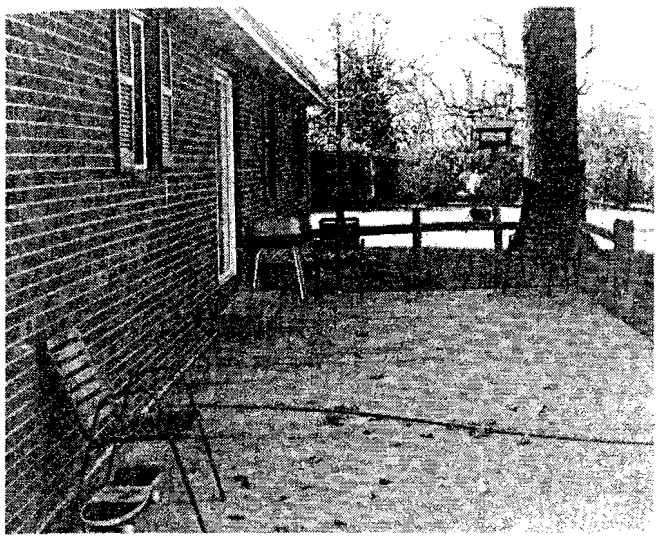
Figure 25.—Uncovered patio at house 201 with tilt toward house's north wall.

Figure 26.—Junction of north wall and patio of house 201 showing evidence of settlement.
