SURVEY OF BLASTING EFFECTS ON GROUND WATER SUPPLIES IN APPALACHIA

UNITED STATES DEPARTMENT OF INTERIOR
BUREAU OF MINES

PHILIP R. BERGER & ASSOCIATES, INC.
BRADFORDWOODS, PENNSYLVANIA 15015

FINAL REPORT

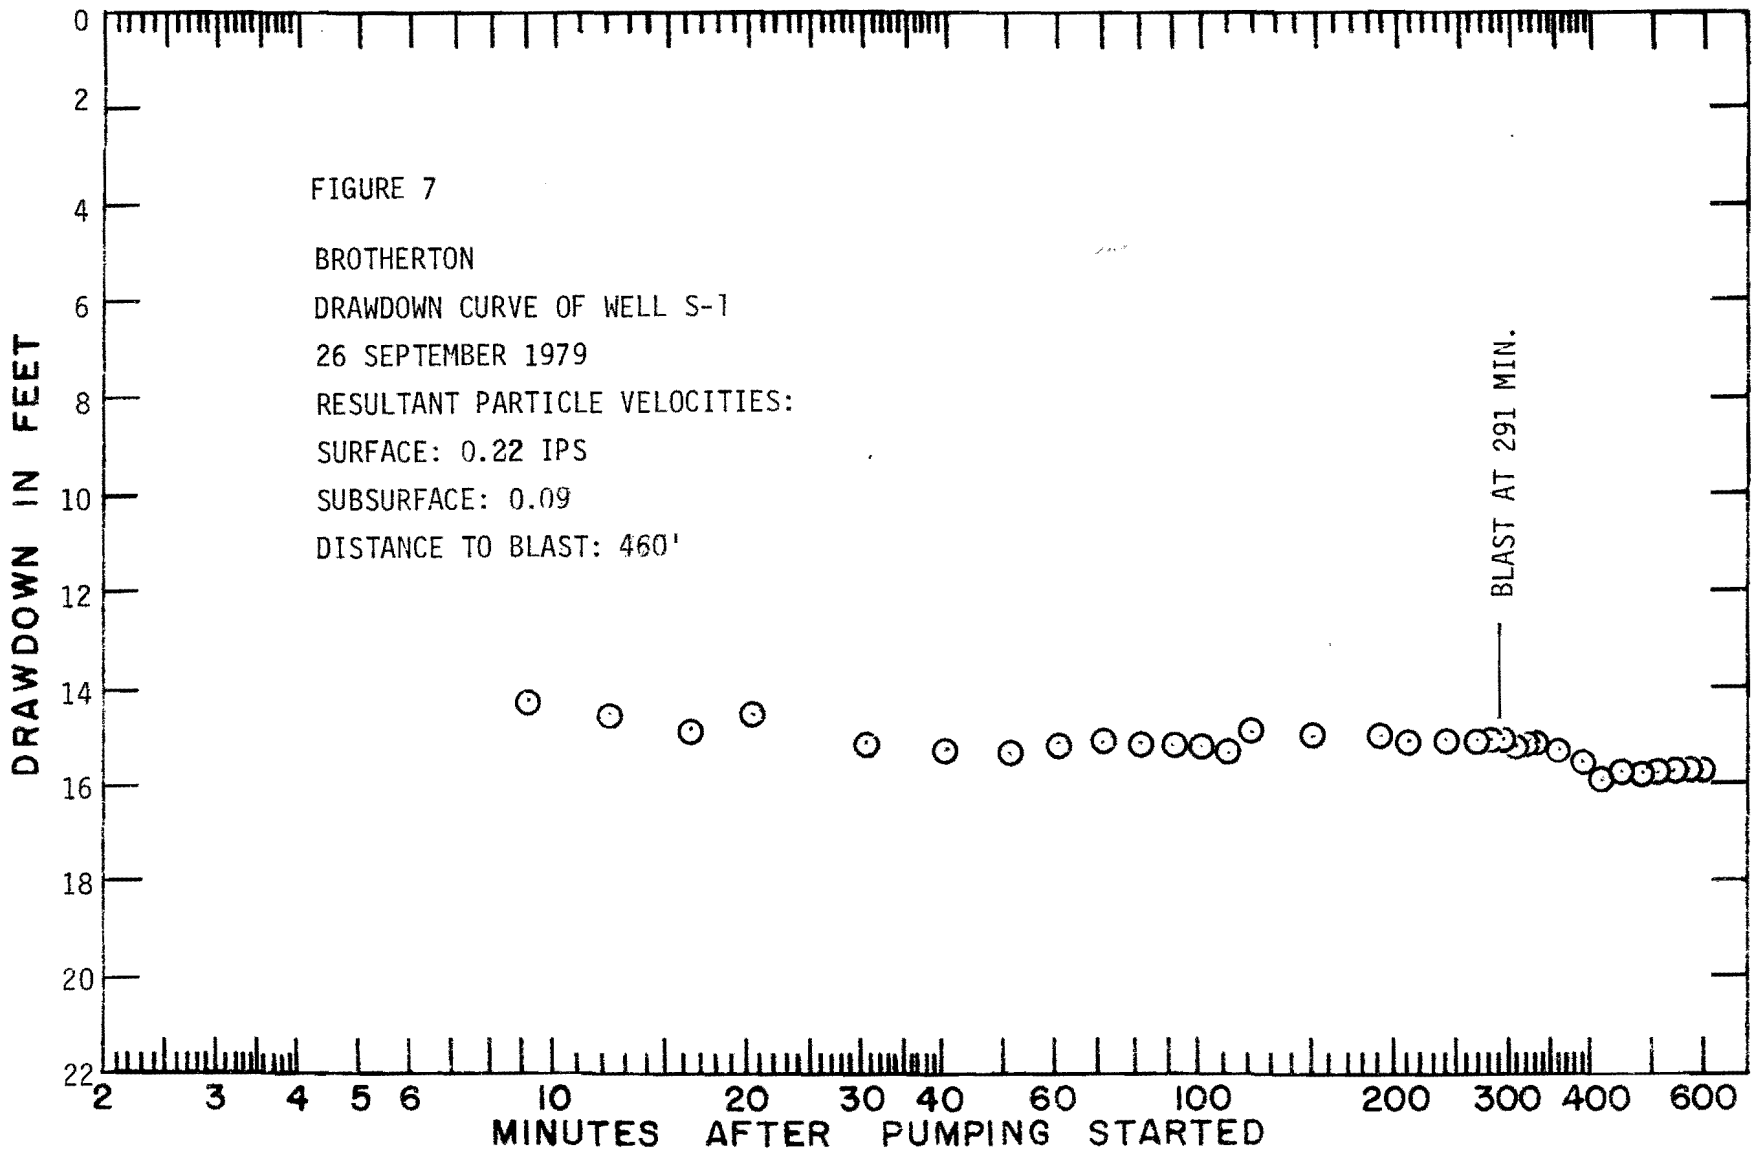
On September 26, 1979, a drawdown test of Well S-1 was conducted while a blast was detonated 291 minutes into the test. Figure 7 is a time-drawdown curve of this test and shows the effect of the blast. There was virtually no immediate effect on the well, if any. Because the changes are in tenths of a foot, the following data gives a more precise measure of the change.

FIGURE 7
BROTHERTON
DRAWDOWN CURVE OF WELL S-1
26 SEPTEMBER 1979
RESULTANT PARTICLE VELOCITIES:
SURFACE: 0.22 IPS
SUBSURFACE: 0.09
DISTANCE TO BLAST: 460'
BLAST AT 291 MIN.
DRAWDOWN IN FEET
0
2
4
6
8
10
12
14
16
18
20
22
2
3
4
5
6
10
20
30
40
60
100
200
300
400
600
MINUTES AFTER PUMPING STARTED

Depth to Water	Net Change
5 minutes before blast	67.94 feet	0 feet
Immediately after blast	67.93 "	+0.01 "
19 minutes after blast	68.15 "	-0.21 "
29 " " "	68.11 "	-0.17 "
39 " " "	68.10 "	-0.16 "
69 " " "	68.30 "	-0.36 "
99 " " "	68.74 "	-0.80 "

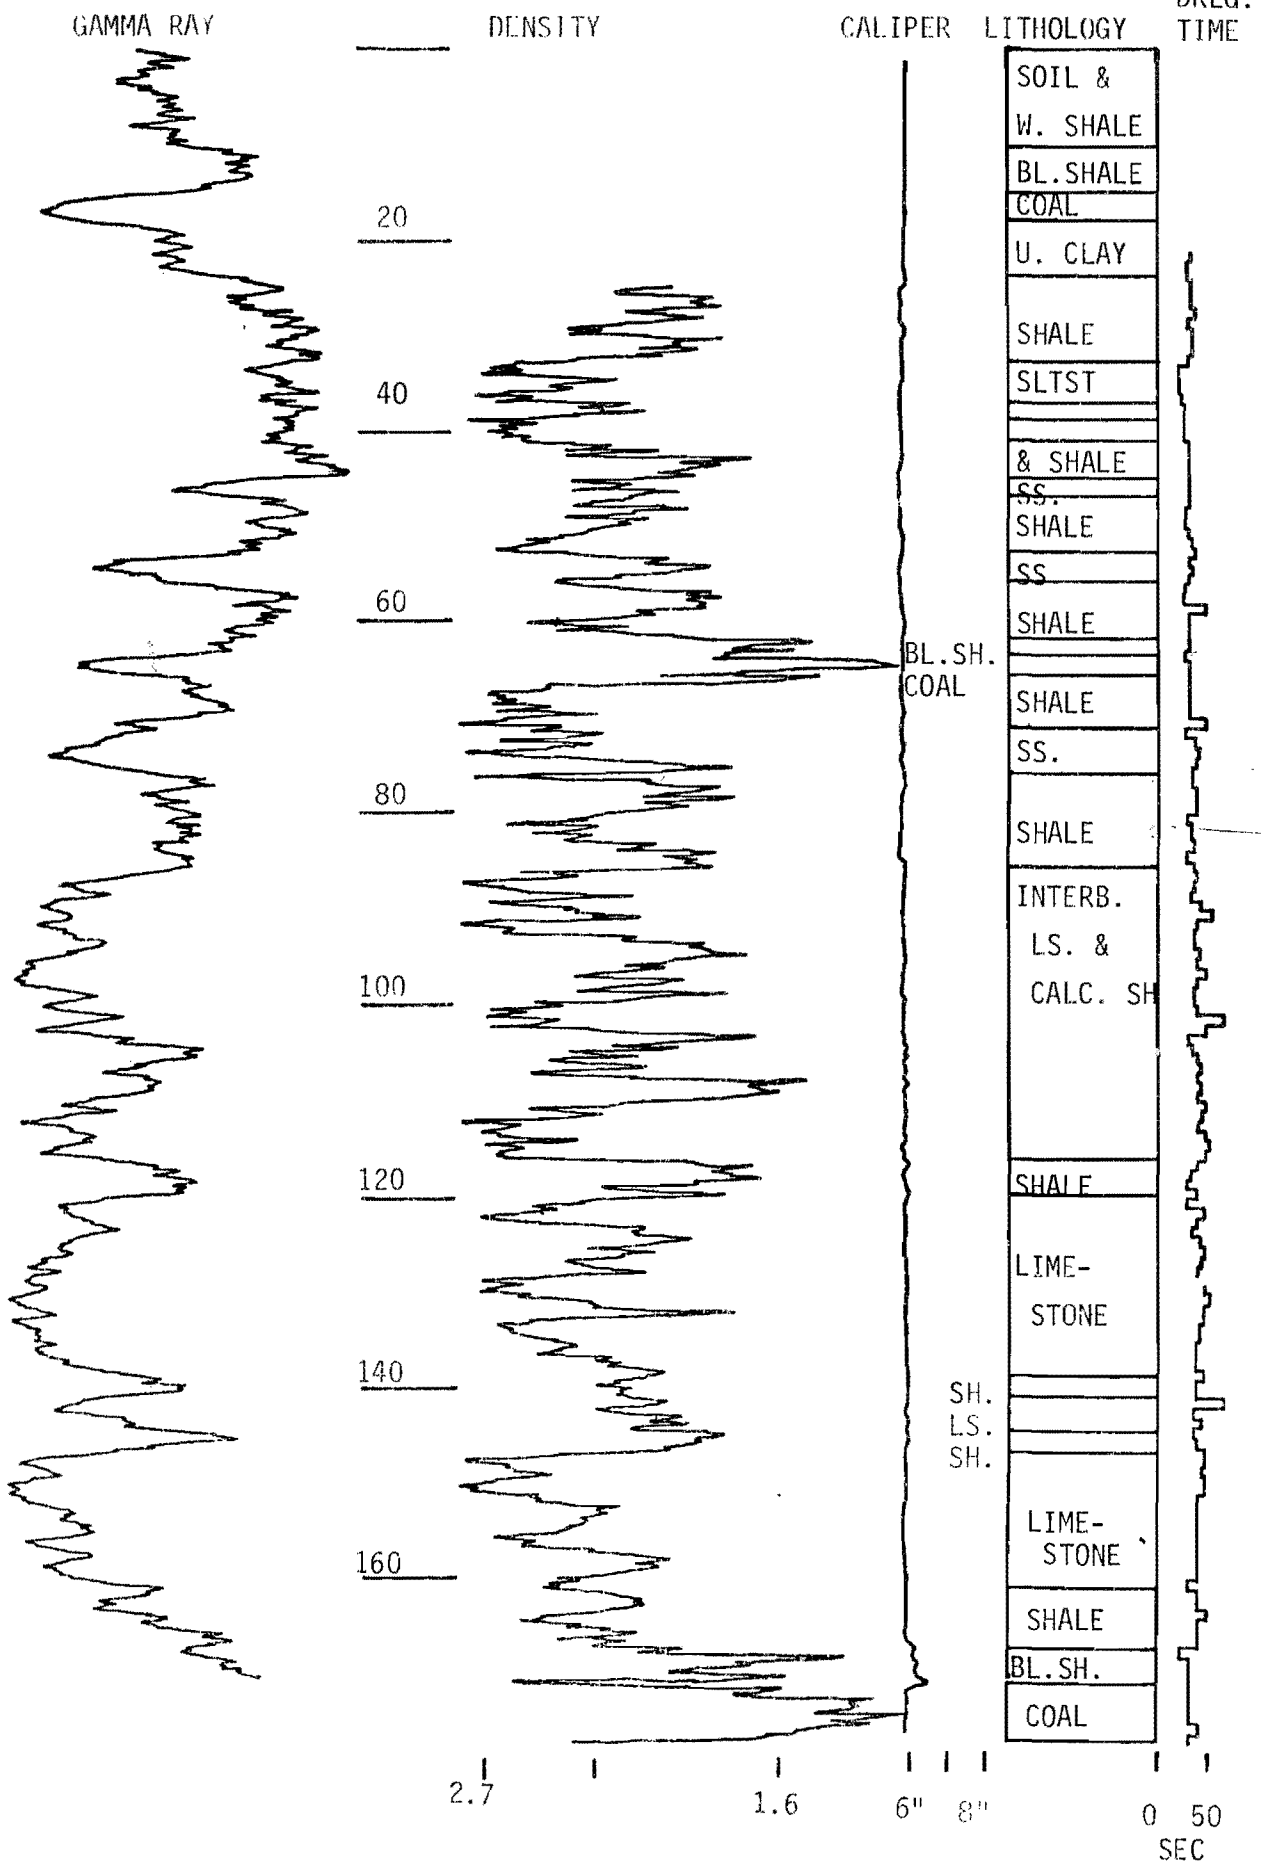
In addition to the drilling time and lithologic logs made at the time of the drilling, gamma ray, caliper, and density logs were run on Wells S-1 and D-1. Caliper logs were run on all of the others. Figure 45 is a composite of all these logs.

FIGURE 45. COMPOSITE WELL LOG ST. CLAIRSVILLE SITE
