Assessment of Stream Resources at Regulated Coal Mining and Remining Sites in Ohio

Robert Baker¹, Tarunjit Butalia¹, Chin-Min Cheng¹, Cheryl Socotch²

¹The Ohio State University, Department of Civil, Environmental, and Geodetic Engineering, 2070 Neil Ave., Columbus, OH 43210; ²OhioDNR - Division of Mineral Resources Management

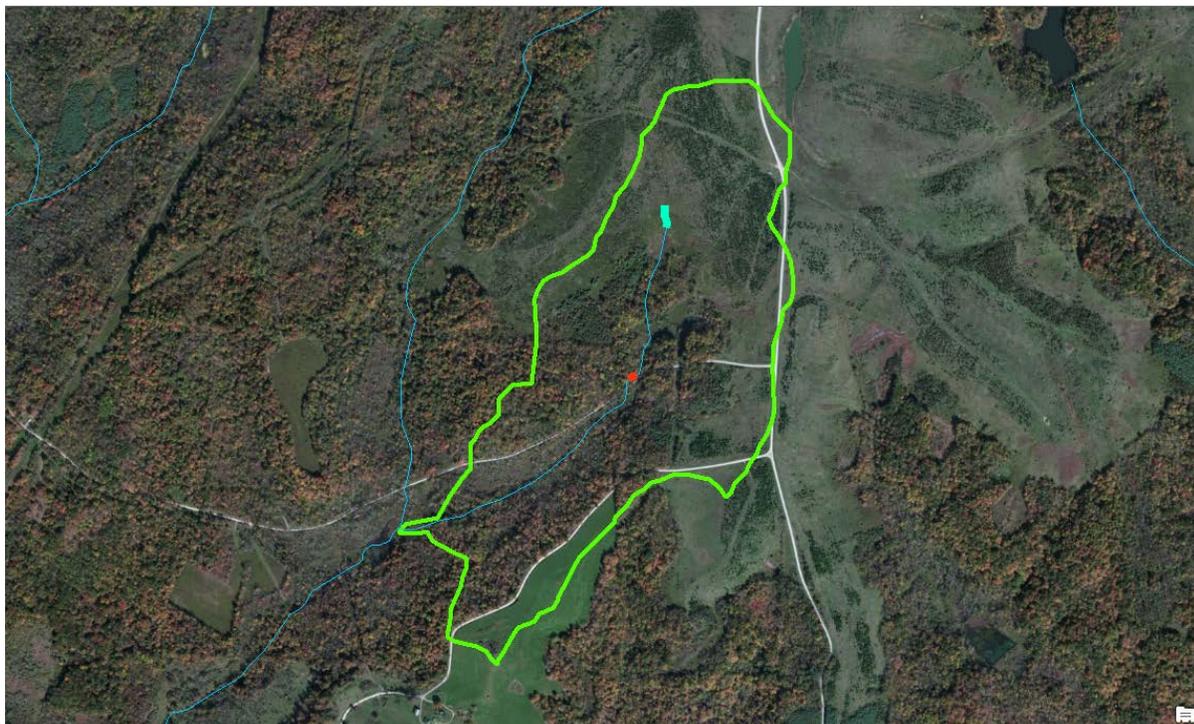
Figure 2. Reconstructed stream reach (turquoise area) and biological assessment site (red spot) locations at C-0209

The mining in the area was conducted in 1970's. After mining was completed in 1979, spoil was graded to approximate original contours and covered with 8 inches of resoiling material. A total of 683 acres were affected on the permit. The stream segment investigated for this site is located in Muskingum County within the Meigs creek watershed. The tributary watershed is depicted in Figure 2. The turquoise area represents the stream reach that only HHEI was studied (reconstructed stream reach) and the red spot represents the stream segment where biological assessment was carried out (bio assessment site).

For this stream reach there was a large amount of tree growth observed in riparian zone. There was marginal tree growth near the head of the stream reach, however, in the lower two thirds downstream there were trees that had circumferences of 25, 29, 32, 38, and 44 inches showing substantial growth and vitality.

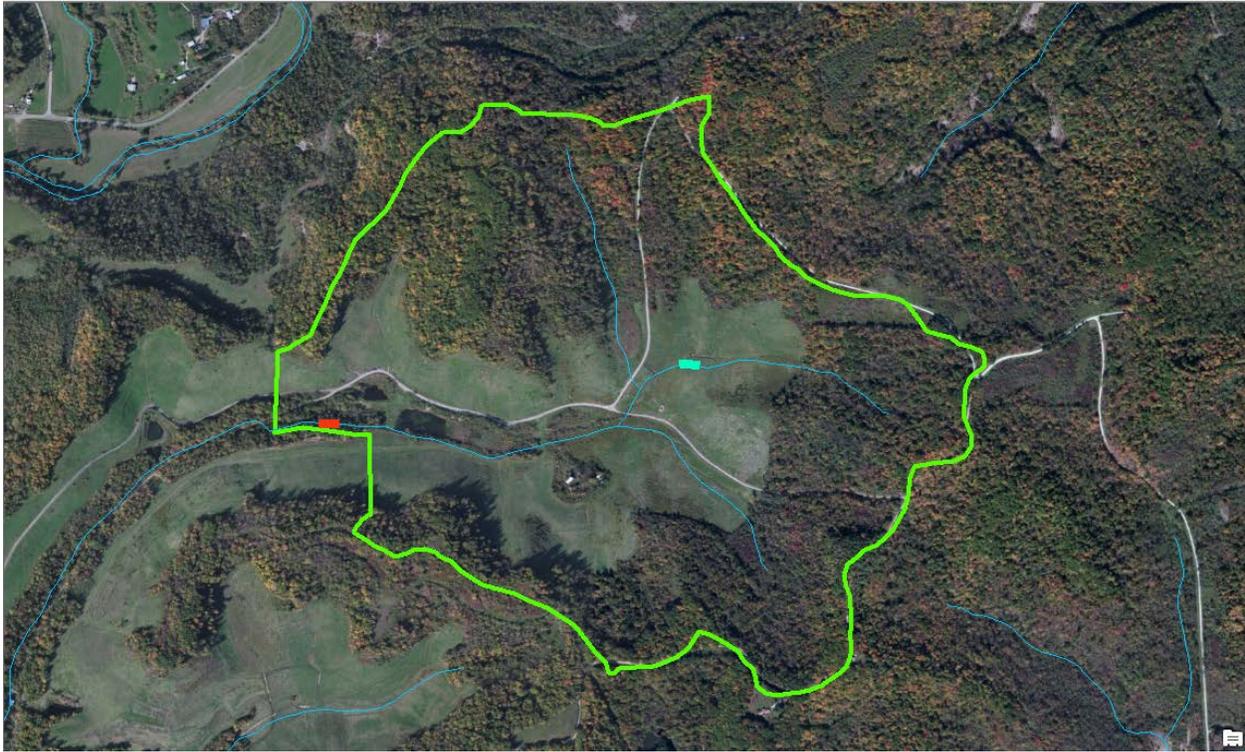
Figure 4. Reconstructed stream reach (turquoise area) and biological assessment site (red area) and biological assessment site locations at D-0807

This reconstructed stream segment is located within the East Fork Duck Creek watershed. The tributary watershed is depicted in Figure 4. The turquoise area represents the reconstructed stream reach and the red area represents the stream segment where biological assessment was conducted. The reconstructed reach has a drainage area of 0.15 square miles based on its location within the tributary watershed. According to StreamStats, the overall drainage area depicted above is about 0.58 square miles. The reconstructed stream reach has a slope of 1% and an annual mean precipitation of 39.6 inches. The HHEI score for the reconstructed stream reach was 35.

The summary HHEI score for the stream segment where the biological assessment was carried out is 73. This biological stream segment is located 4,120 feet downstream of the reconstructed stream channel. According to Ohio's PHWH classification, this stream segment can be classified as a Class 3 PHWH (Perennial). A riparian width of greater than 10 meters on the left bank and a riparian width of less than 5 meters on the right bank was observed. On both banks of the biological stream reach there was a floodplain quality of a mature forest or wetland. At the time of the reach observation the stream regime was stream flowing. The stream had an observed sinuosity of 2 and had an observed stream gradient of 2.5 ft/100 ft which is between 2 ft and 10 ft per 100 ft meaning the stream reach has a gradient of moderate to severe.

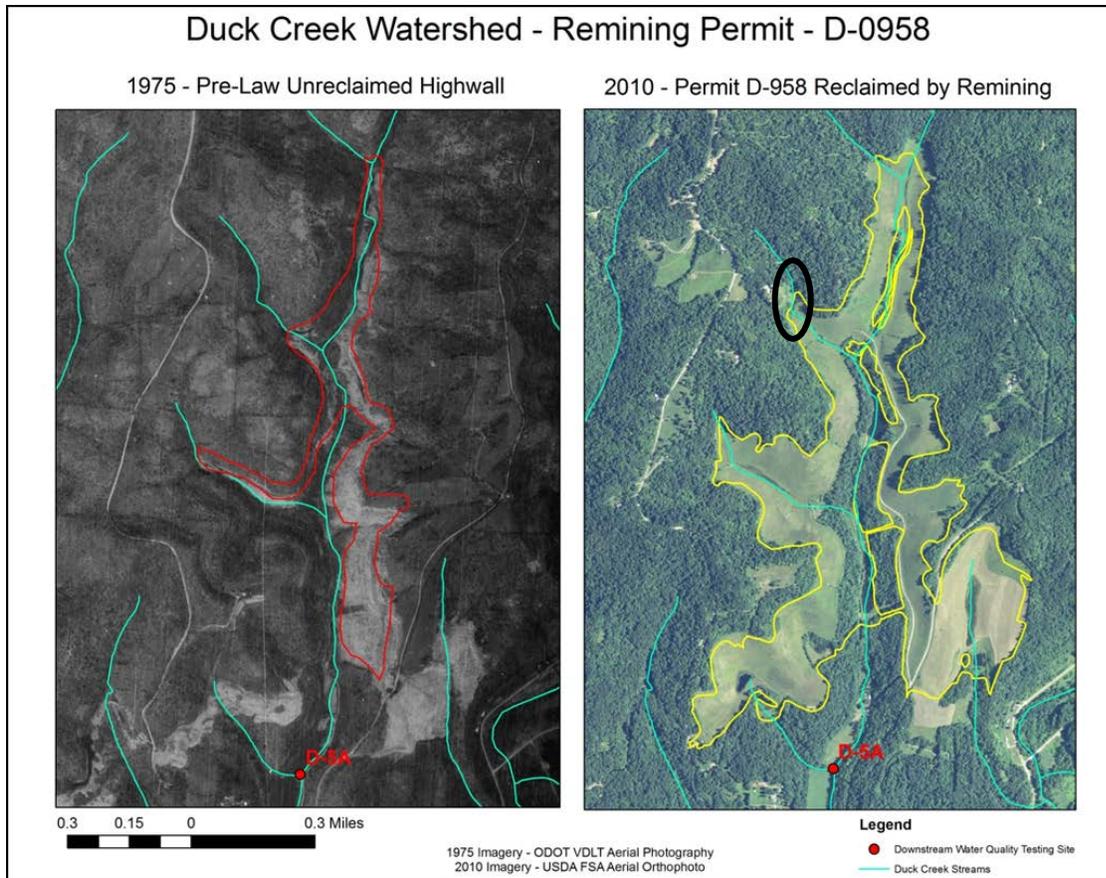
Figure 7. Remining, highwall elimination, and reconnected stream (black oval) D-0958

This permit was a remining secondary coal recovery operation utilizing pan & dozers to advance and eliminate approximately 12,840 linear feet of unreclaimed highwall and extract the #9 and 9a coal reserves. The site was resoiled with eight inches of suitable alternative resoiling material. Figure 7 depicts the location of the stream segment reconstructed which also reconnected the stream segment with the unaffected drainage area. The natural drainage system was interrupted by past mining practices that left an unreclaimed highwall and pit complex. The Year 6 segment containing the reconstructed stream was planted in 1998 and released in 2003 by ODNR.

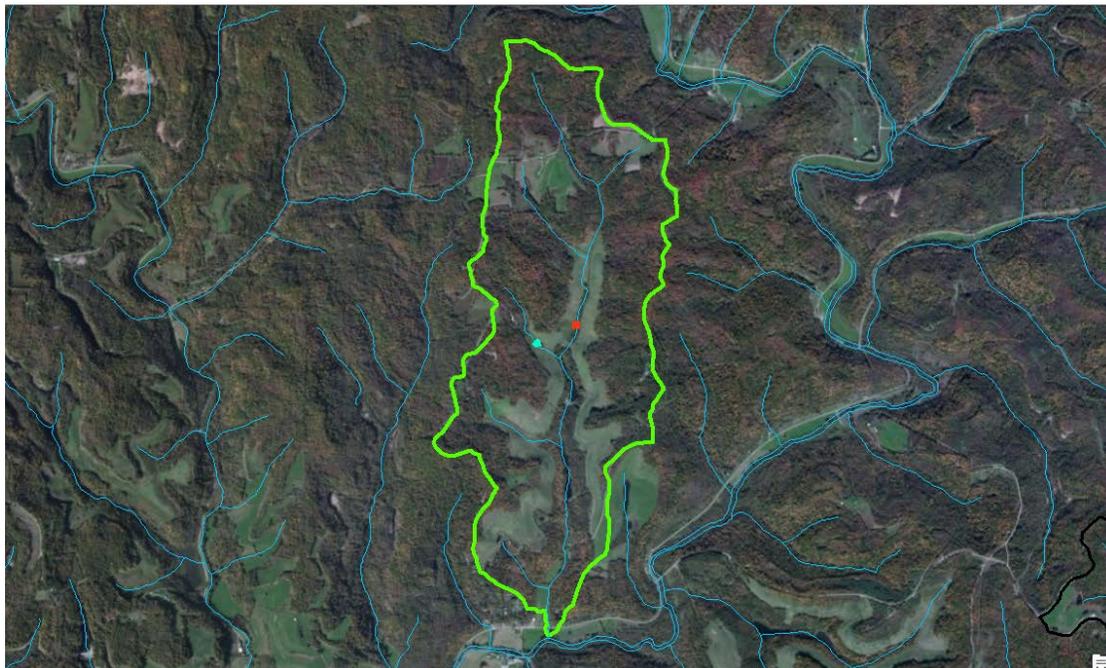
Figure 8. Reconstructed stream reach (turquoise area) and biological assessment site (red area) and biological assessment site locations at D-0958

This stream segment is located in Noble County within the East Fork Duck Creek watershed. The tributary watershed is depicted in Figure 8. The turquoise line represents the reconstructed stream reach and the red line represents the biological stream that was analyzed.
