## U.S. DEPT. OF THE INTERIOR OFFICE OF SURFACE MINING Mine Site Inspection Federal Program

Permittee:	Crimson Oak Grove Resources, LLC	
Permit Number:	Alabama P-3232	
Mine Name:	Oak Grove Mine	
Date of Inspection:	November 6, 2024	
Type of Inspection:	Federal Inspection - Partial	
Inspector:	Jeff Hosselton (#115)

## **Inspection Narrative:**

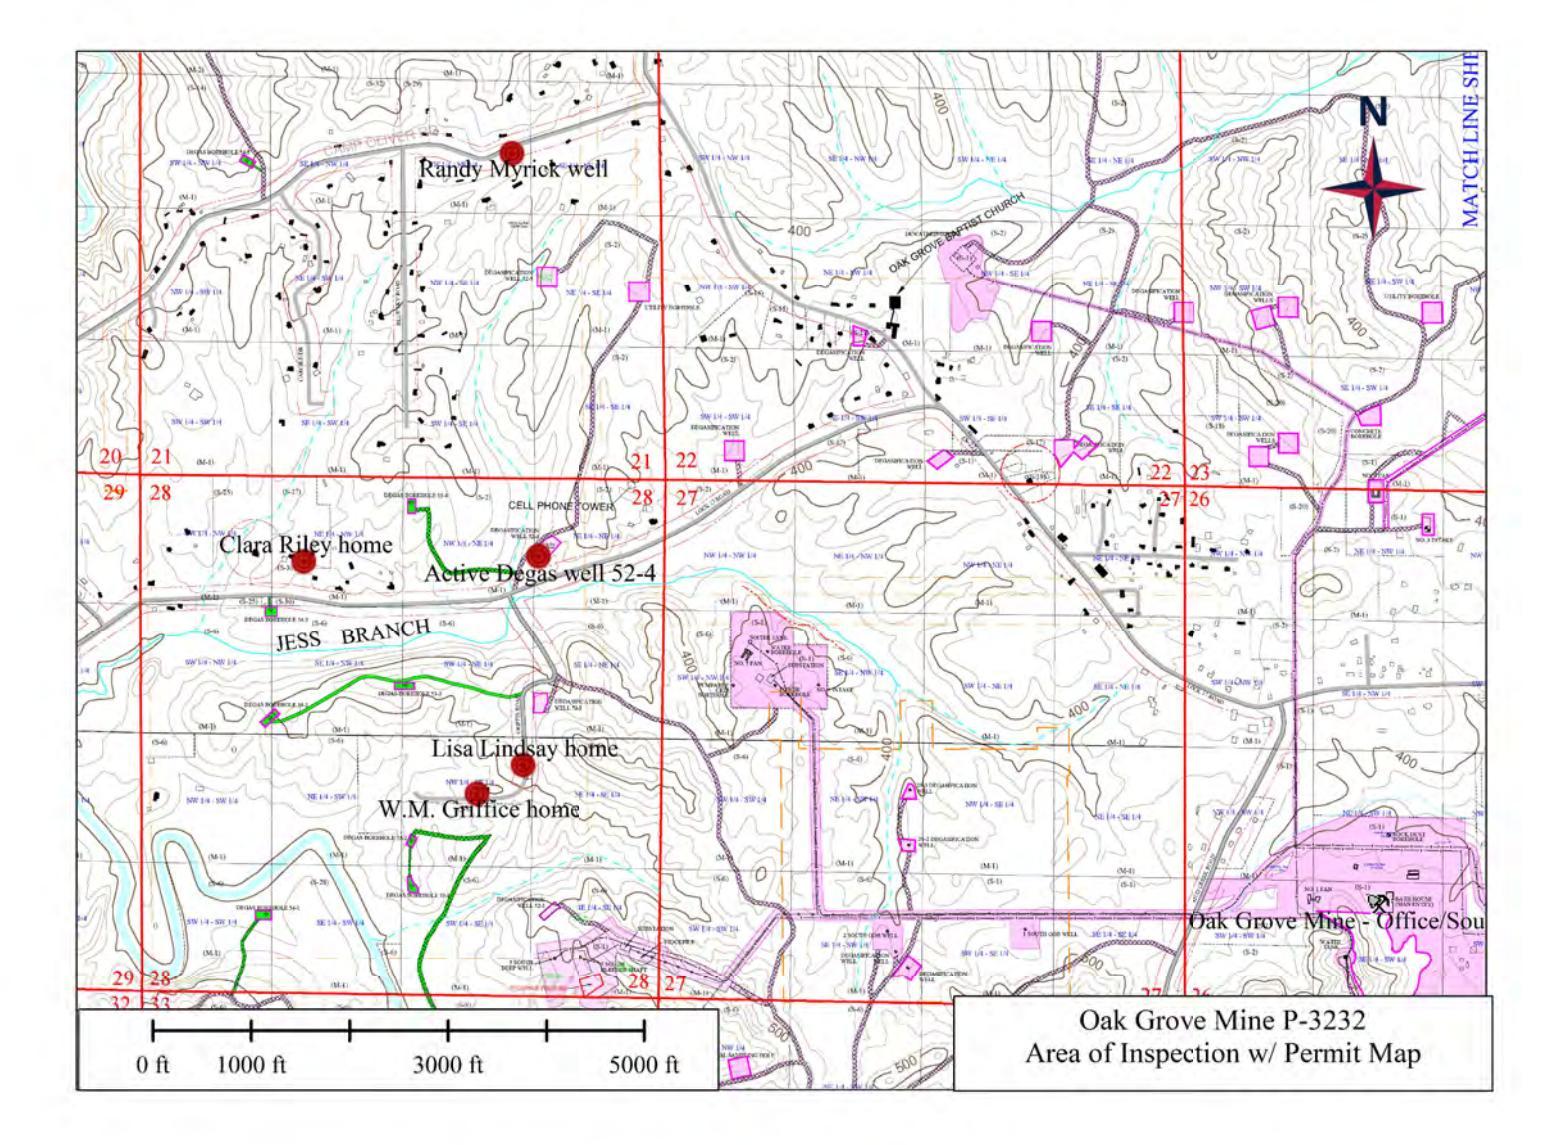
The second site visited was the home of Mrs. Lisa Lindsay at 2290 Griffis Road, Adger, Alabama. This home was just around the corner from Mr. Griffice's home. Mrs. Lindsay has a current subsidence complaint pending with the Oak Grove Mine. Typically, the coal company waits four to six months after mining to initiate repairs to the home. Mrs. Lindsay showed Mr. Hicks, Mr. Kiser, and me around the foundation of the home where most of the subsidence damage is located. See Photo ID #60868. Mr. Hicks took a reading with the multi-gas monitor under the crawl space the Lindsay home. The meter did not detect any gas under the home. See Photo ID #60869. The attached photos show the foundation cracks that concern Mrs. Lindsay and Brian Hicks testing for gas.

<image/>	Notes: This photo shows Brian Hicks testing for gas at the Lindsey home. The photo also shows the suspected subsidence cracks in the foundation. Photo ID: 60868 Photographer: SMJHOSSELTON Date Taken: 11/6/2024 State: AL
<image/>	Notes: This photo shows Brian Hicks testing for gas at the Lindsey home. The photo also shows the suspected subsidence cracks in the foundation. Photo ID: 60868 Photographer: SMJHOSSELTON Date Taken: 11/6/2024 State: AL County: JEFFERSON Latitude: 0.0000000
<image/>	Notes: This photo shows Brian Hicks testing for gas at the Lindsey home. The photo also shows the suspected subsidence cracks in the foundation. Photo ID: 60868 Photographer: SMJHOSSELTON Date Taken: 11/6/2024 State: AL County: JEFFERSON Latitude: 0.0000000 Longitude: 0.0000000
With the second seco	Notes: This photo shows Brian Hicks testing for gas at the Lindsey home. The photo also shows the suspected subsidence cracks in the foundation. Photo ID: 60868 Photographer: SMJHOSSELTON Date Taken: 11/6/2024 State: AL County: JEFFERSON Latitude: 0.0000000 Longitude: 0.0000000

In addition, I recommend immediate monitoring consistent with 30 CFR 784.20(b)(4) and 817.121(a)(2) and the OSMRE report "U.S. DEPT. OF THE INTERIOR, OFFICE OF SURFACE MINING – TECHNICAL MEASURES FOR THE INVESTIGATION AND MITIGATION OF FUGITIVE METHANE HAZARDS IN AREAS OF COAL MINING". The referenced report indicates:
