Yankee-Vukonich Gob Reclamation Project (during-construction).

Lake Valley AML Reclamation Project overview.

Gold Hill AML Safeguard Project – Site Overview.

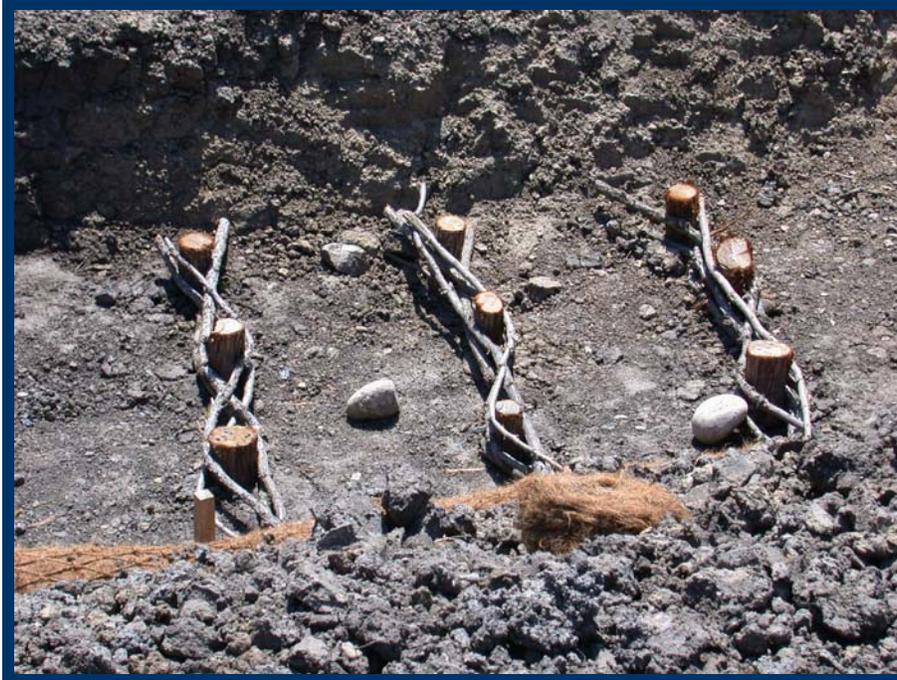
Wood Anchors to support Channel Grade Control.

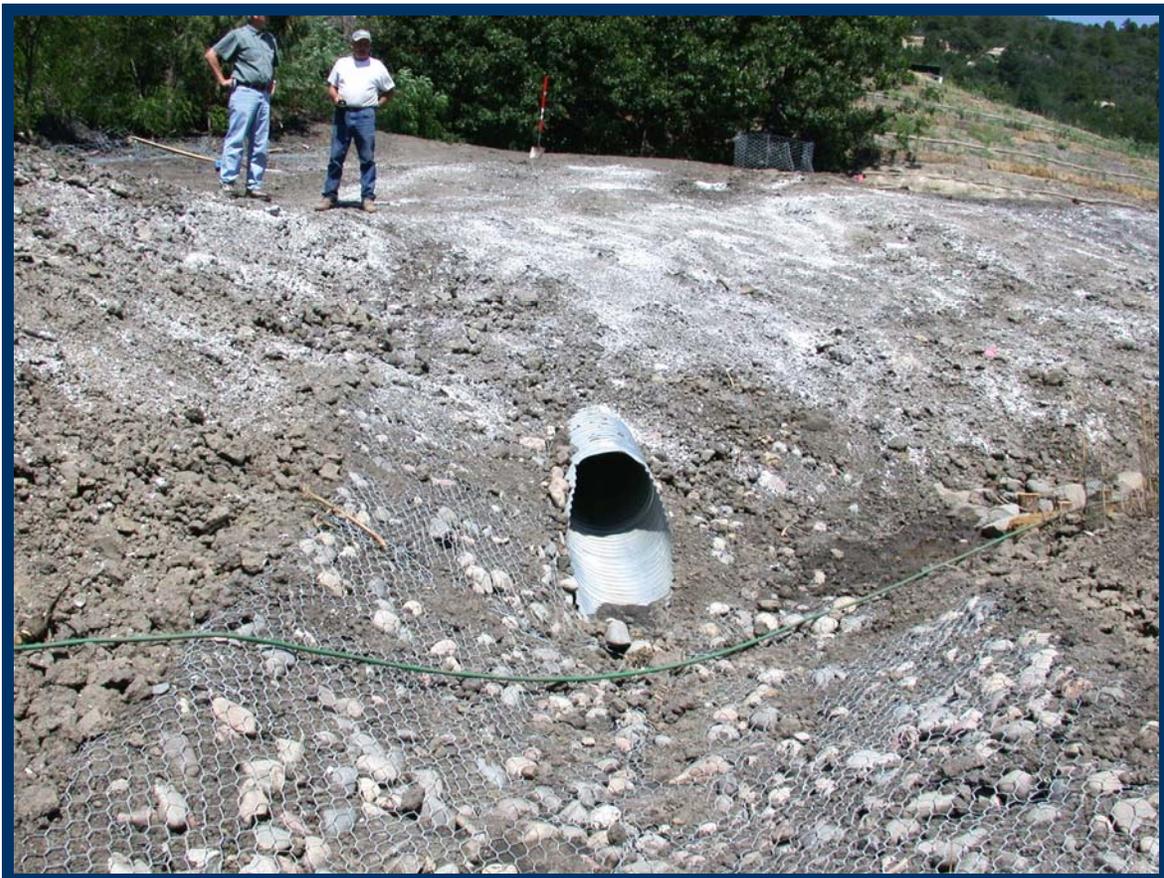
Metal Culvert Outlet into RipRap & Metal Fabric Channel with Soil Amendment.

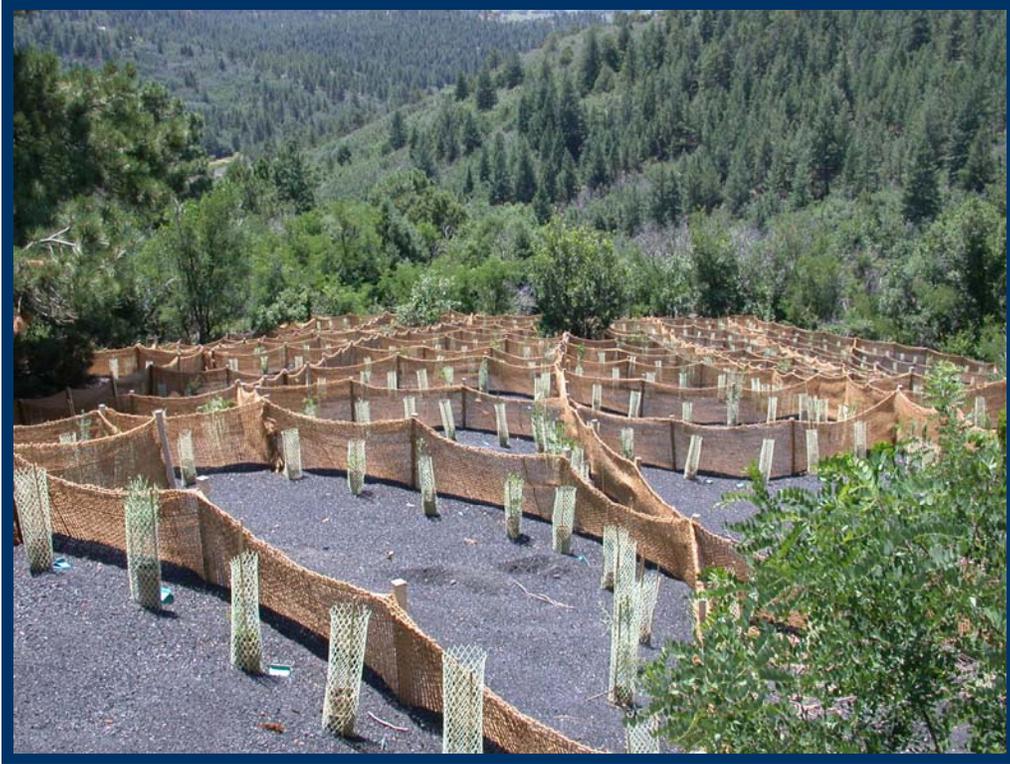
Diamond Pattern Fabric Fencing for Erosion Control.

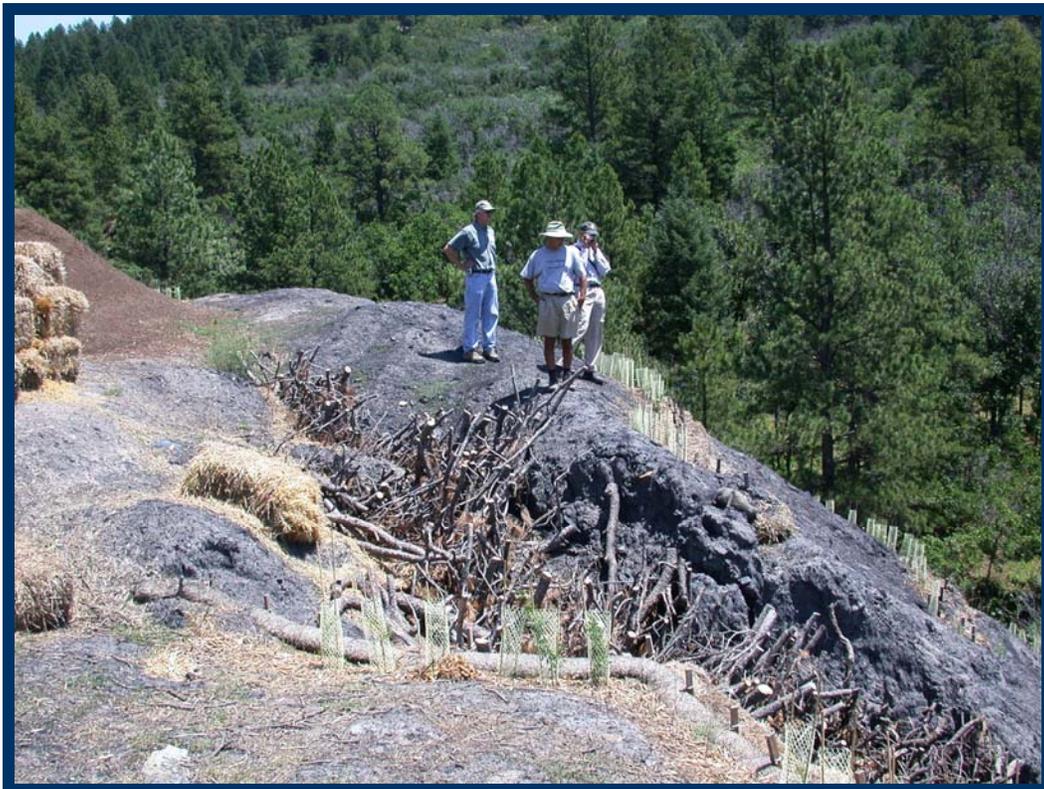
Branch Packing in Erosion Channel for Stabilization.

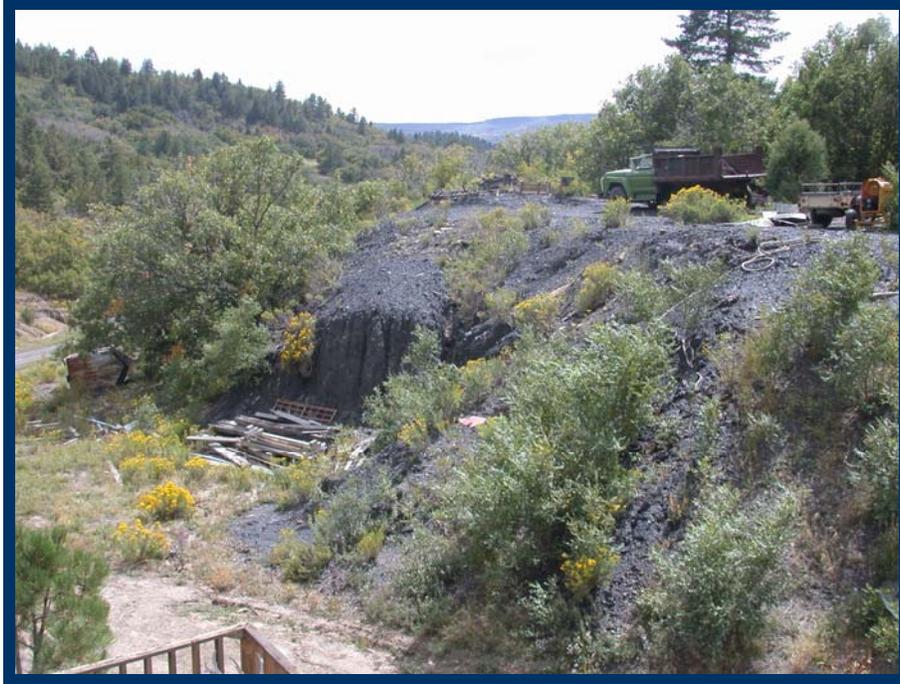
Yankee-Vukonich Gob Reclamation Project – Before Reclamation.

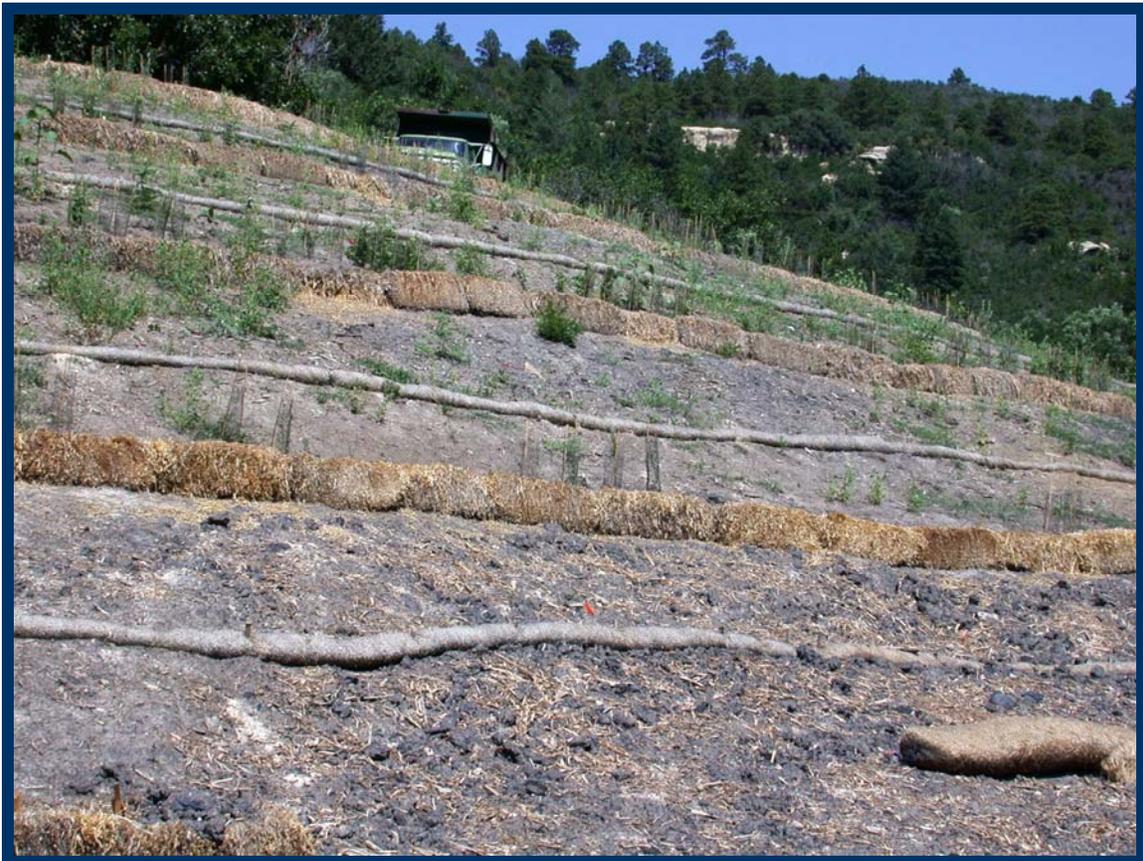
Yankee-Vukonich Gob Reclamation Project – After Reclamation

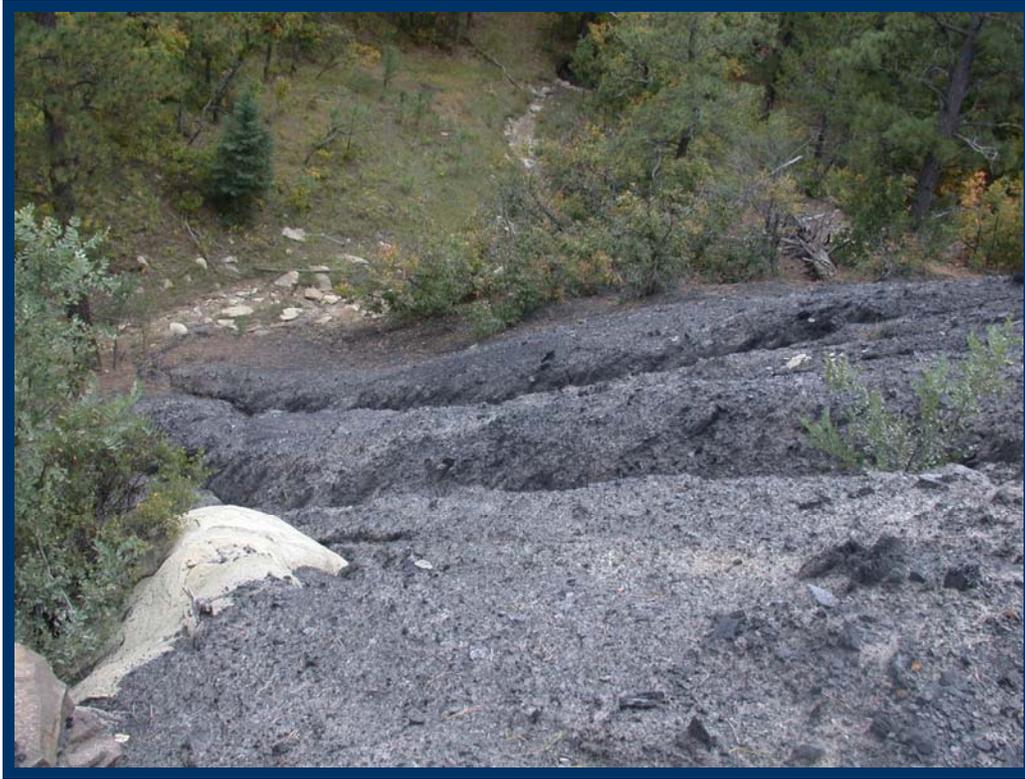
Yankee-Vukonich Gob Reclamation Project – Before Reclamation.

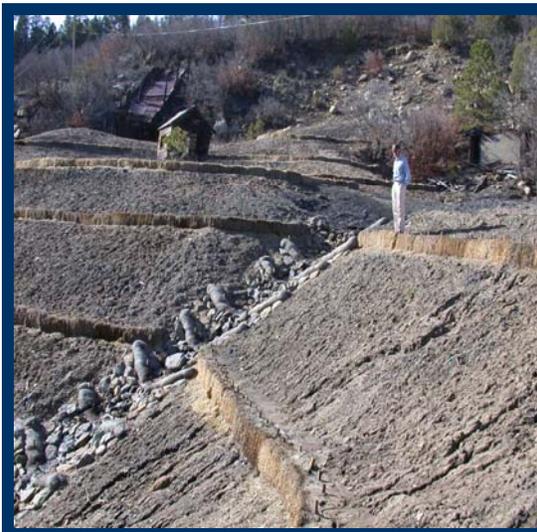
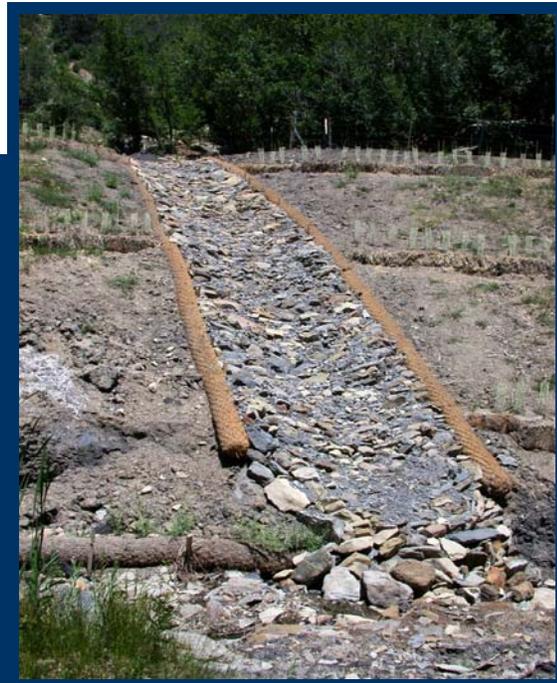
After Reclamation.

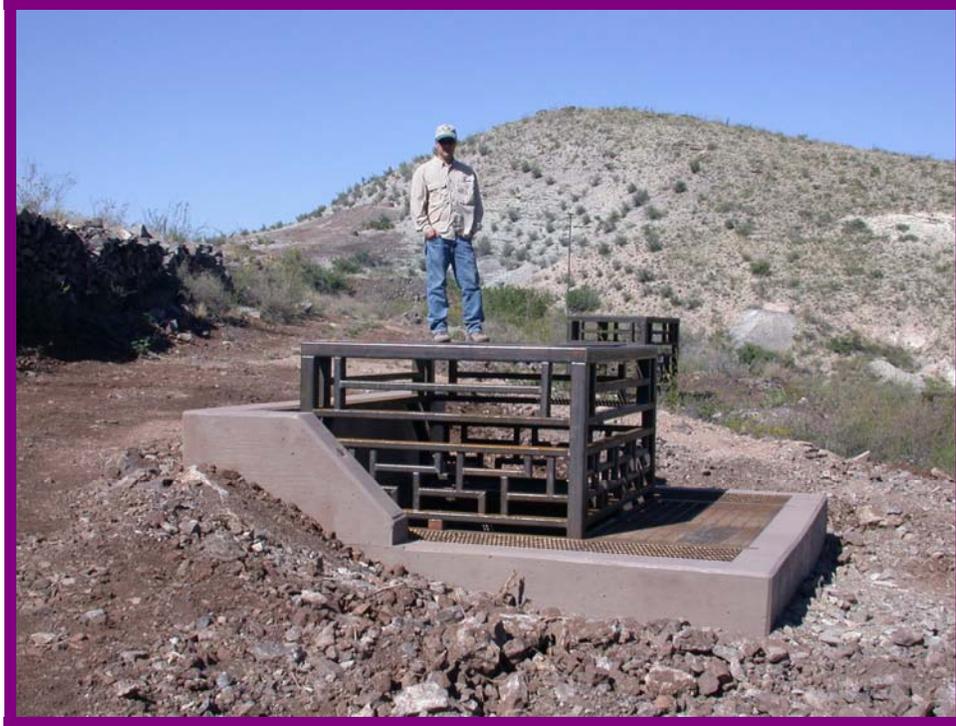
Loyd Moiola atop Bat Cupola at Lake Valley Reclamation Project.  
The concrete foundation was dyed to blend into landscape.

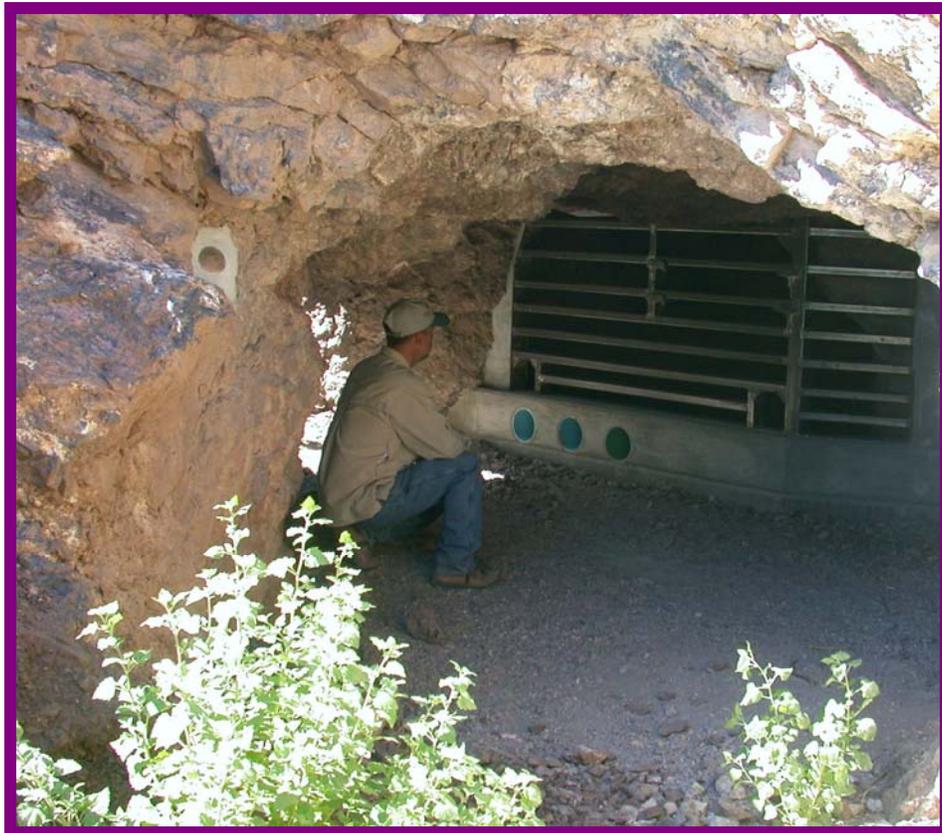
Bat gate with small animal access and water drain outlets

at Lake Valley AML Reclamation Project.

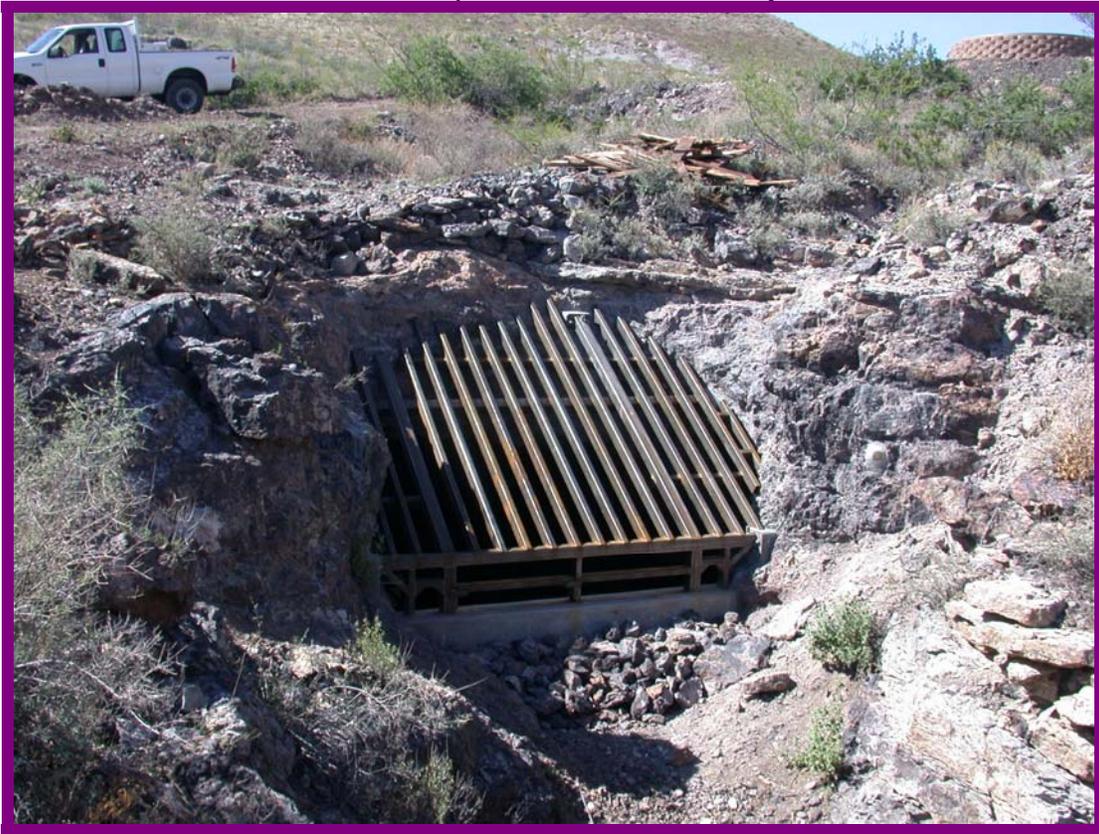
Air-vent closure at Lake Valley AML Reclamation Project.

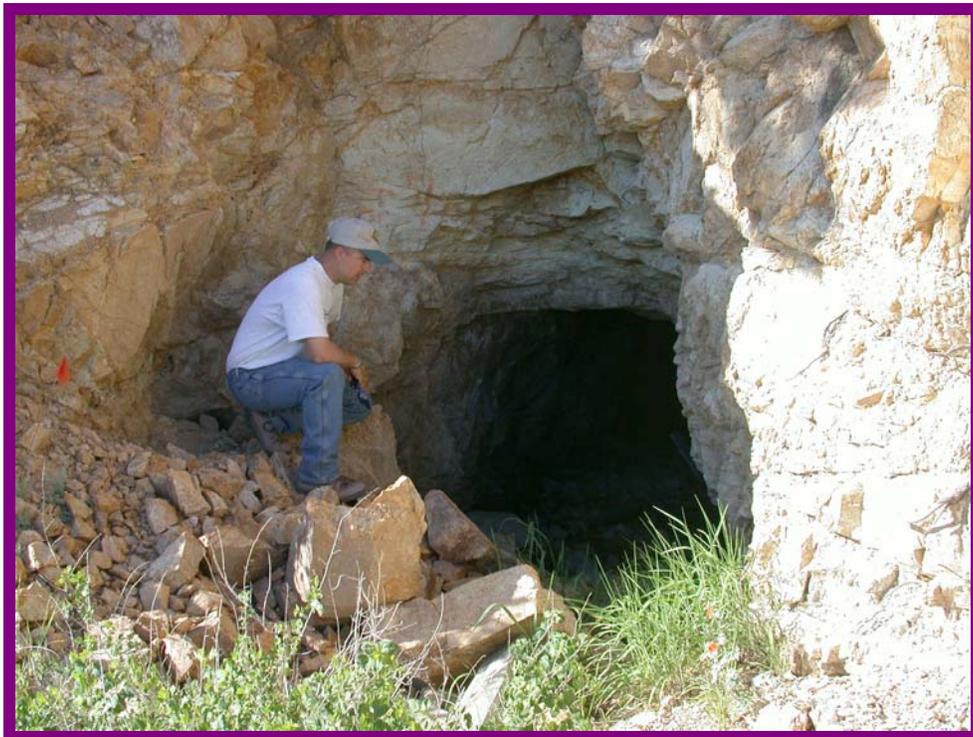
Gold Hill- Open portal, to be reclaimed / safeguarded.

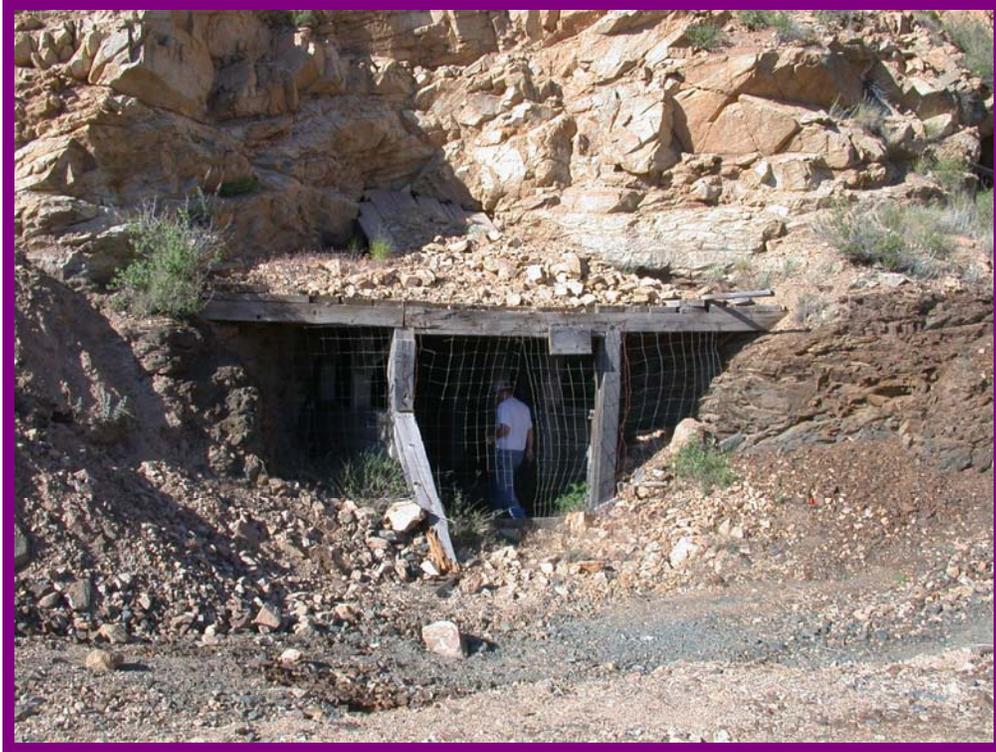
Mine drift-opening on hillside at Gold Hill AML safeguard project.  
(To be reclaimed / safeguarded)

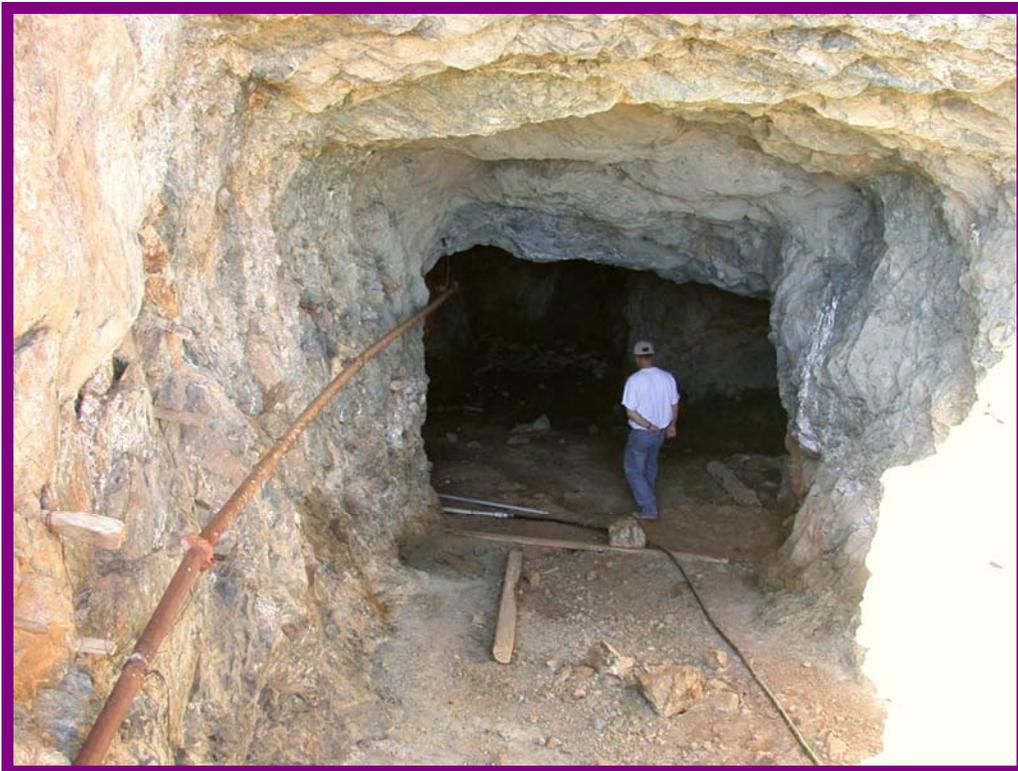
Open portal at Gold Hill AML Safeguard Project.  
(To be reclaimed / safeguarded)
