**2004 Abandoned Mine Lands
Reclamation Awards**

Brier Ridge Burning Gob Pile

Village of Dillonvale, Jefferson County, Ohio

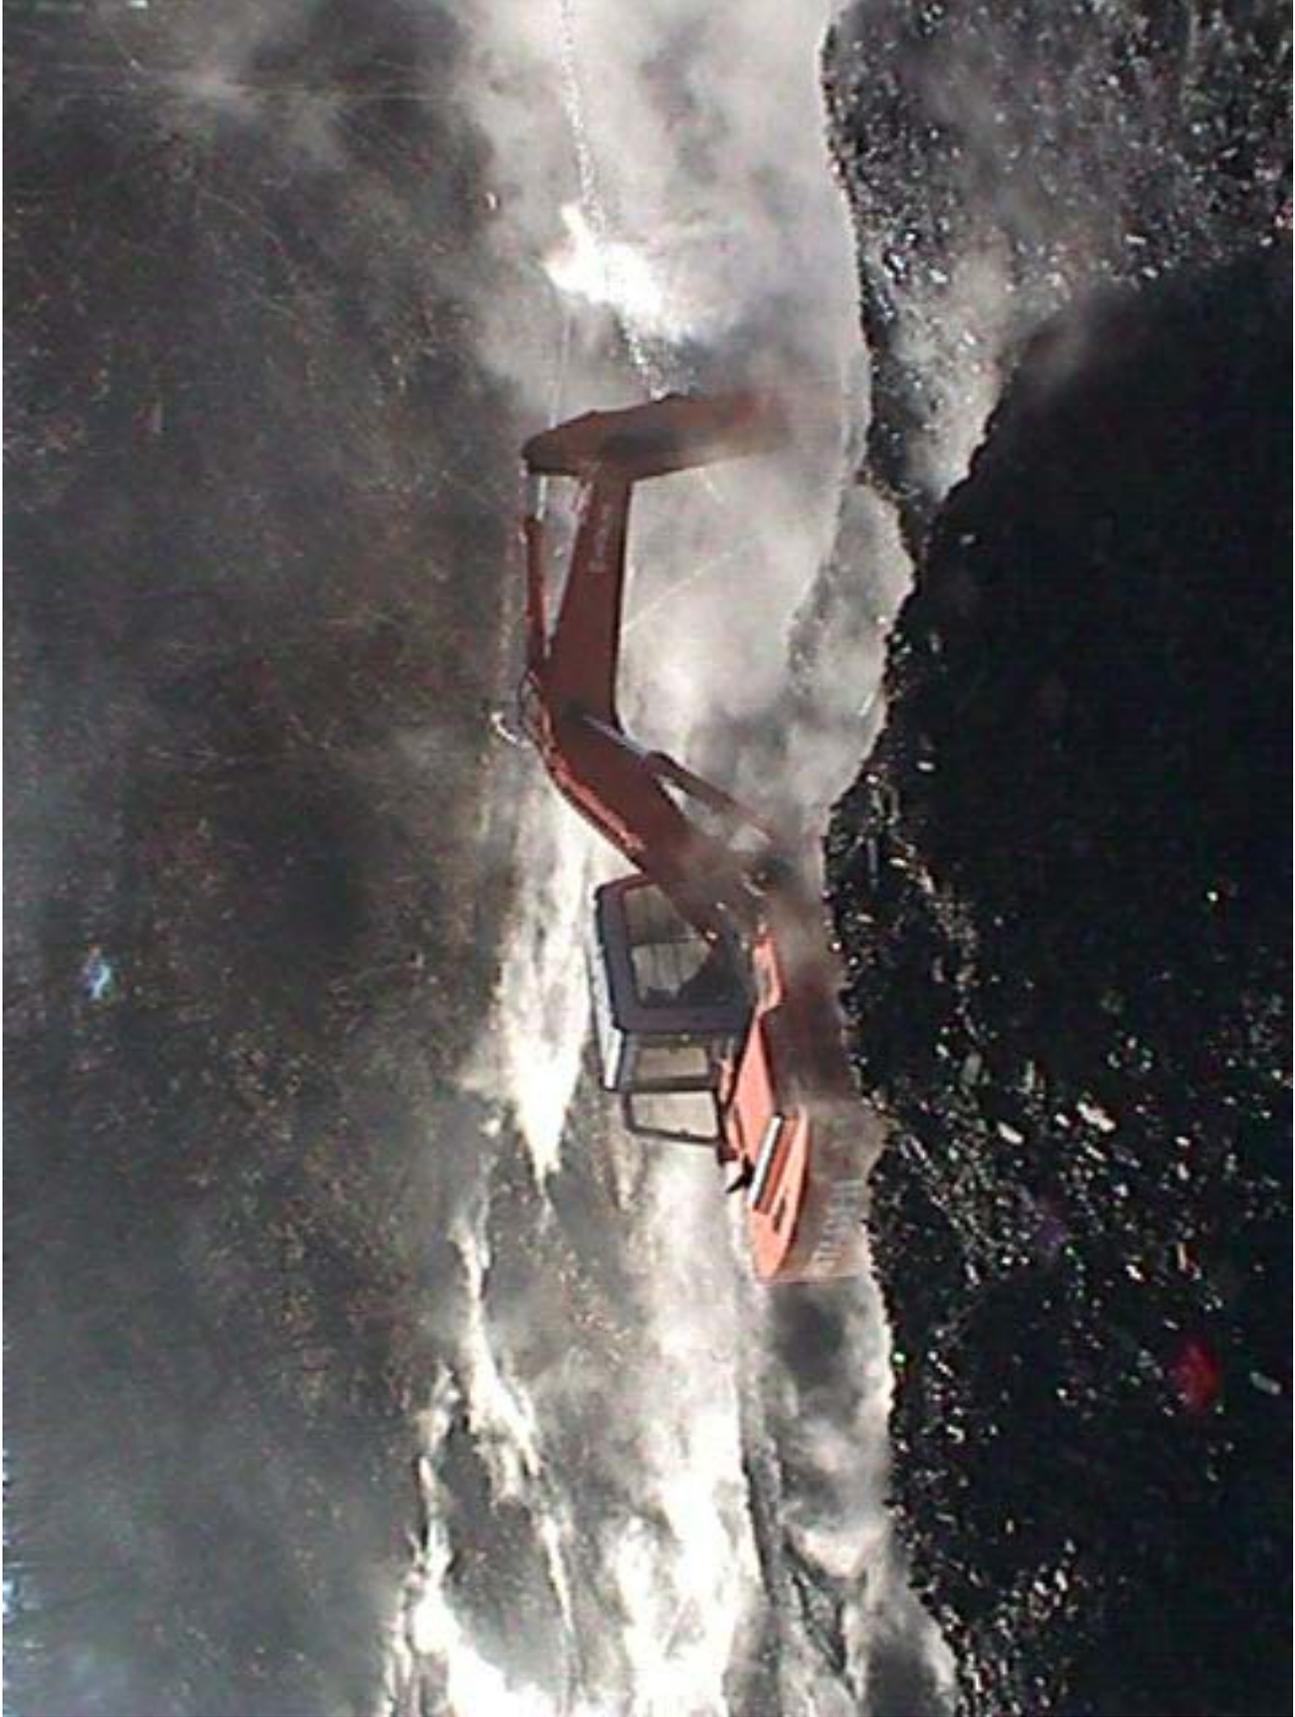
Cover Photograph: Date - February 10, 2002. Hazards associated with extinguishing the burning gob fire range from noxious gases and acidic steam to superheated conditions causing hydrogen gas explosions to occur without warning.

The contractor and his crew were faced with many hazards and obstacles in the process of extinguishing the fire. The noxious gases and steam required them to wear protective masks. The application of the water to the burning gob created superheated steam and caused hydrogen gas explosions to occur without warning. (*See Photograph #3.*) The acidic steam caused the electrical connections on the operator's equipment to corrode and malfunction. In addition, the heat from the fire scorched the paint on the contractor's equipment.

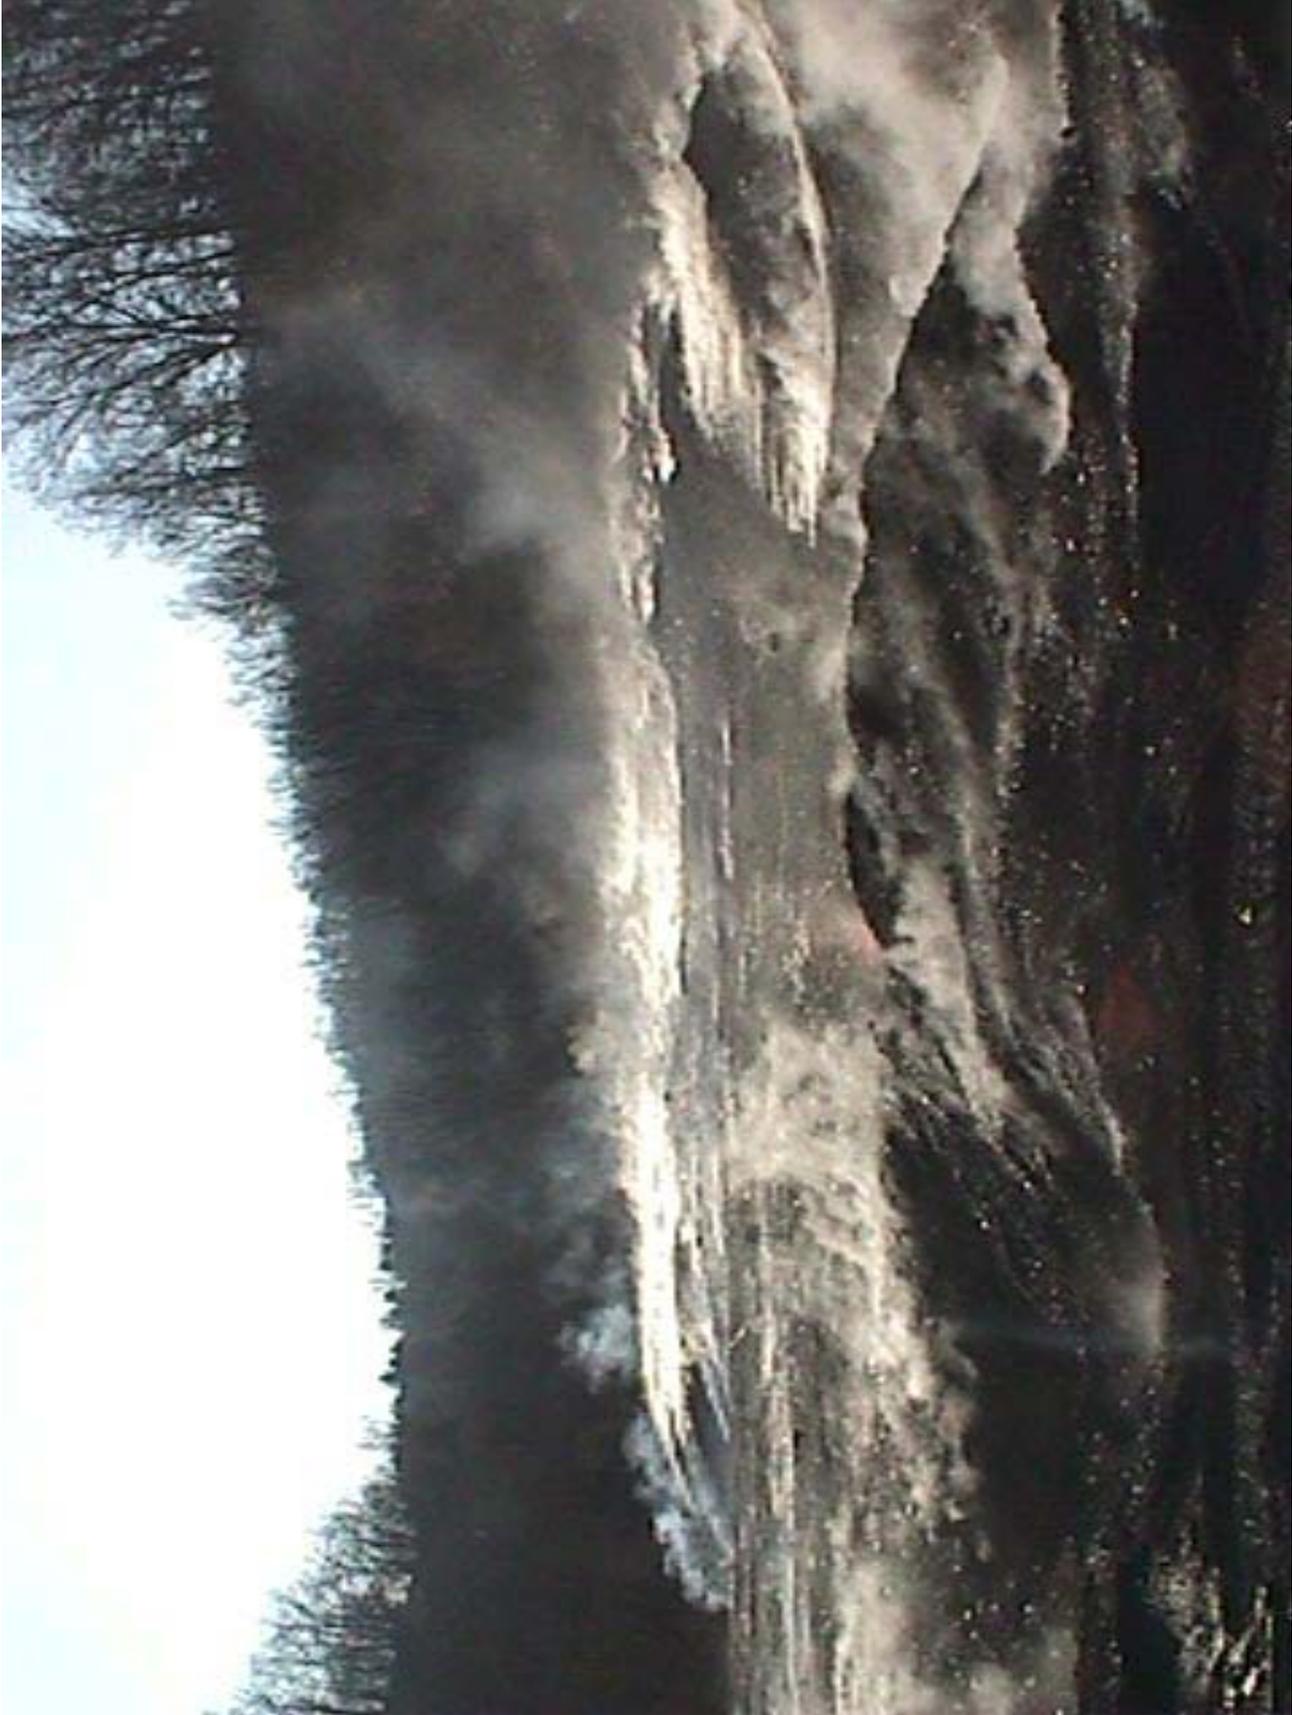
Photograph #1: Date - January 21, 2002. Burning coal refuse (gob). Project area consisted of a 2- acre gob pile with an approximate depth of 25 feet.

The Ohio Division of Mineral Resources Management (DMRM) received a complaint in November of 2001 indicating that the gob pile located on Brier Ridge was on fire. Upon inspecting the site it was discovered that an approximate 1000 square foot portion of the pile was on fire or smoldering and that the fire had spread to some of the surrounding trees. The Ohio Division of Forestry had been to the site the previous day to extinguish the burning trees and to cut fire breaks

A public meeting was conducted to review the concerns raised and to outline the Division's plan to extinguish the fire and reclaim the site. Meanwhile the fire was spreading within the pile rapidly and it was becoming a serious danger to the people that used the area. The high percentage of coal in addition to the porous composition of the pile allowed oxygen to fuel the combustion within the pile.

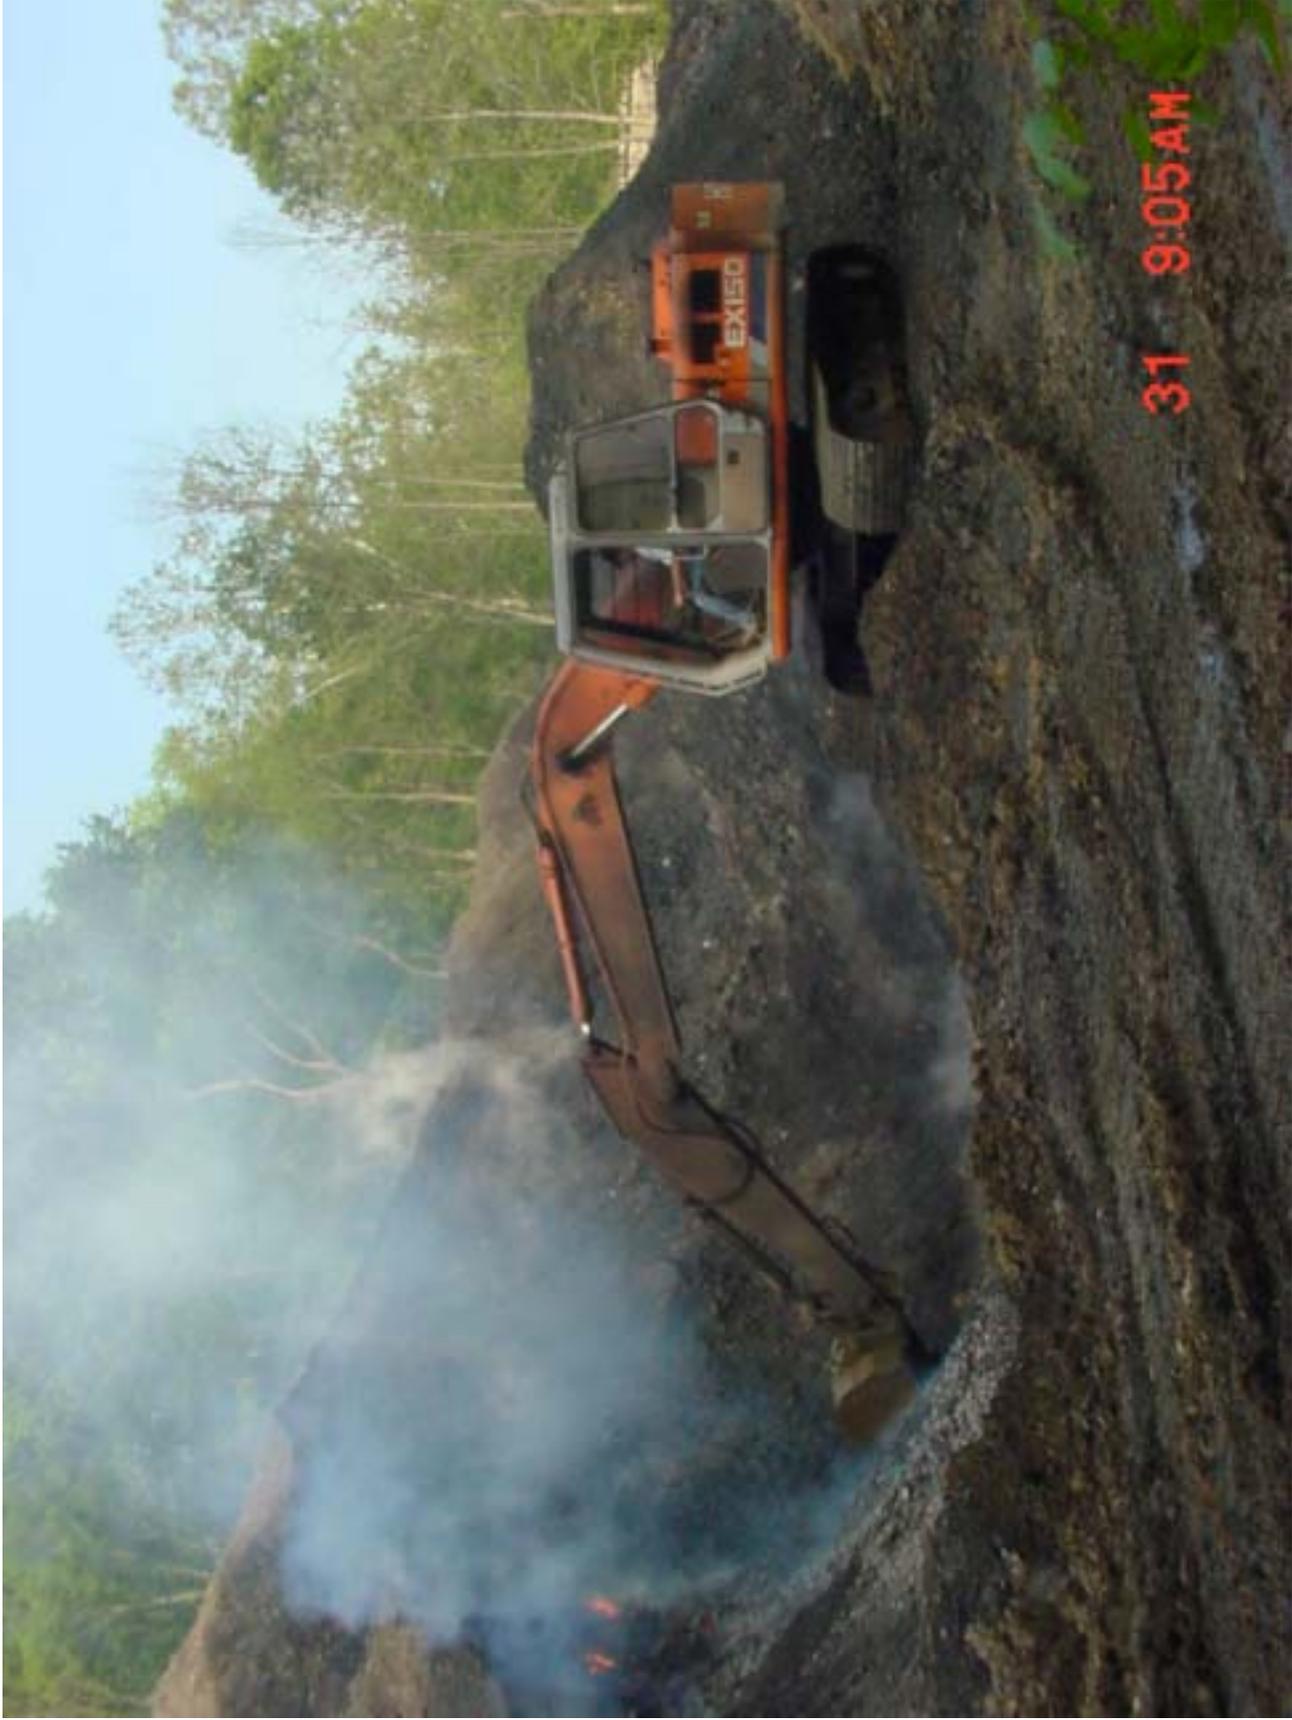
Photograph #2: Date – February 1, 2002. Track hoe excavating four foot wide trenches into the burning gob.

The contractor mobilized track hoes and dozers to the site. The track hoes were used to excavate

and place the burning material for quenching. (*See Photograph #2.*) The dozers were used to mix the hot material with the water and then to backfill the trenches with the quenched material. The contractor utilized three water pumps during the peak of the project. The water pumping was made difficult at times because of freezing weather.

The design to reclaim the gob pile required that four-foot wide vertical trenches be constructed throughout the pile and filled with buffer material to act as a firebreak. In addition, two-foot horizontal lifts of buffer material were incrementally installed to further segment the gob

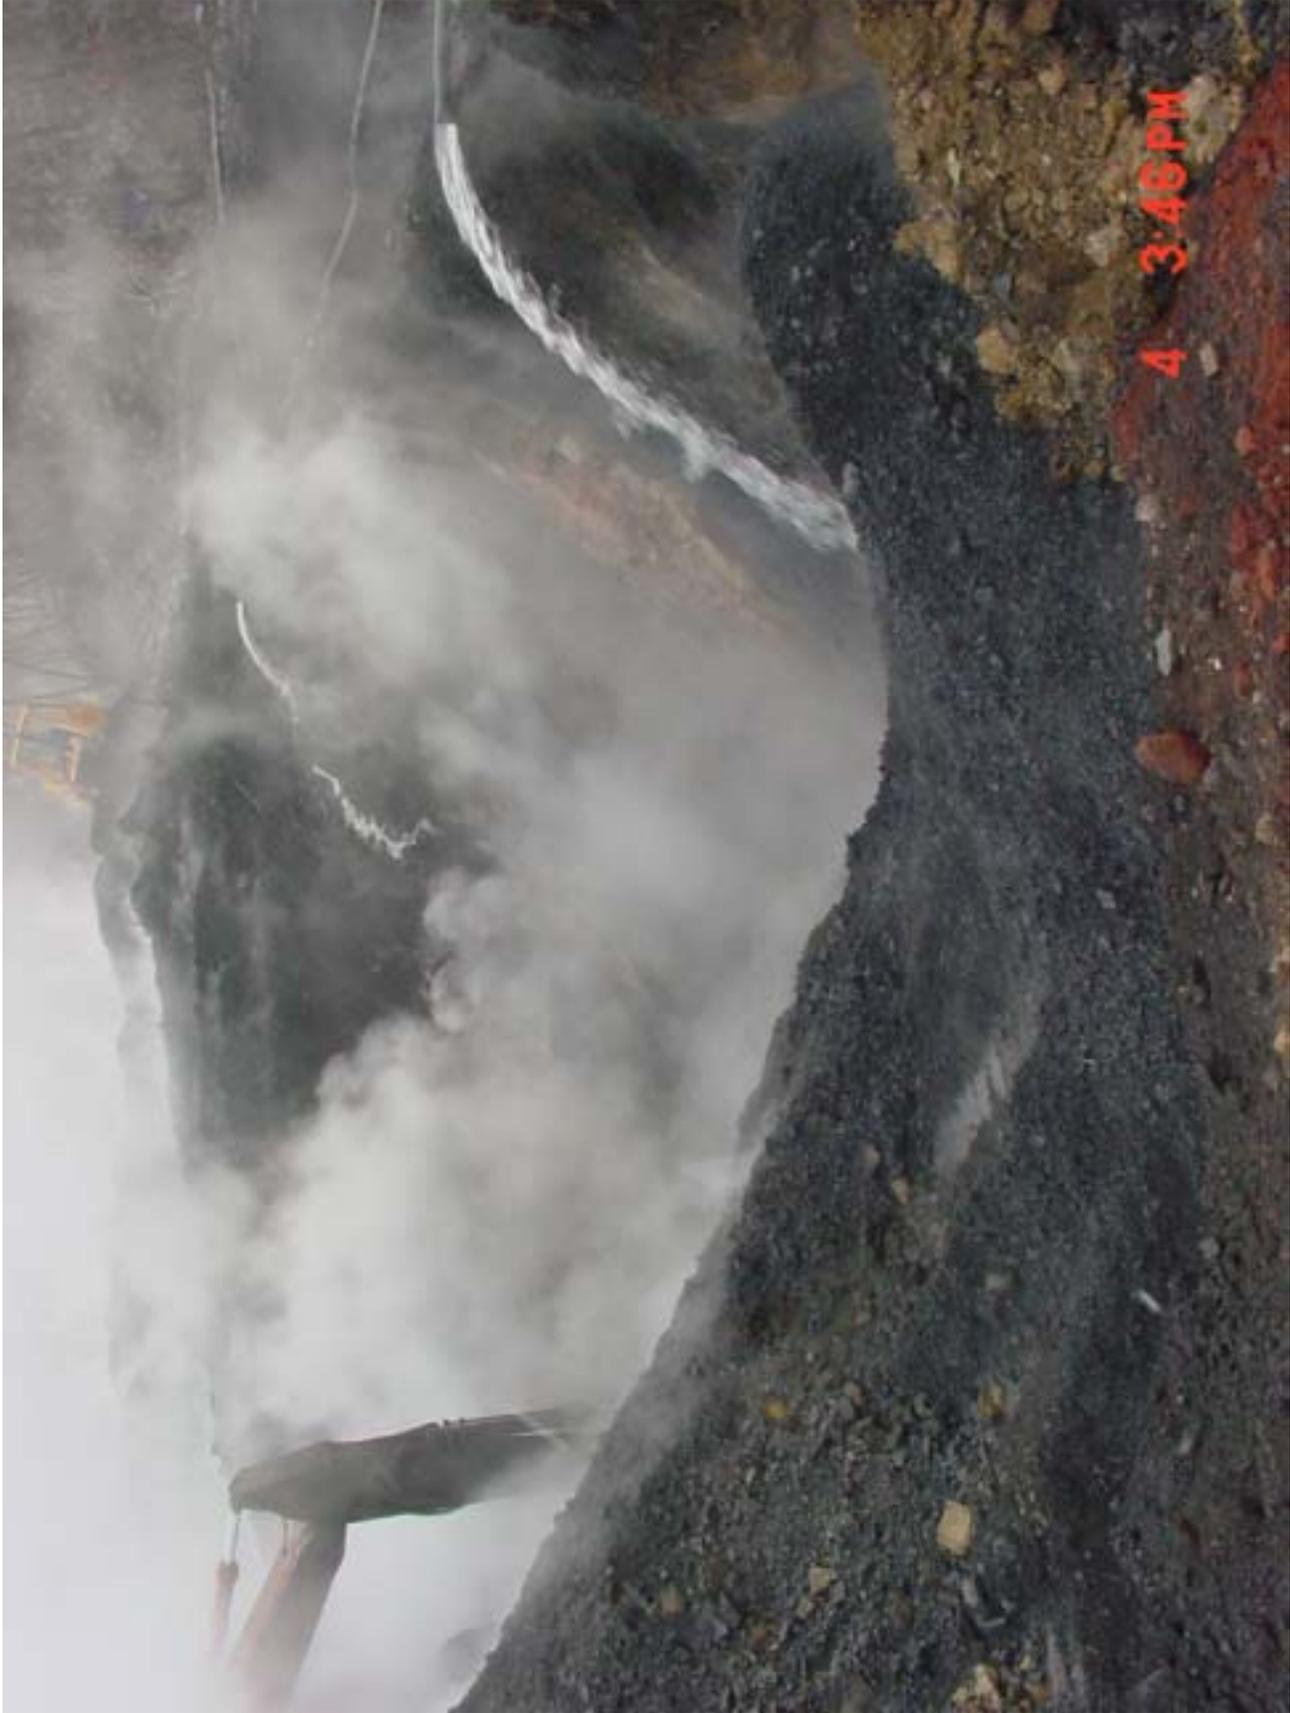
Photograph #3: Date – February 3, 2002. Quenching burning gob material. Two pumps discharging water into the sump and quenching the gob material. Track hoe excavating quenched material and placing it into four foot wide trenches.

The first phase of the project commenced on January 21, 2002. The design called for the contractor to gain access to the site, construct trenches and to extinguish the burning material excavated from the trench using water pumped from nearby Piney Fork Creek. The extinguished material would then be placed back into the trench and compacted to reduce porosity. Diversion ditches and silt fences were used to protect the surrounding area including Piney Fork Creek from sediment during construction.

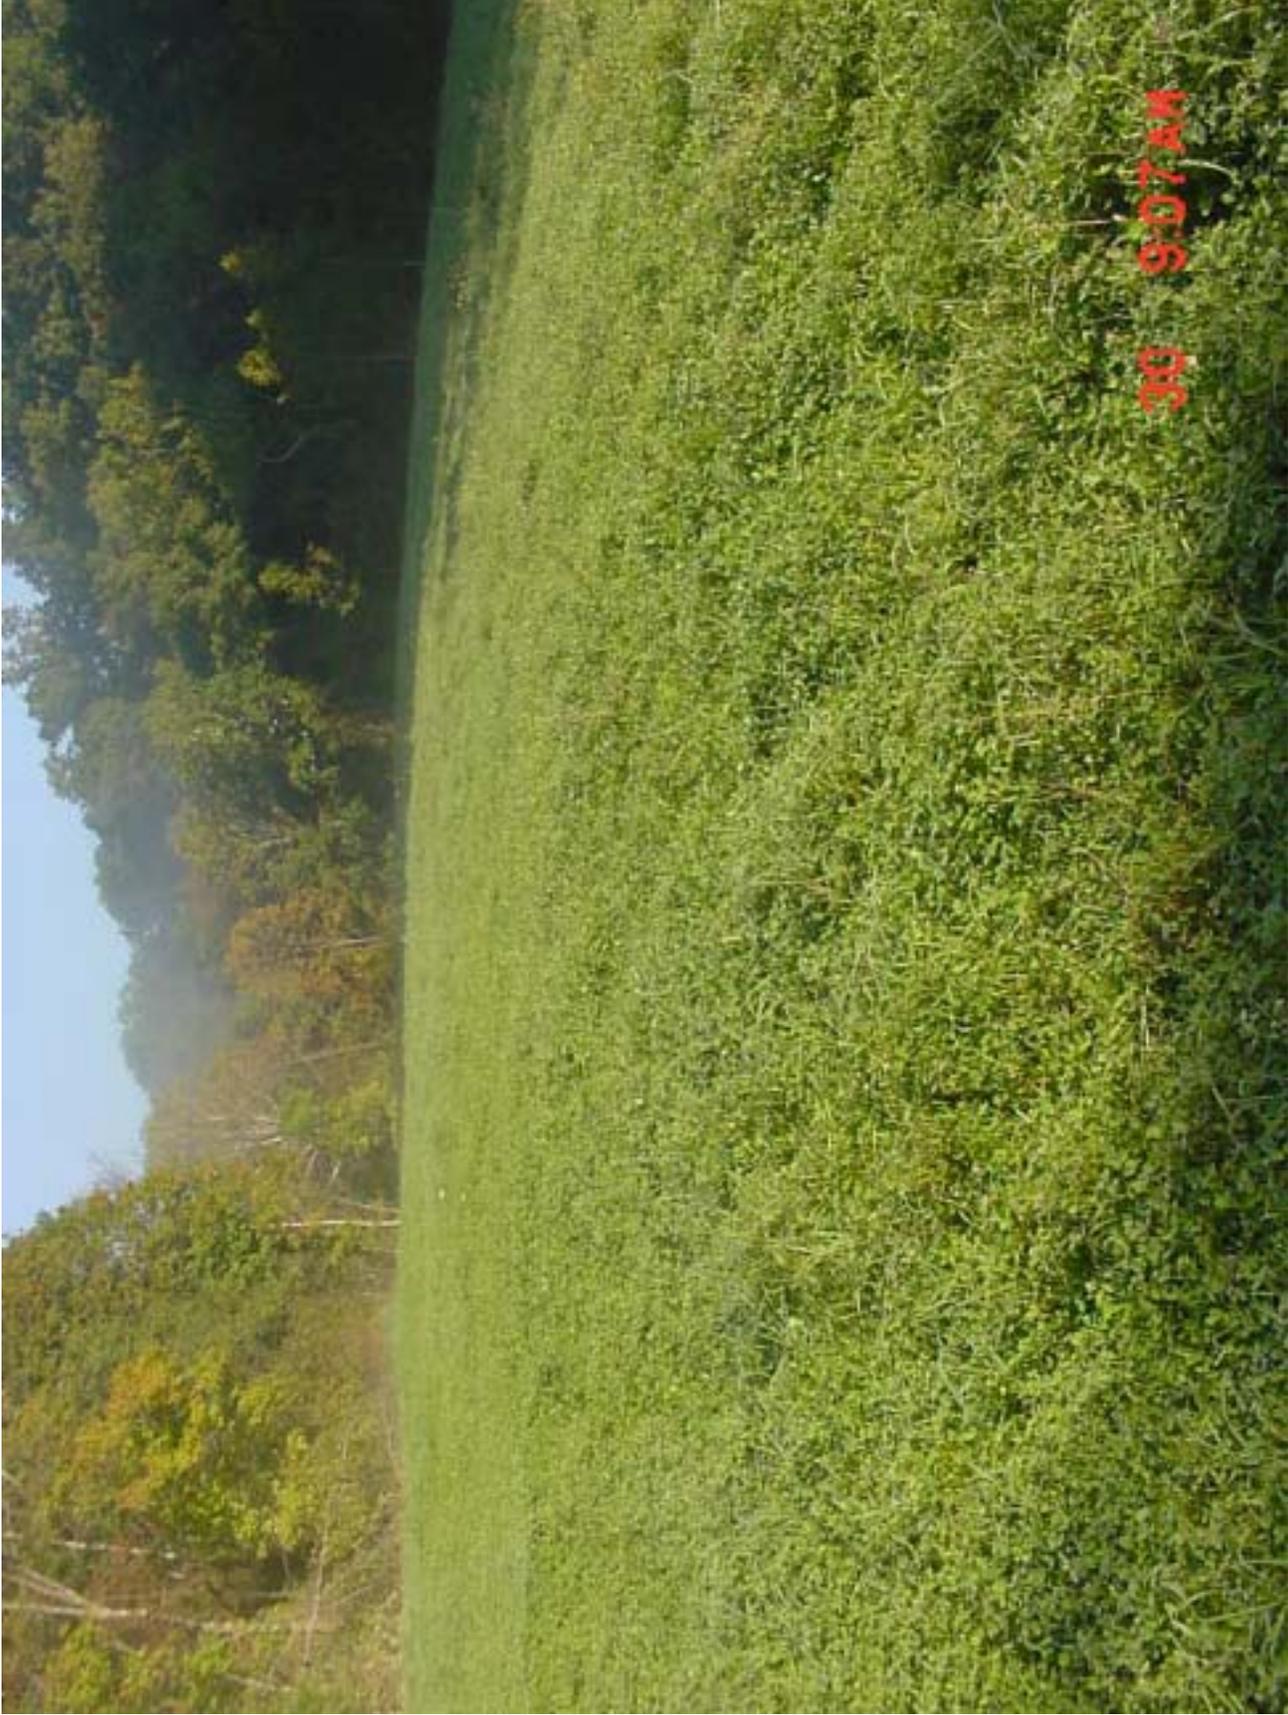
Photograph #4: Date - October 15, 2002. Reclaimed gob pile. Fire extinguished, layered with non-combustible material, capped with 8 inches of soil, vegetated with grasses and legumes.

A major problem faced in the project's second phase was that a new fire had engulfed the entire previously unaffected portions of the site. The fire started back up as consequence of it not being totally extinguished after the first phase. The contractor had to excavate these new areas and quench them using the same technique that was used to complete the first phase. This required the additional burning refuse to be excavated and quenched. The contractor used non-combustible material from the abandoned railroad roadbed to mix with the gob throughout the site. The design called for the compaction of the pile and grading the perimeter slopes to 10 degrees or less. The entire site was resoiled to a depth in excess of 8 inches and seeded and mulched.

The two-phase project has eliminated any present or future fire danger from the gob pile site. The reclamation of the 2 acre gob pile was done in such a manner as to create gentle slopes and establish vegetative cover to eliminate future sedimentation and water quality problems occurring from the gob pile into Piney Fork Creek. *(See Photograph #4.)* A serious threat to hunters, ATV and recreational users has been eliminated. Local homeowners are no longer concerned about noxious gases and fumes from the gob pile. The historic railroad trestle abutments remain intact and the overall reclamation project has enhanced the natural beauty of the area.
