HOUSE RESPONSE FROM BLAST-INDUCED
LOW FREQUENCY GROUND VIBRATIONS AND
INSPECTIONS FOR RELATED INTERIOR CRACKING

Final Report to the Office of Surface Mining
Contract ID: 143868-PO96-12616

Steven V. Crum¹
Geophysicist

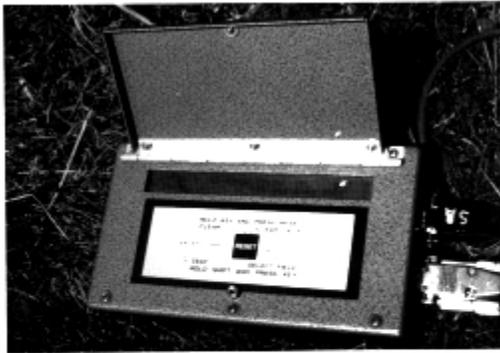
Figure 14. The Mini-Seis Seismograph.

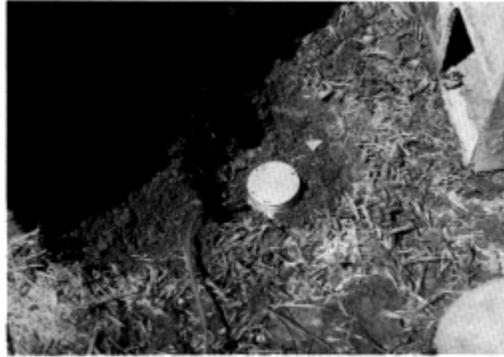
Figure 15. Shallow-burial installation of the Mini-Seis ground vibration transducer. Before monitoring, the geophone was covered with soil, lightly tamped around the edges and top.

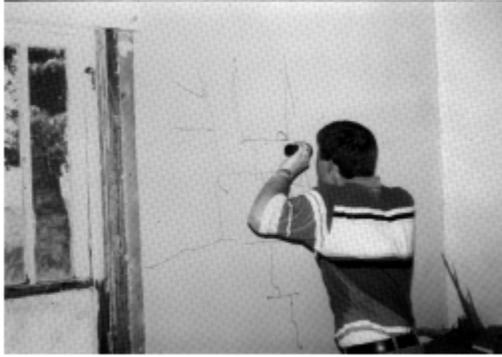
Figure 28. Visual inspections for cracking at the Shack. A 7-power optical magnifier and sidelight are being used. Preexisting cracks before the study were highlighted with marker.

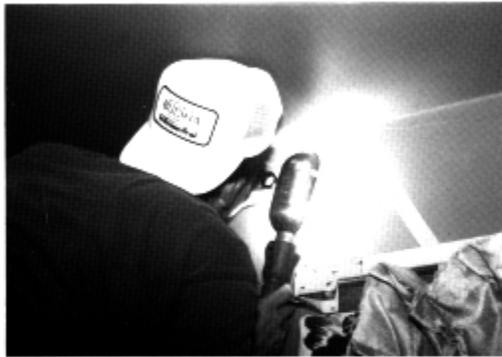
Figure 29. Visual inspections for cracking at the Lhemkuher house showing the optical magnifier and 100 watt sidelight.
